Maintenance Painting of a 20-year Old Metallized Through Truss

Todd S. Thompson, PE – South Dakota DOT

J. Peter Ault, PE – KTA-Tator

Aberdeen Truss

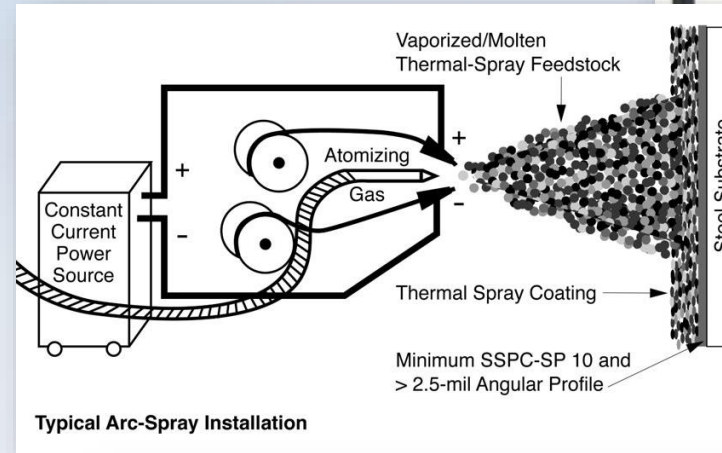
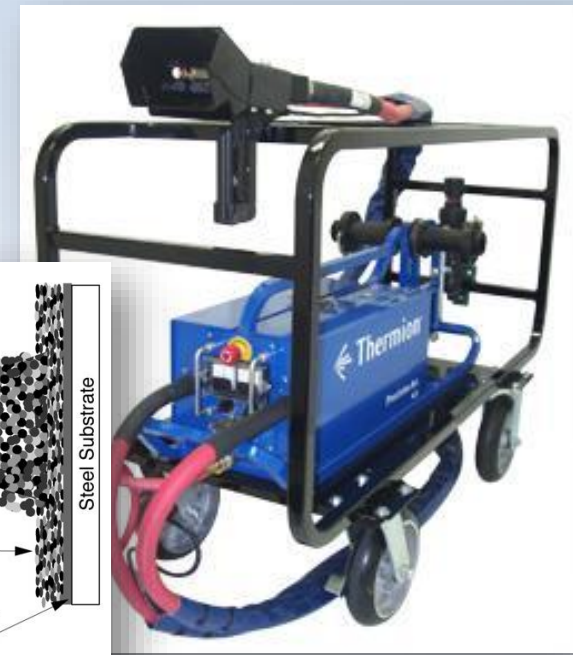
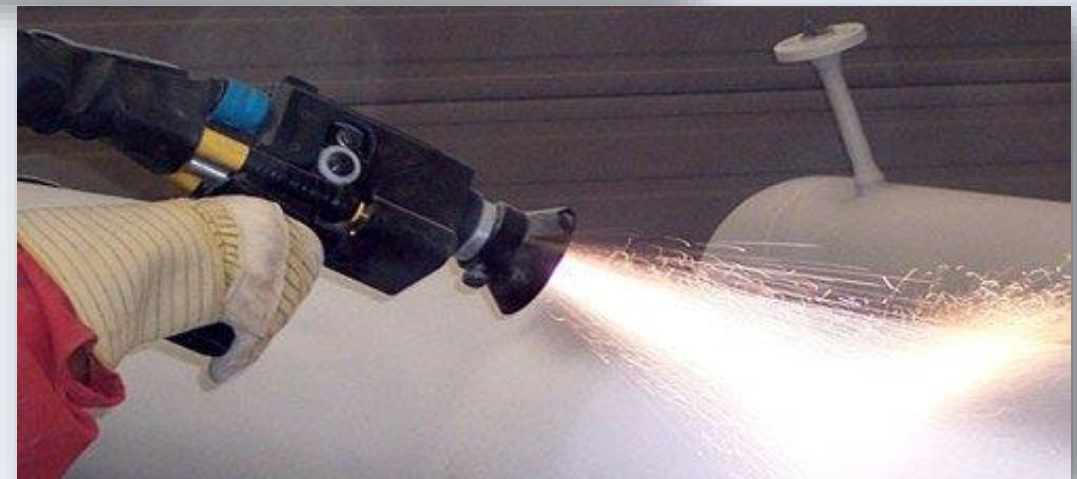
- Fabricated, metalized and seal coated in a shop
 - SSPC SP5, White Metal Blast Cleaning; surface profile of 2.5 to 4.0 mils
 - 85/15 Zinc-Aluminum TSM, 10 to 12 mil thick
 - Theoretical 1.5-mil sealer coat applied to all metallized surfaces
- Field repairs reported

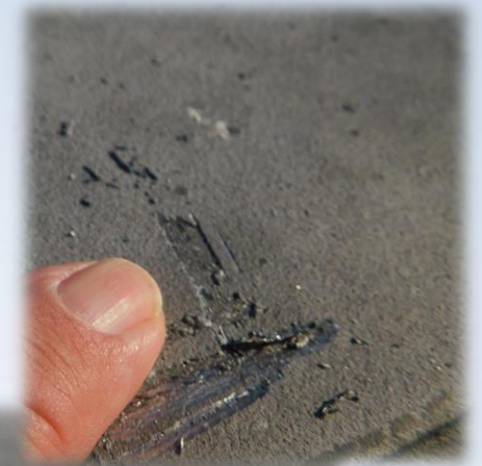
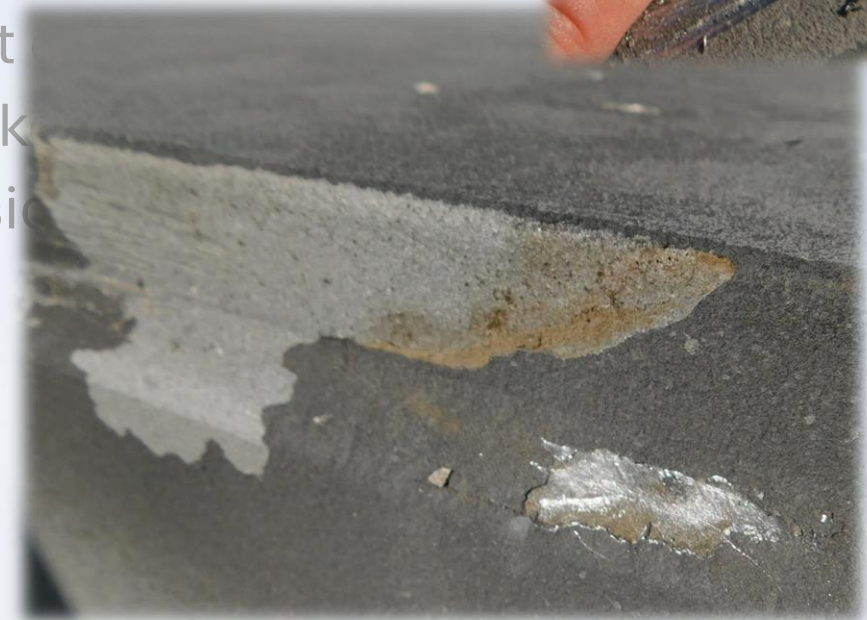
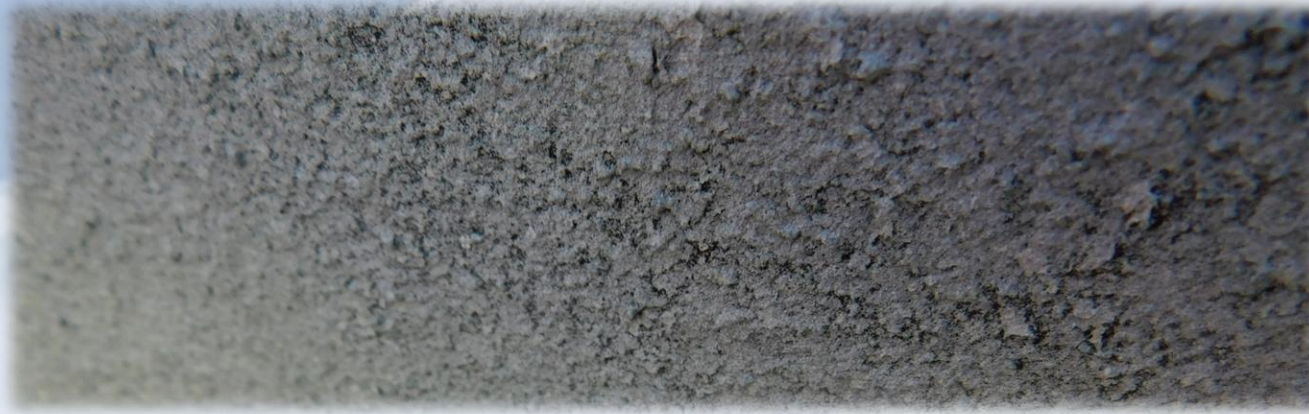
- Coating investigation showed
 - Delamination of field repair coating
 - Blistering and delamination on flame cut
 - Mottled appearance due to uneven break
 - No significant section loss due to corrosion

- Flame Cut Edges
 - Solvent Clean as necessary
 - Grind accessible edges (no adjacent welds)
 - Prepare to SP-10, Near White Metal Blast Cleaning
 - Apply organic zinc primer, epoxy intermediate and urethane topcoat
- Remainder of the Structure
 - Solvent Clean as necessary
 - Prepare to SP-18, Thorough Spot and Sweep Blast Cleaning for Industrial Coating Maintenance
 - Apply organic zinc primer to bare steel locations
 - Apply penetrating primer to retained metallizing
 - Apply epoxy intermediate and urethane finish coat to all surfaces

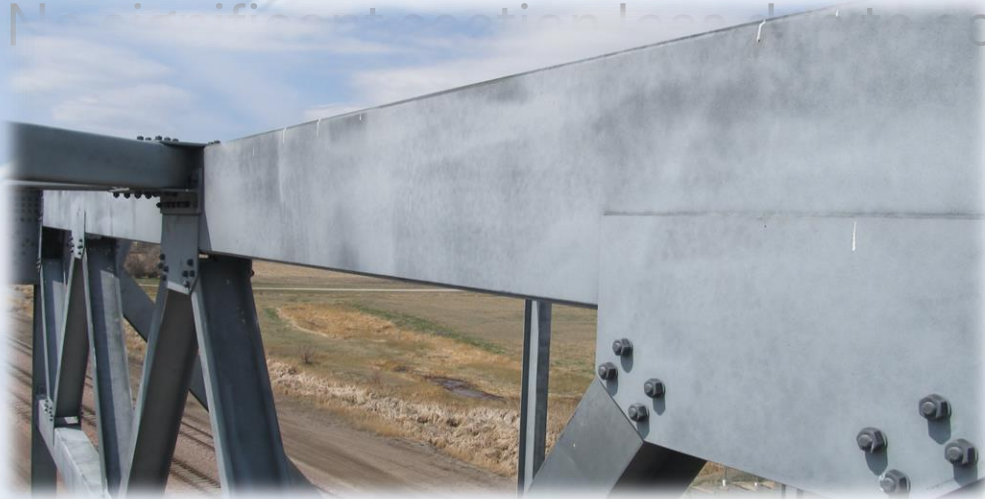
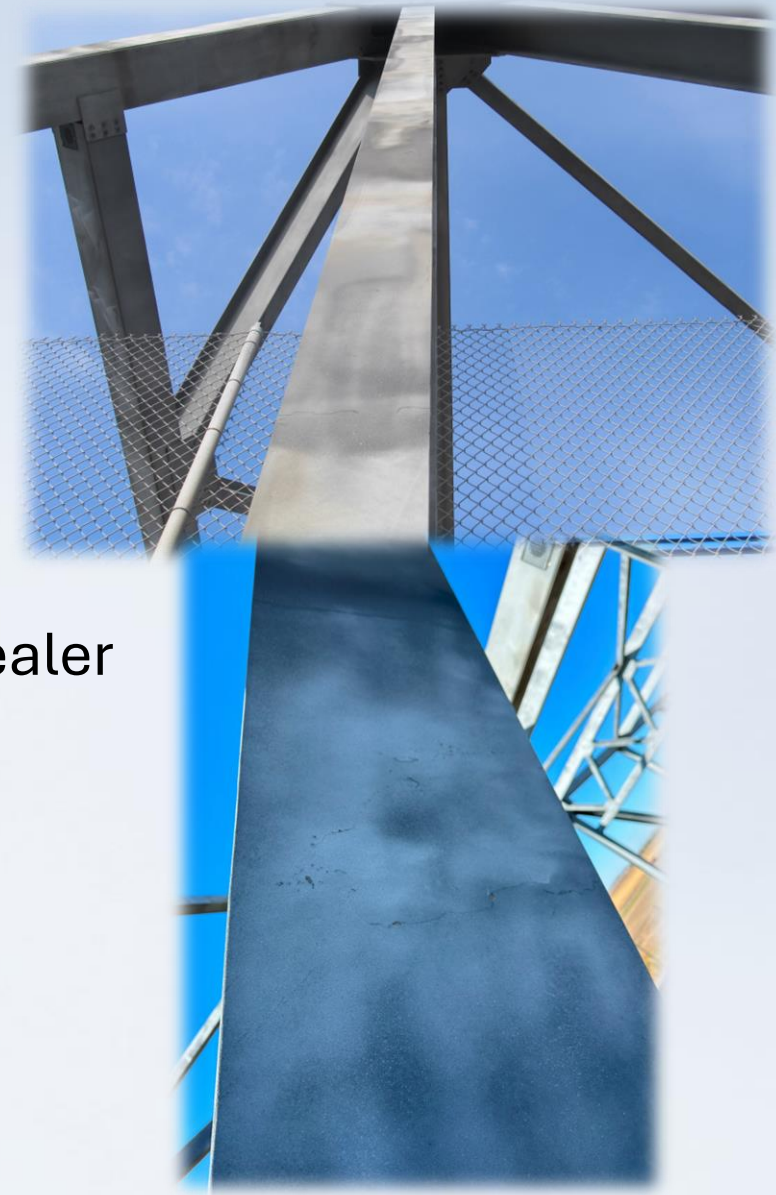
- Coating investigation showed
 - Delamination of field repair coating
 - Blistering and delamination on flame cut edges
 - Mottled appearance due to uneven breakdown of sealer
 - No significant oxidation loss or pitting corrosion

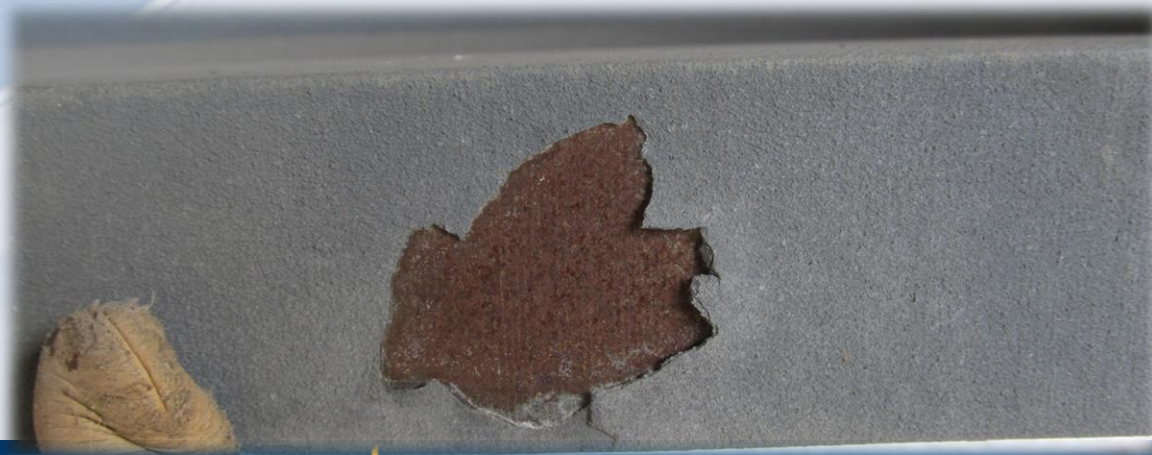
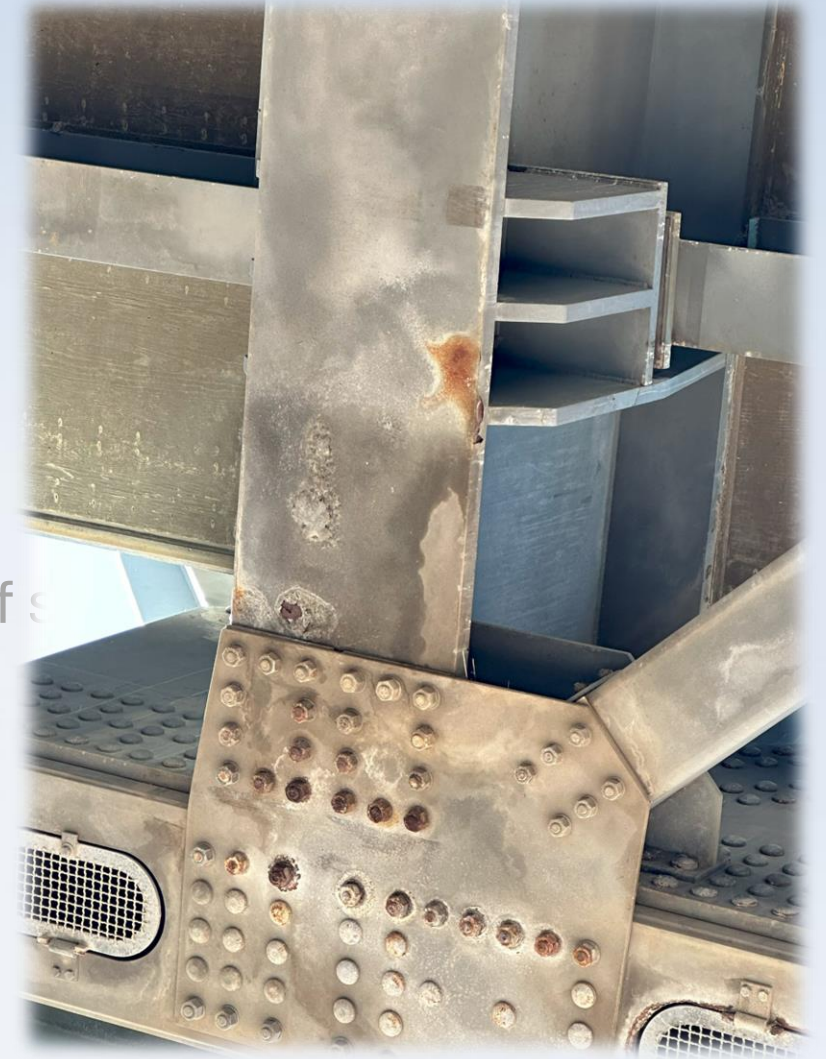
- Coating investigation showed
 - Delamination of field repair coating
 - Blistering and delamination on flame cut edges
 - Mottled appearance due to uneven breakdown of s
 - No significant section loss due to corrosion
