NDE and Live Load Testing

Emergency Investigation of AASHTO Girders

Rebecca Nix, SE
Utah DOT

Shane Boone, PhD, PE
BDI

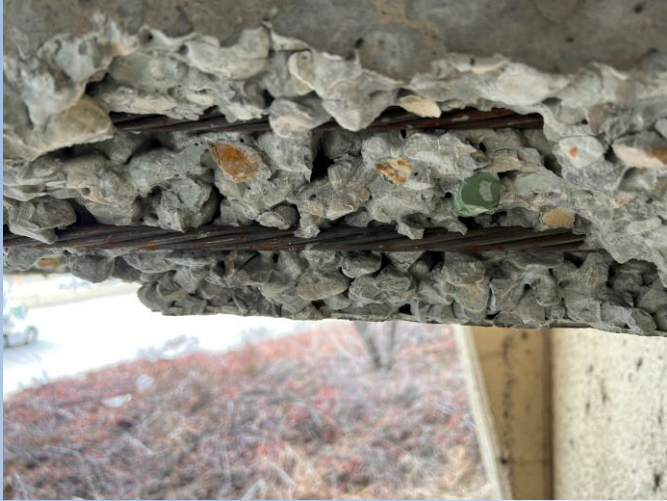
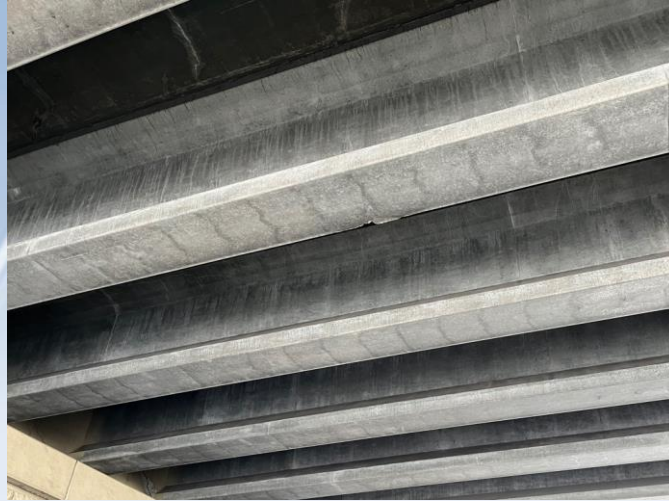
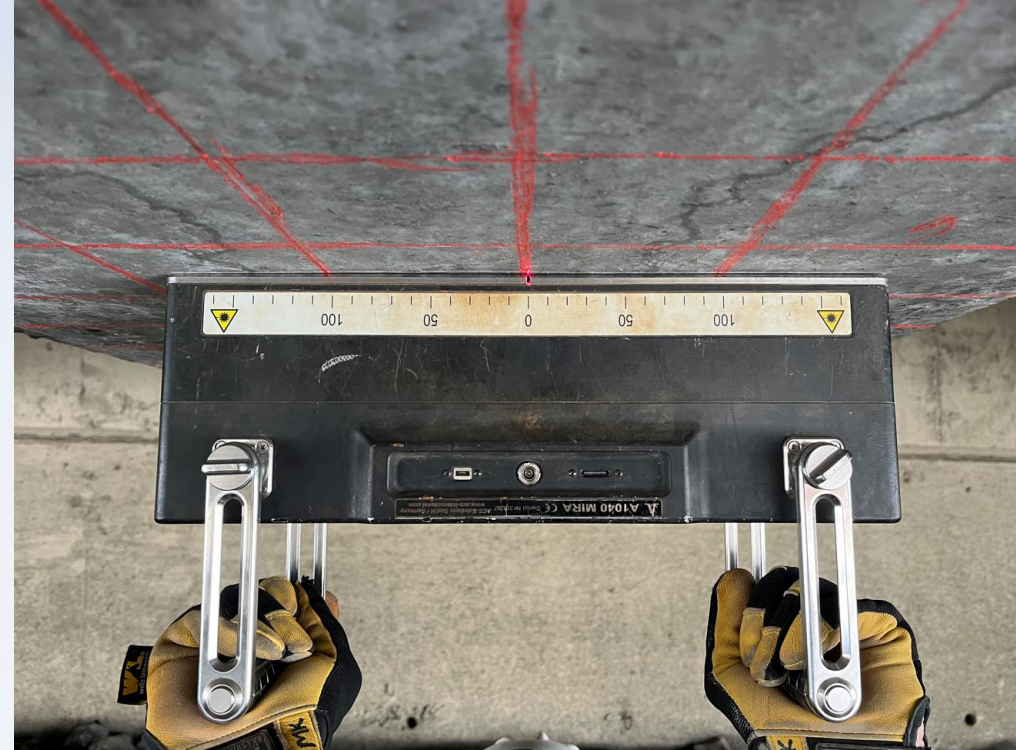
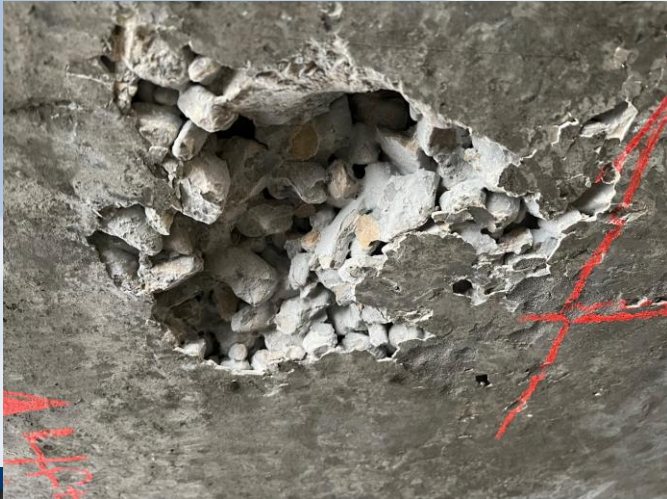
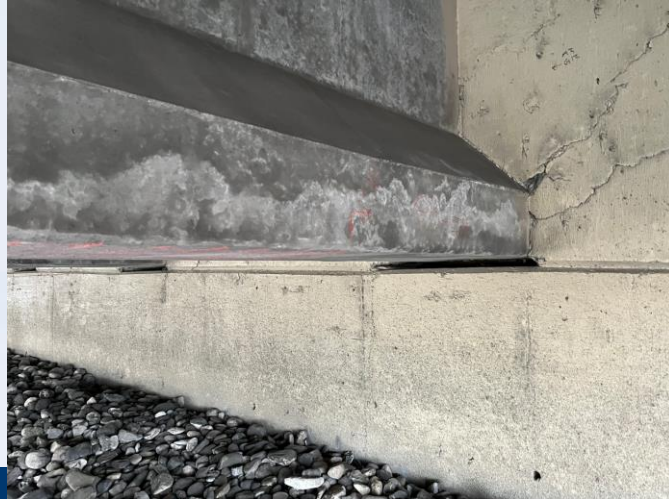
Field Observations and Ultrasound Application

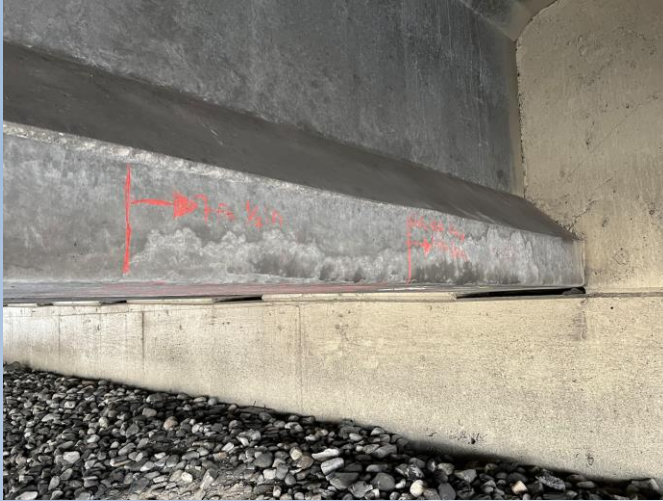
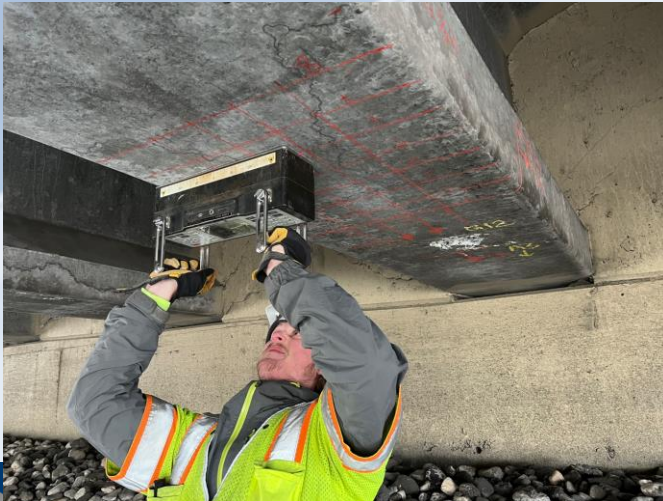
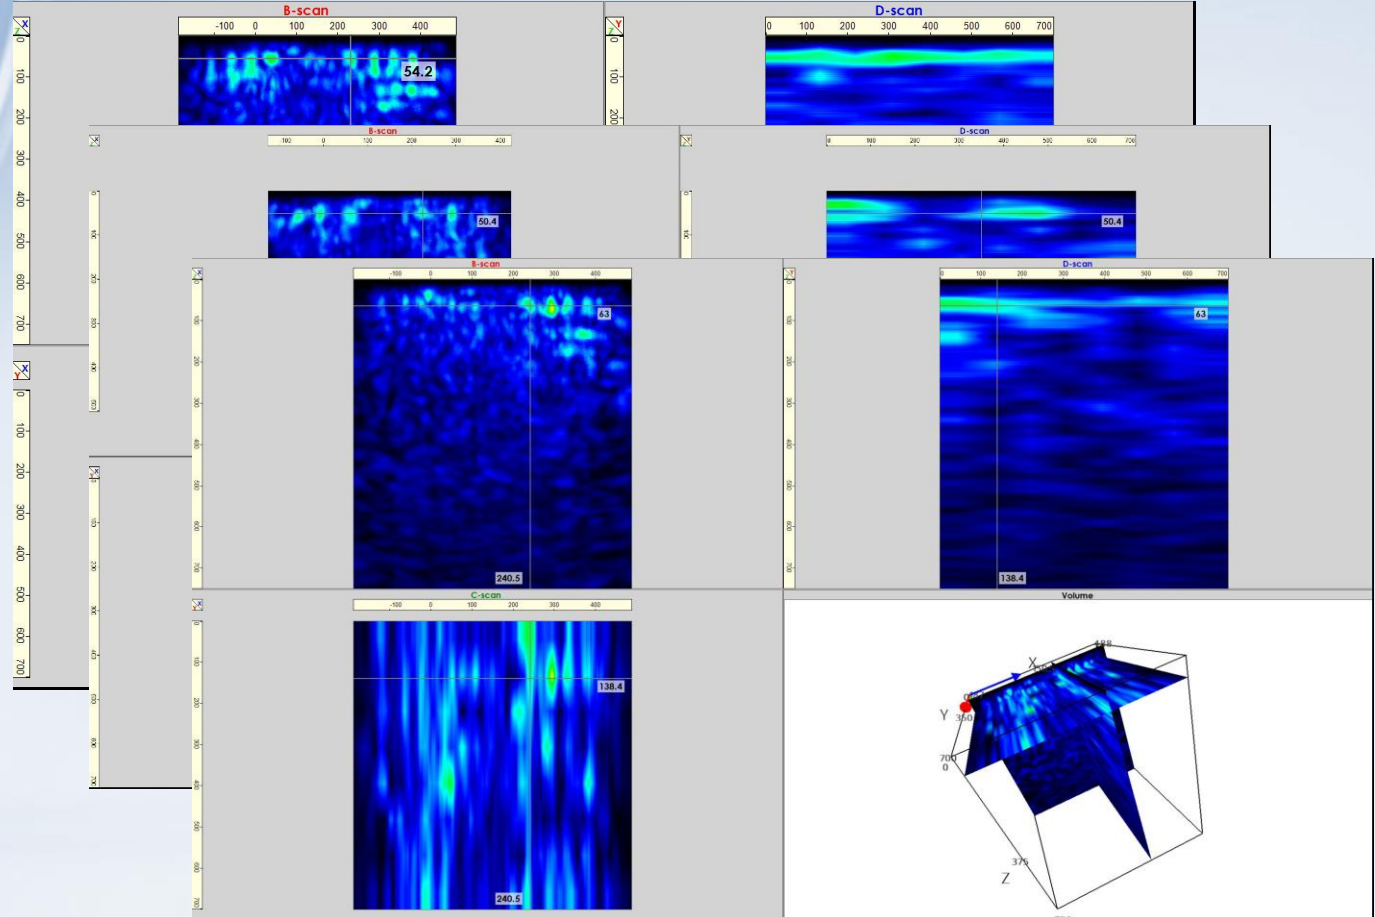
NDE Investigation

- Voids in flanges were likely caused by inadequate consolidation and segregation at the time of placement
 - Inadequate vibration/over vibration
 - Stiff concrete mix
 - Delayed placement
- Honeycombing between the prestressing strands may affect the flexural and shear strength along the beam.
- Substandard concrete in thin web precast girders may:
 - Reduce shear strength capacity and thereby reduce the member's load-carrying capacity.
 - Increase cracking and reduce durability.

- Initial Recommendations:
 - Remove poorly consolidated concrete, patch, and fiber wrap
- Final Decision
 - Replace bridge as part of a capacity project

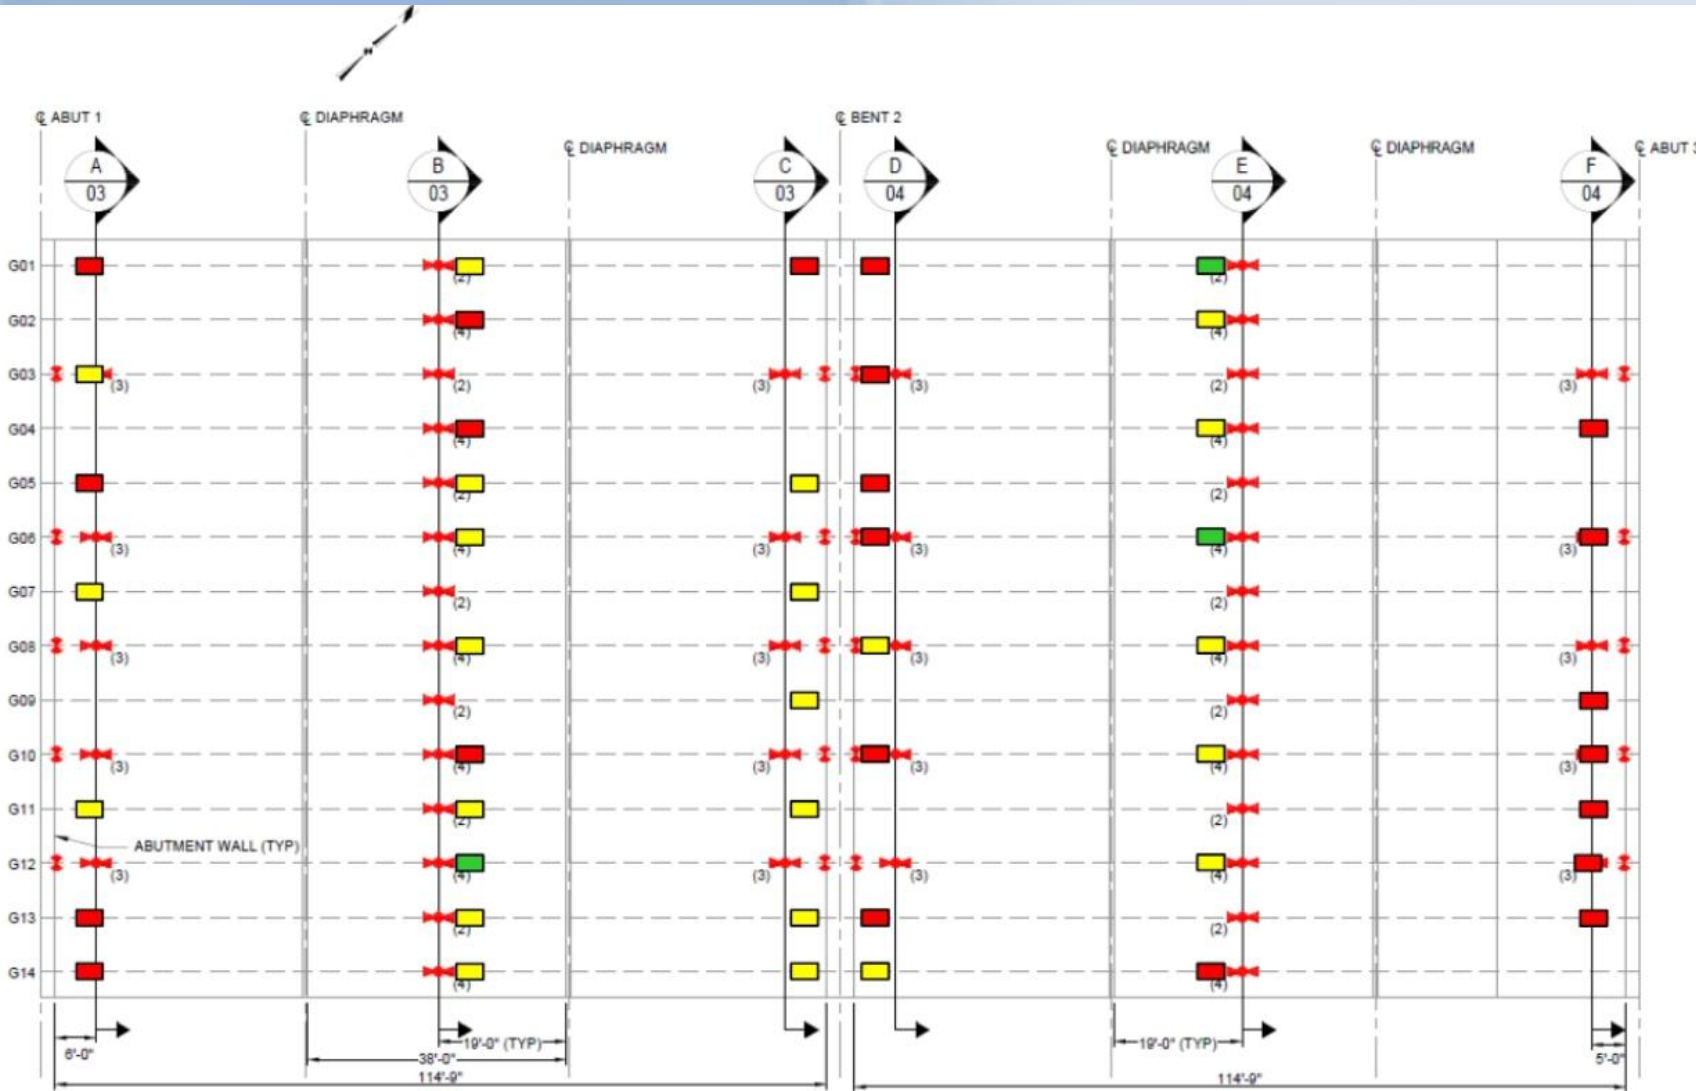
NDE Investigation – Deliverable

Total segments tested: 48

- 21 severe (44%)
- 3 good (6%)
- 24 poor (50%)

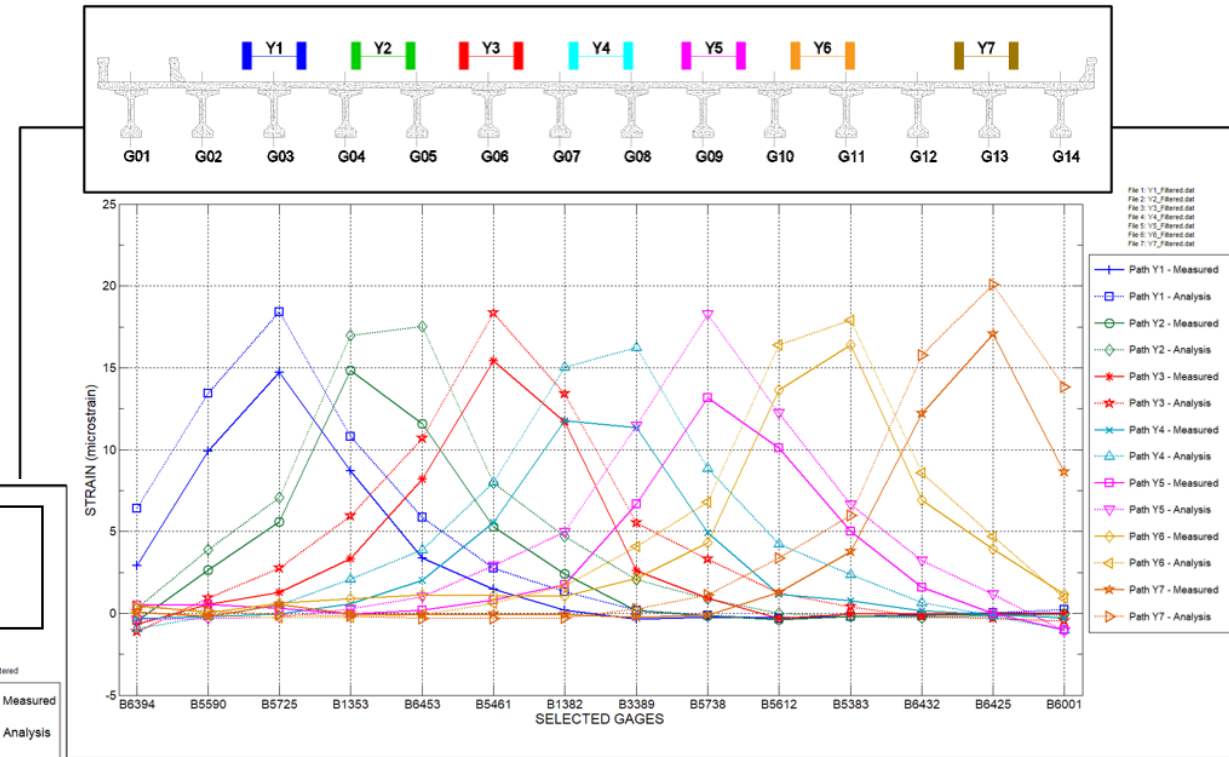
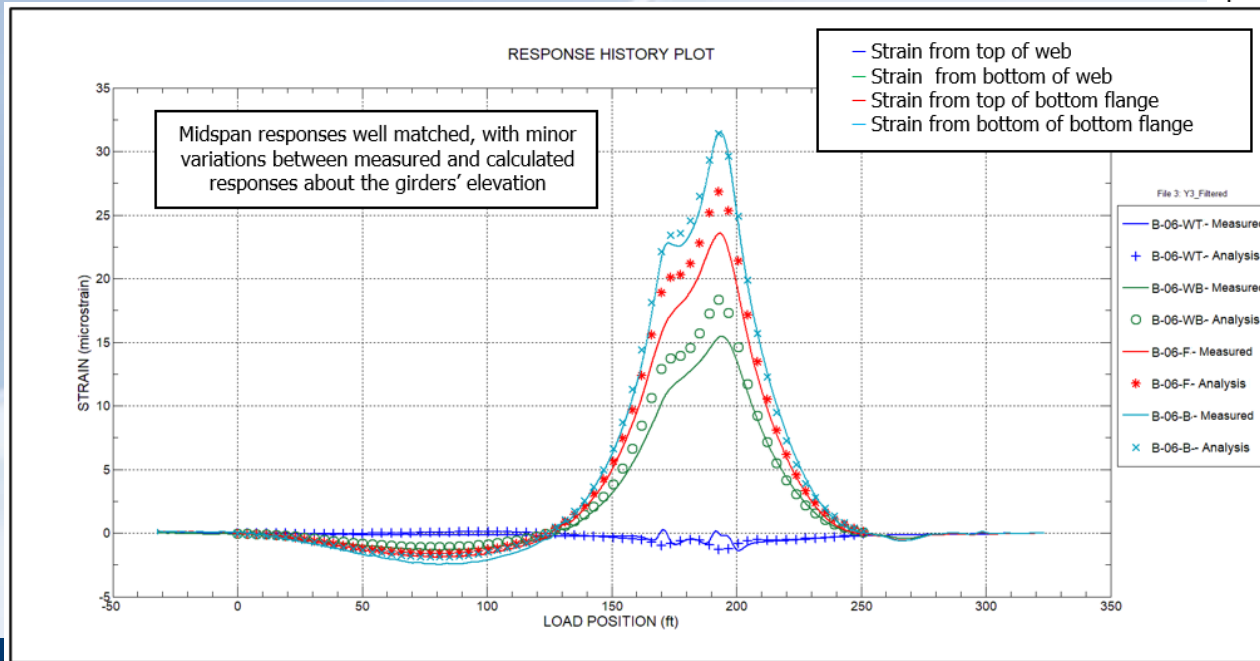
- Girder stiffness as expected and consistent
- Girder supports nearly fixed with some variation
- Concrete defects not yet influencing load paths
- Does not suggest potential strand bond reduction

- Modeled distribution paths typically align better with response vs. other distribution factor methods.
- Modeled and test response correlate well at this time.
