CASE STUDY OF THE REHABILITATION AND PRESERVATION OF POST-TENSIONED (PT) COMPLEX BRIDGE 690

NATIONAL BRIDGE PRESERVATION CONFERENCE 2024
Innovation for Infrastructure Resiliency

SCOPE OF SERVICES

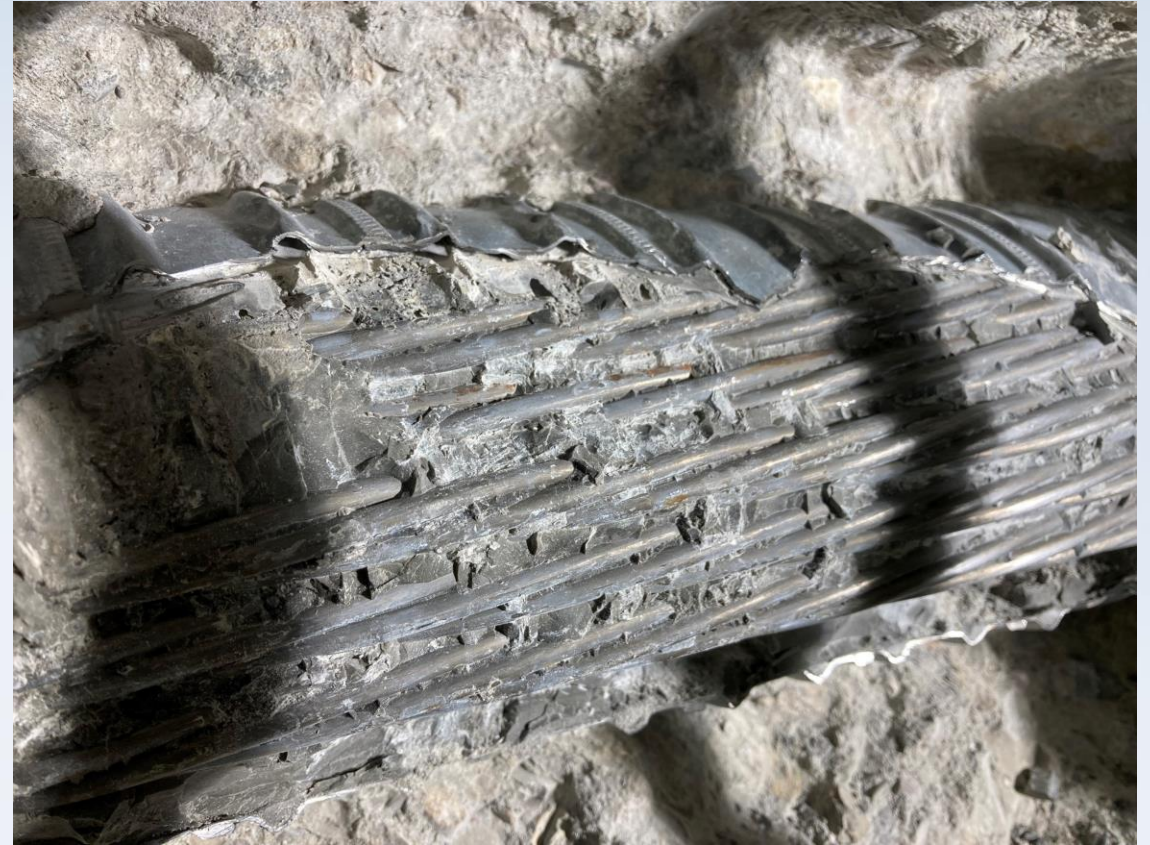
SUMMARY OF FINDINGS

- Voids were encountered at 100 of 170 borescope locations (59%). Void depths ranged from 0.25 inches to 4 inches (no grout).
- Six locations had visible water. 4 of 6 had standing water which exited during the drilling process.
- Fifty-one locations contained exposed strands.
- Sixty locations contained white/chalky grout pieces (**chunky**).
- Thirty-eight test locations contained white/chalky colored grout (**smooth**).
- Seventy-two locations contained hard, gray colored grout (**hard**).
- Strands were in fair-to-good condition with light corrosion.
- Ducts were in poor-to-fair condition with light to heavy corrosion on the insides.

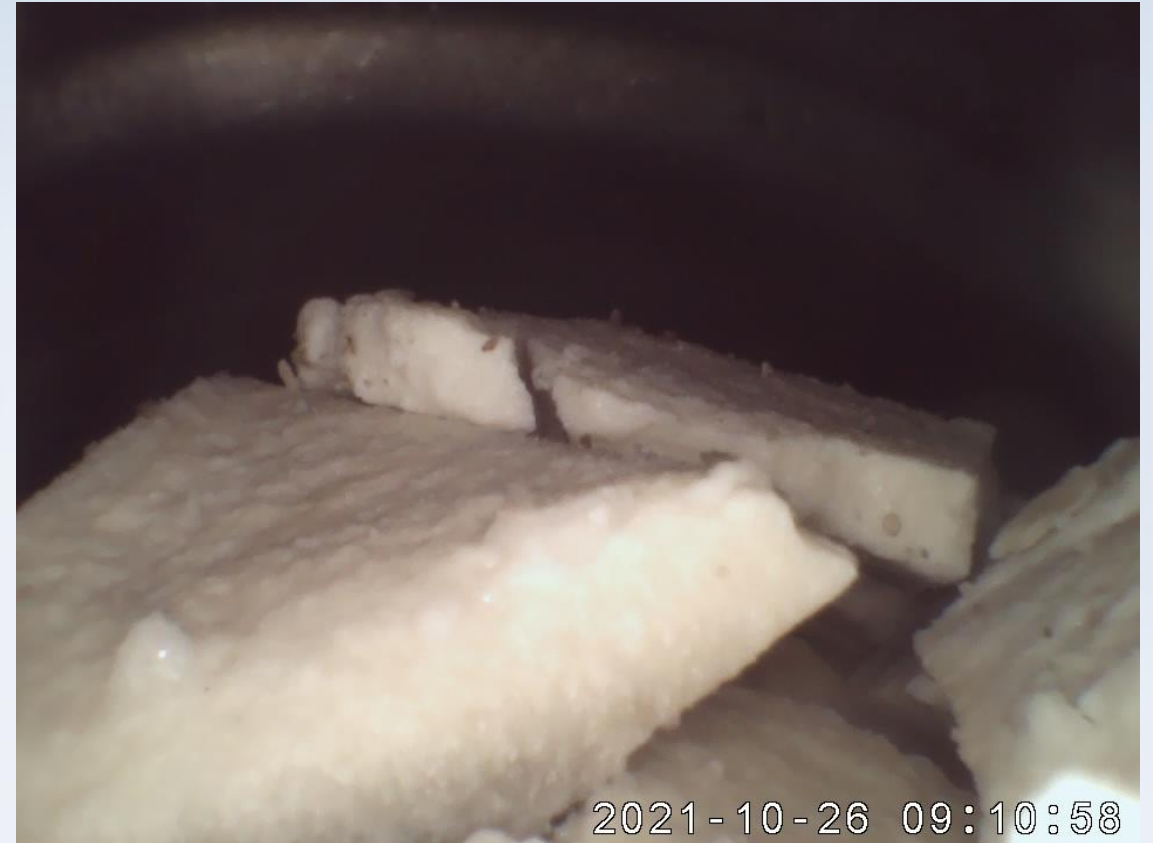
SUMMARY OF FINDINGS

- Upper limit of normal moisture content is 25%. Some of the chunky and smooth grout had up to 36.2%!
- Chloride content ranged from 0.011% to 0.042% below the upper threshold of 0.08% for new PT structures.
- Sulfate content ranged from 2.0% to 2.8% within upper threshold limits (3% typically).
- Six of nine locations exhibited a 90% probability of active corrosion (potential), 5 of 6 locations exhibited corrosion on duct interiors and/or strands. Remaining locations had inconclusive results.
- Four of seven locations exhibited moderate corrosion rates.
- Petrographic analysis indicated high pHs of 12 and above while within the duct. When exposed to air, carbonation took effect reducing the pH.
- Of the two borescope tests performed for the diaphragm tendons of pier 3, no deficiencies were found.

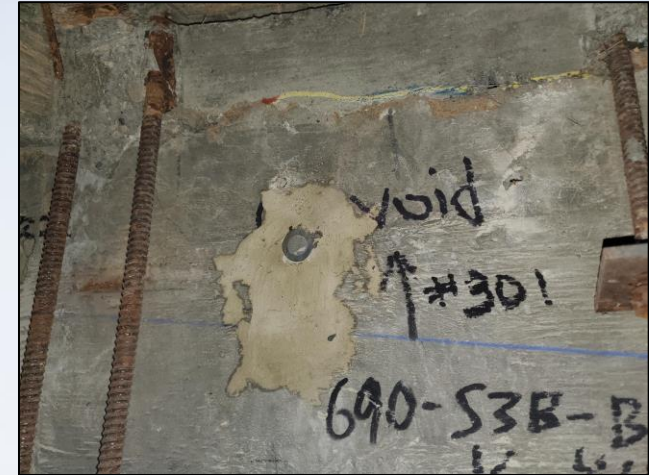
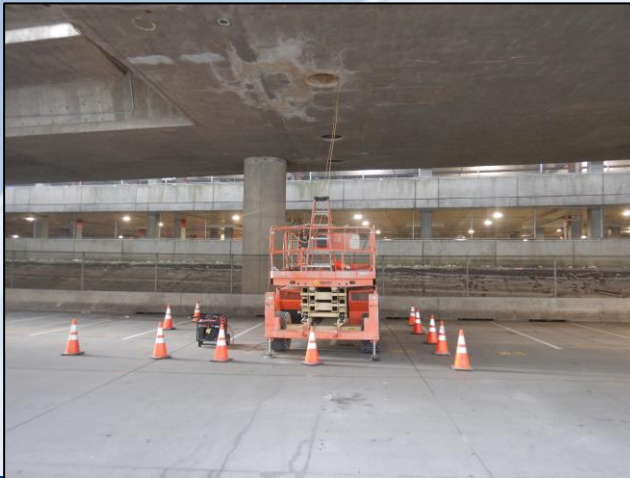
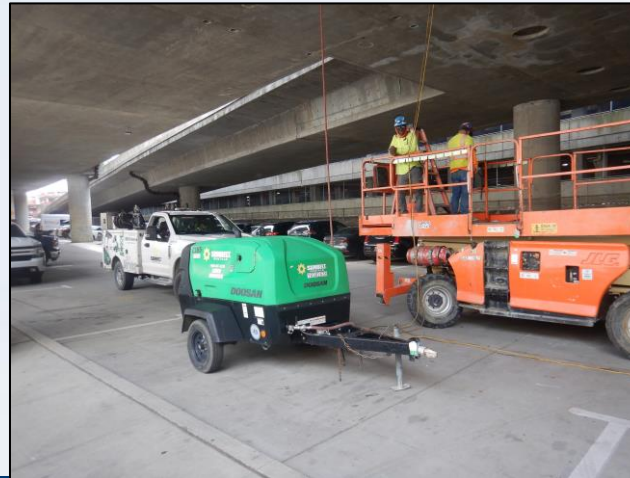
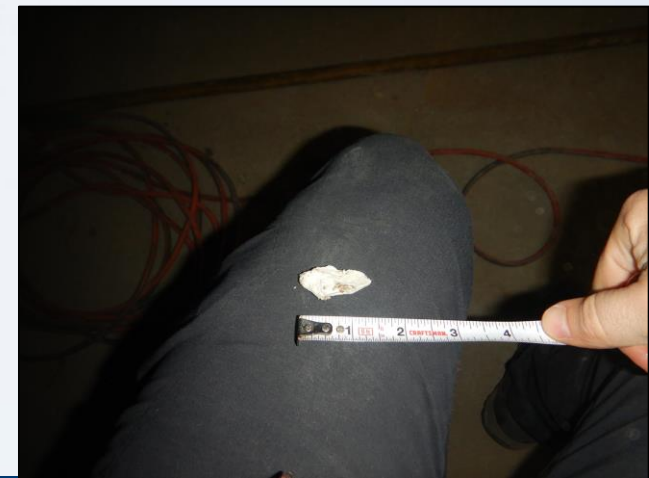
FINISHING REMARKS

- Cleaning ducts proved more difficult than expected.
- Hard to determine lengths of voids and volume of grout needed with continuous tendons.
- All plastic valves cut and ground flush with existing concrete web after remedial grouting was performed.
- All equipment was removed from project site.
- The top of the bridge was flood coated during the duration of project.
- Epoxy injection did not occur, cracks in the girder web exteriors were determined to be too narrow.
