TxDOT In-House Bridge Repairs

Seth Cole, P.E.

TxDOT Bridge Division

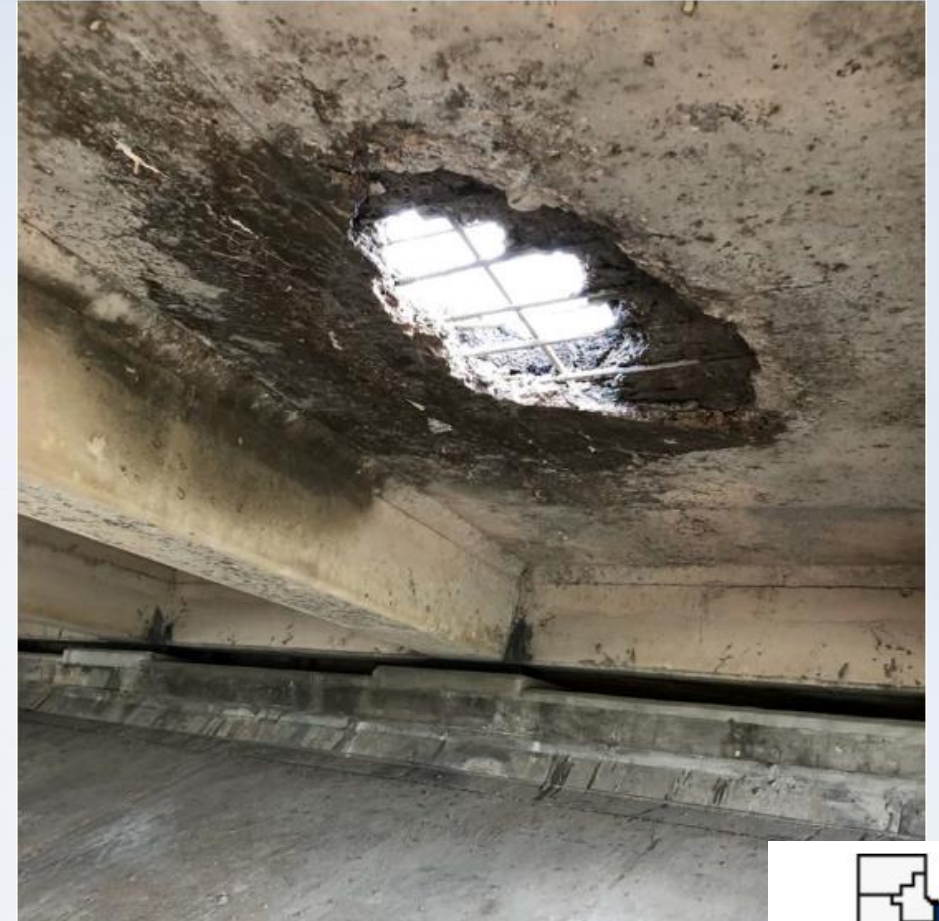
Emergency Deck Repair – Wichita Falls District

- SL 11 @ US 287 SB
- Issue reported 6/2/2021, 3:30 pm
- Immediate lane closure
- Tools, equipment and personnel dispatched early next morning
- Repairs completed by 2:30 pm 6/3/2021
- Lanes opened 6/4/2021

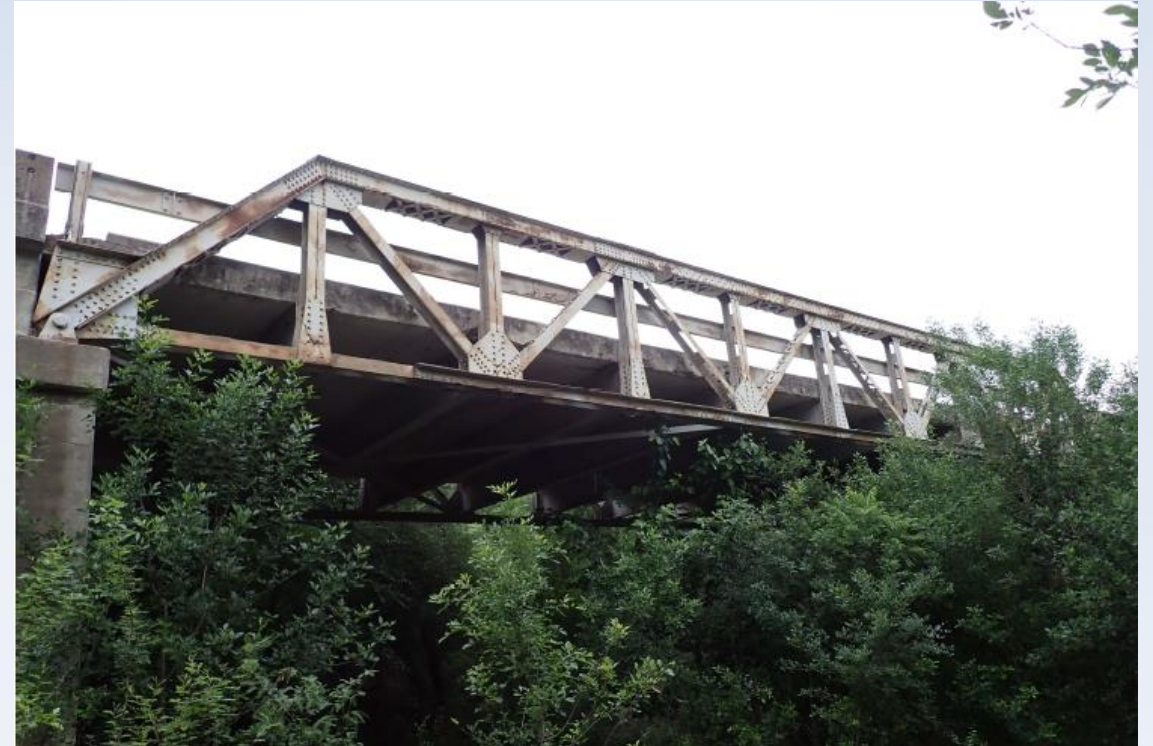
- US 281A @ Atascosa River
- Built 1925
 - Single span, warren pony truss
- Advanced section loss in gusset plates and lower chord, prompting a reduction in load posting
- Replacement in 1-2 years
- Goal – avoid reduction in load posting until replacement

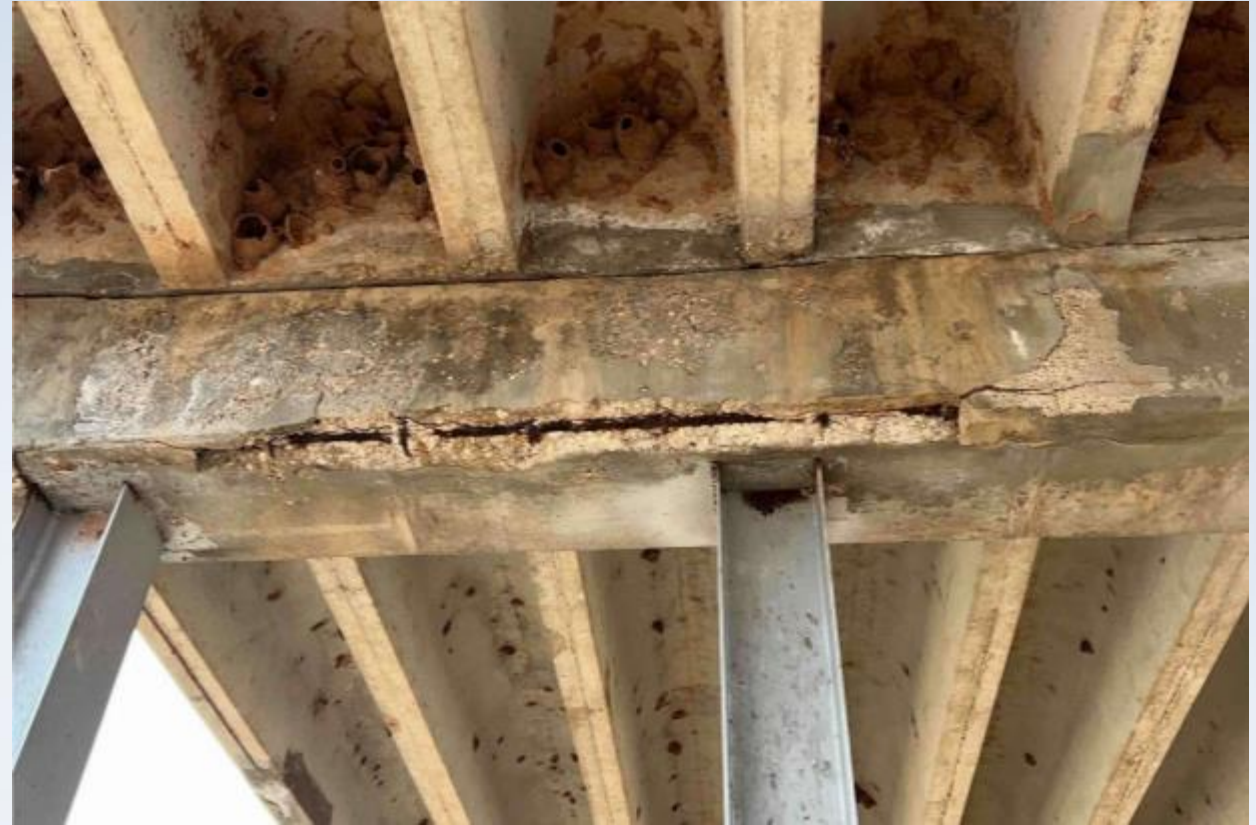
- SH 70 @ Quitaque River
- Built 1965
 - CIP “Pan girder” bridge
- Advanced section loss in primary cap reinforcing, prompting a load posting
- Replacement in 3-4 years
- Goal – avoid load posting until replacement

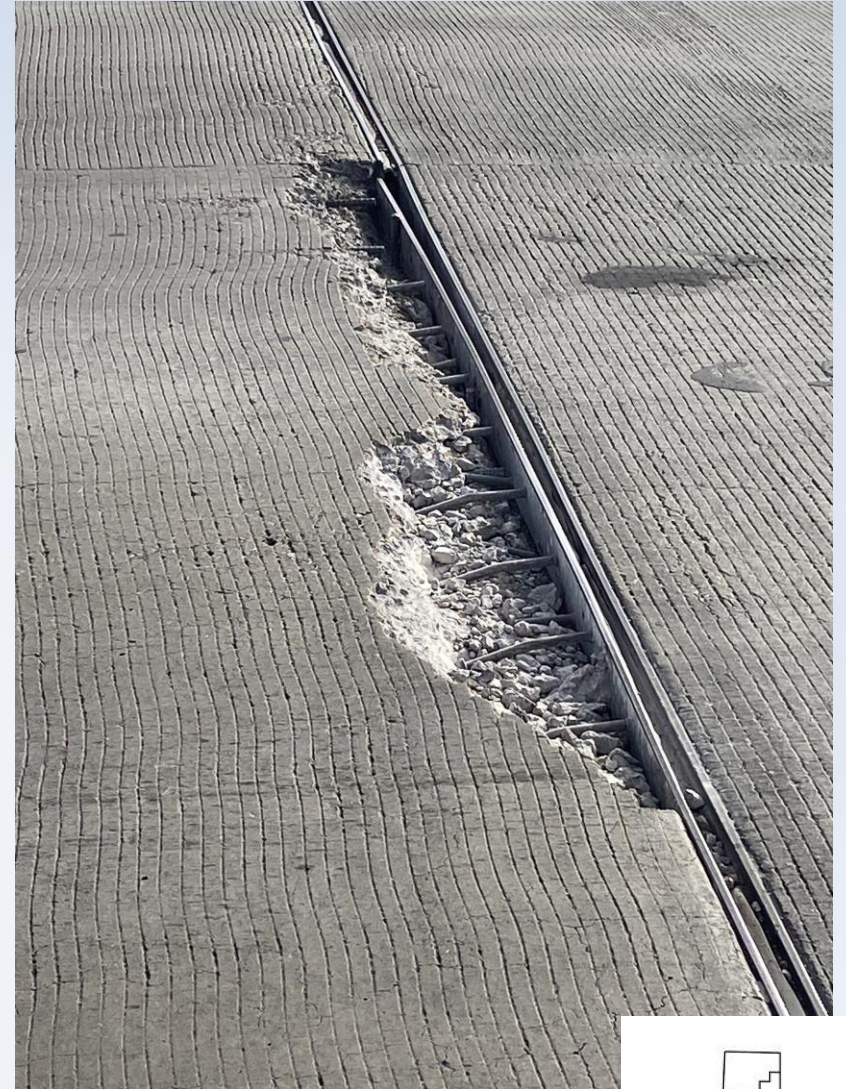
- IH 10 WB @ Geronimo
- Built 1990
 - Prestressed Conc. Box Beams
- Major spall in deck and loose armor plate
- Emergency Repair – week before Christmas!

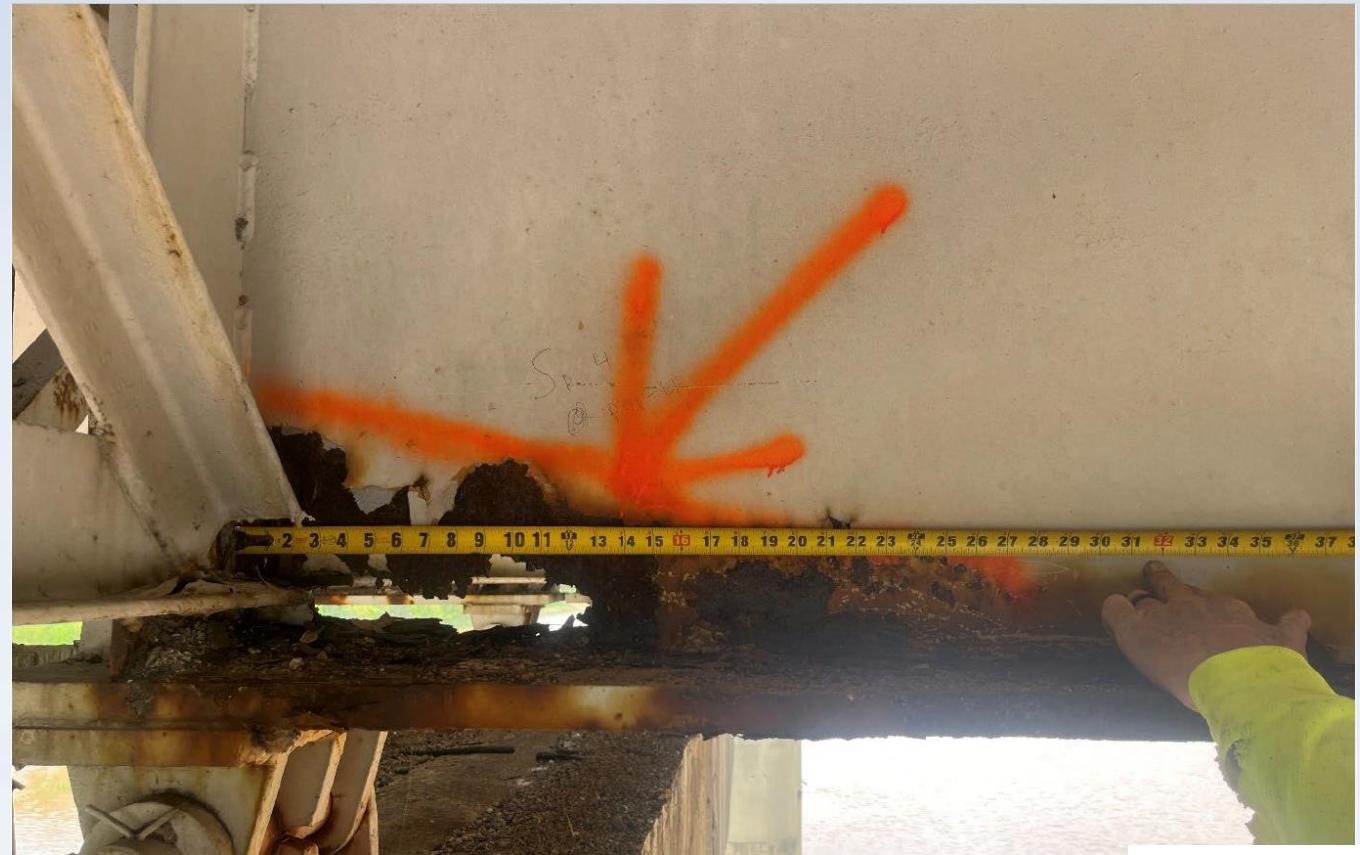
- IH 35 @ Red River
- Built 1957
 - Steelplate girder bridge
 - 48” webs
- Inspection – Oklahoma
- Maintenance - TX
- Advanced section loss at beam end prompting critical finding

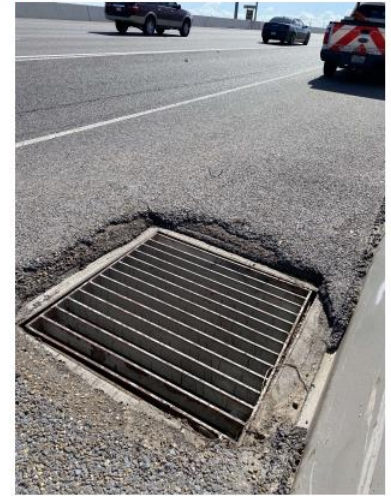
PHOTO 1 Recommended Maintenance Needs
Description 21-109-0039-18-282 VIEW 8 - TYPICAL CLOGGED DRAIN INLET AT APPROACHES ALONG SOUTH SHOULDER

PHOTO 1
Description Remove debris from drain inlets along south shoulder at approaches and check for proper drainage.
