MALP Stops Corrosion but Can We Live with the Cracks?

Coatings & Corrosion Protection Session I
Tuesday September 10, 2024
Imperial Ballroom C/D

Walt Peters P.E.
wpeters@odot.org

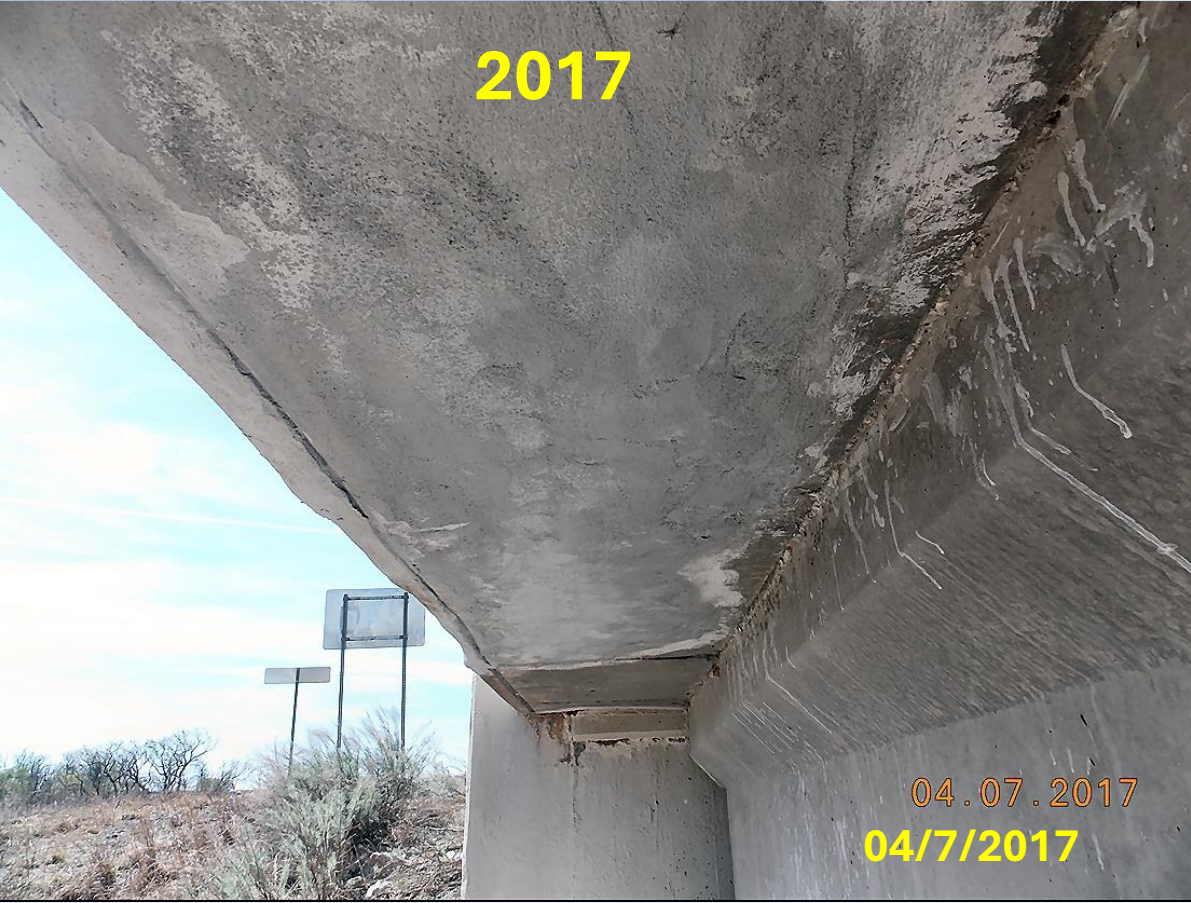
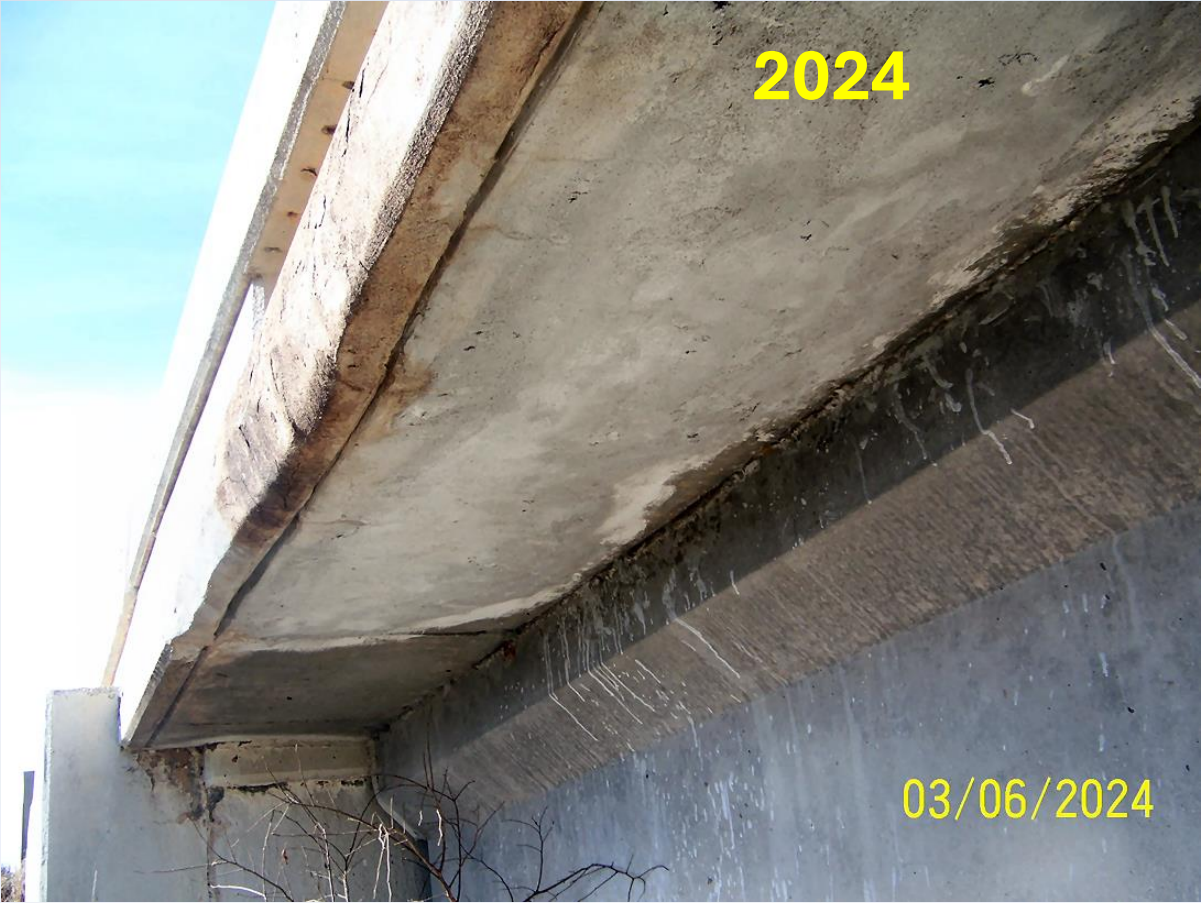
Comparison 2017 photo to 2024 photo

Large Cracks appeared on the exterior face middle portion in early 2017

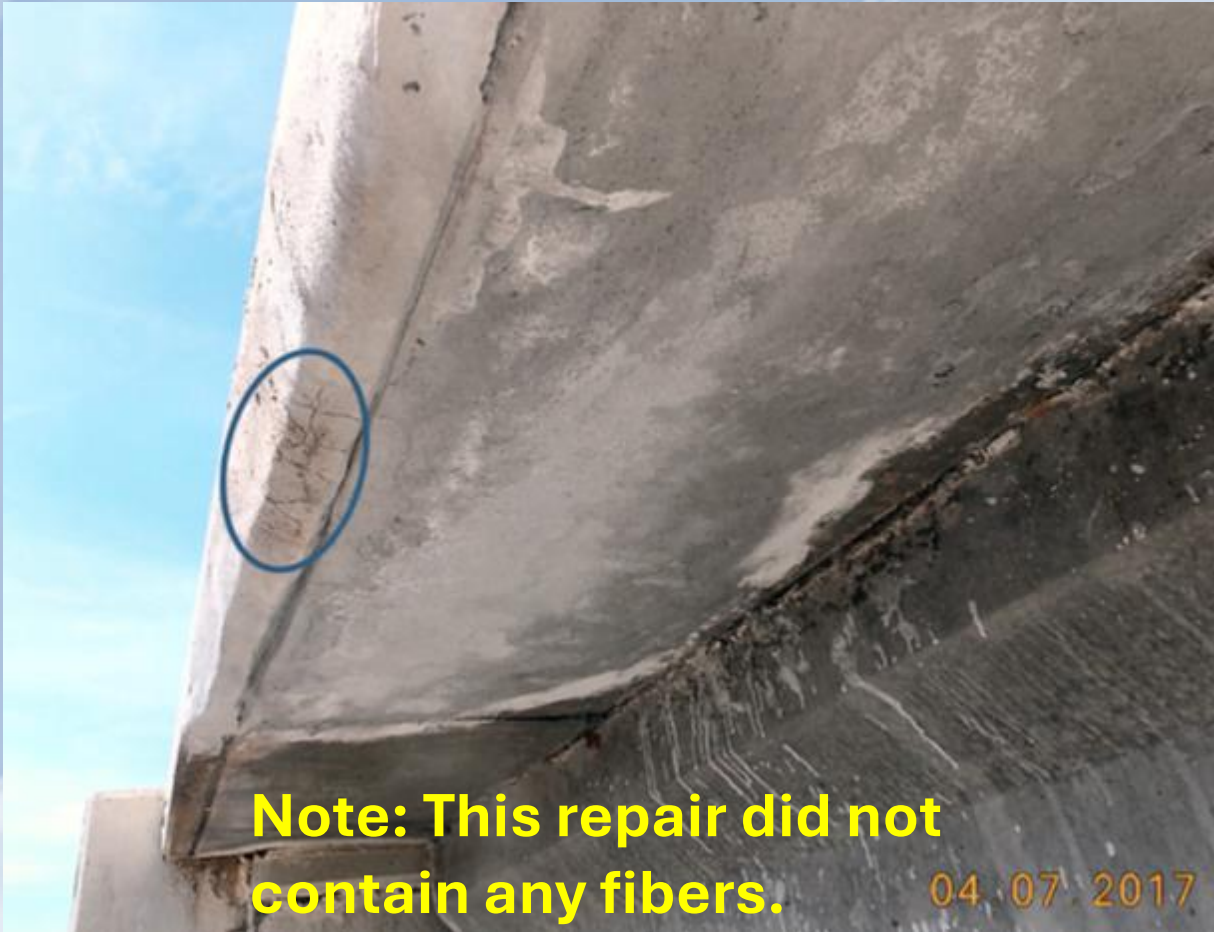
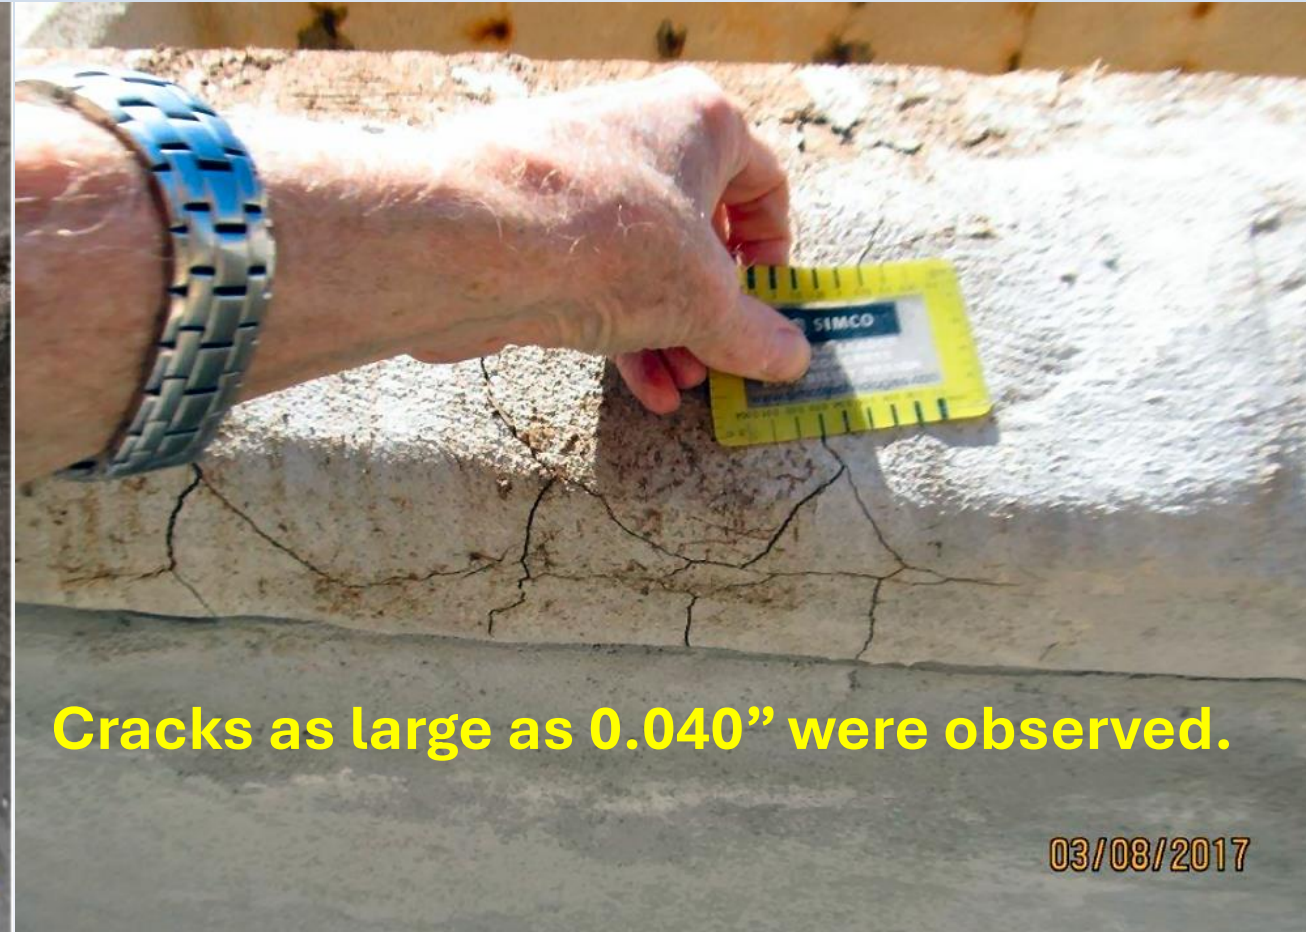
Cracks felt very solid when tapped with a hammer.

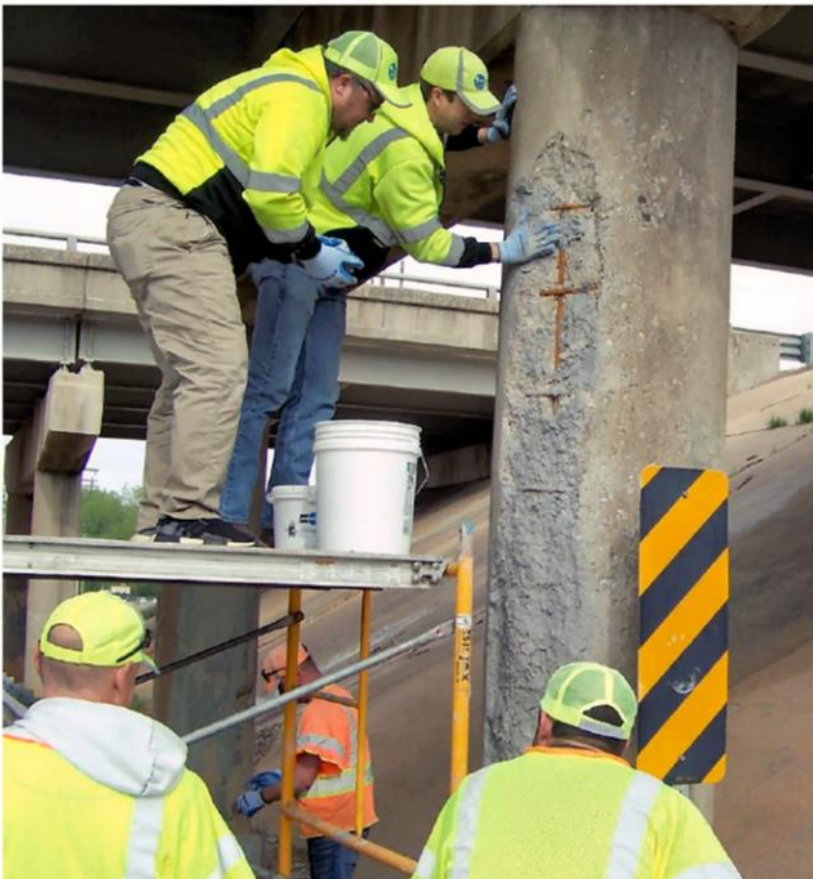
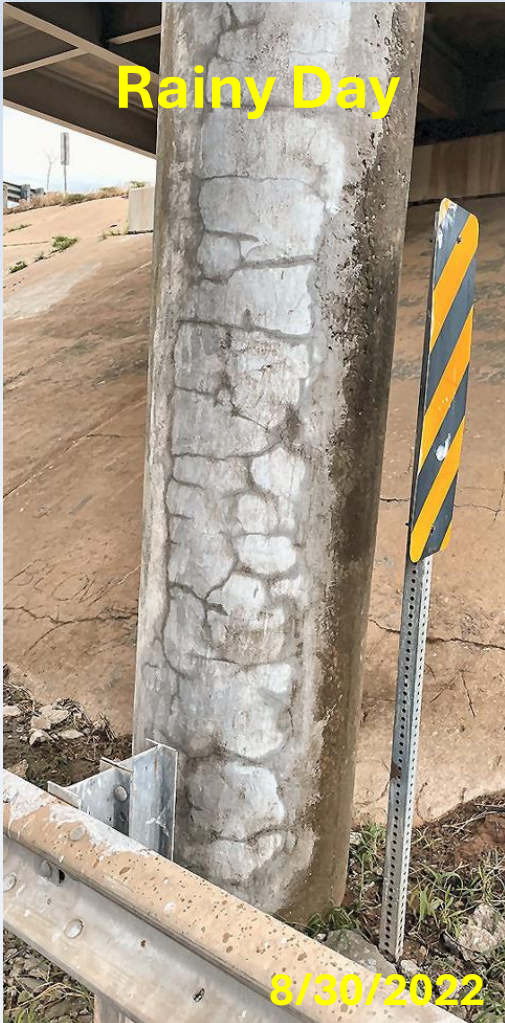
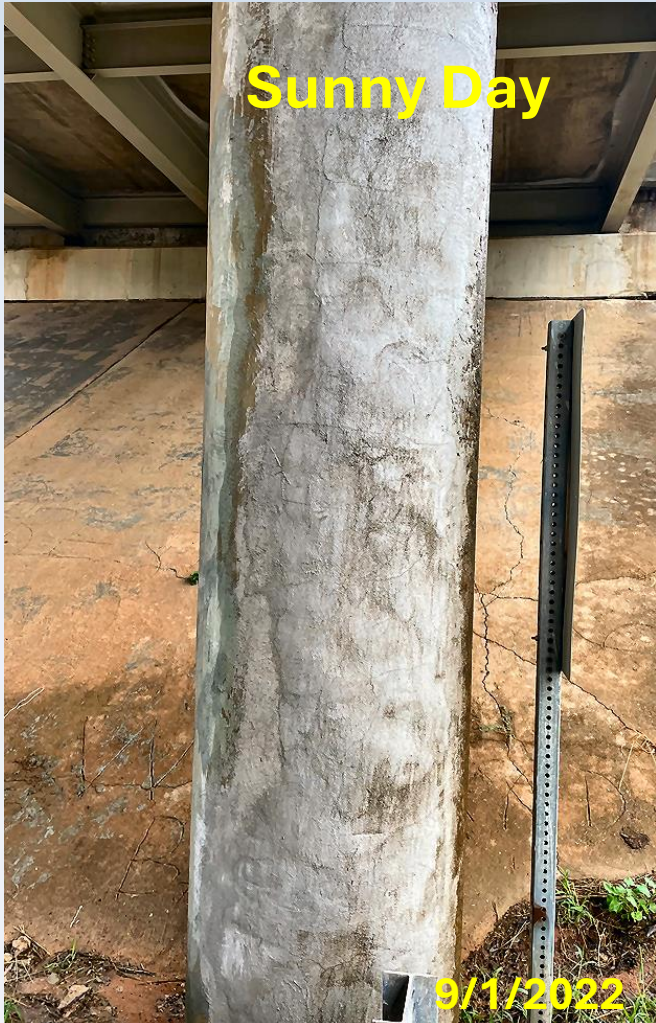
NBI 16938 Built 1967

Column Condition at time of MALP Placement, Note that MALP Converts iron oxide to iron phosphate

Flash Rust

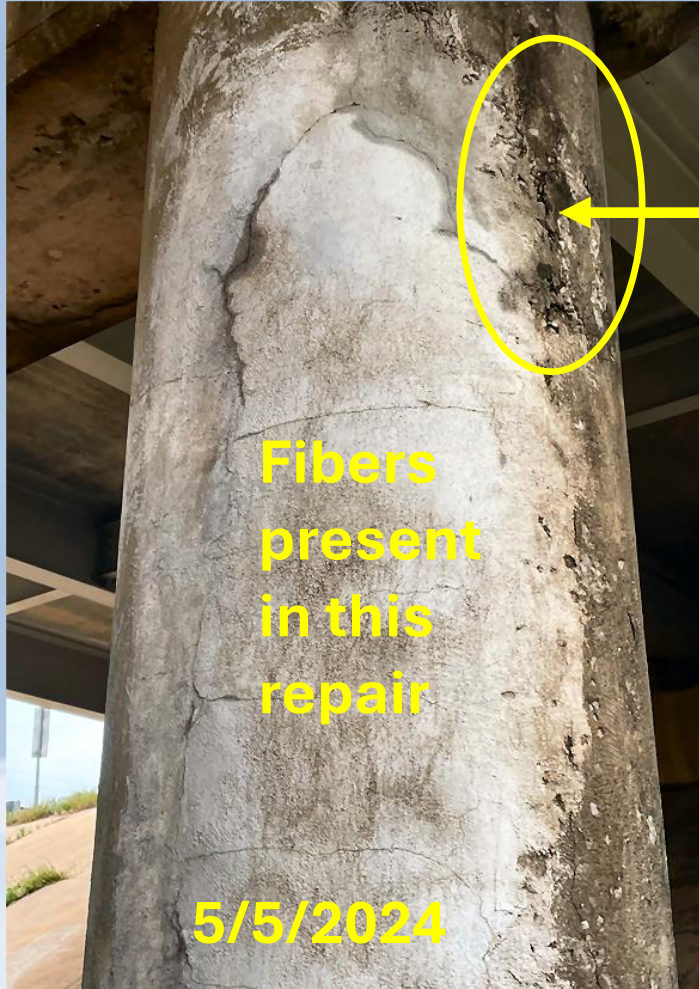
Appears to be spalling on the side of the column

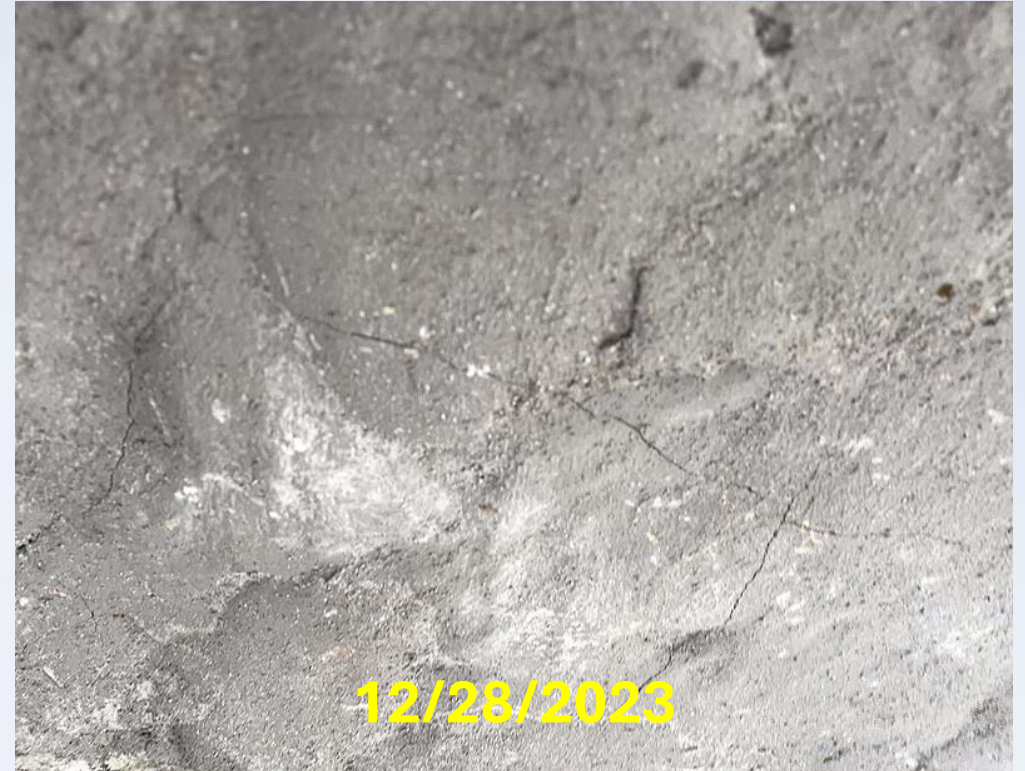
Close up of cracks – vary from 0.01 to 0.025”

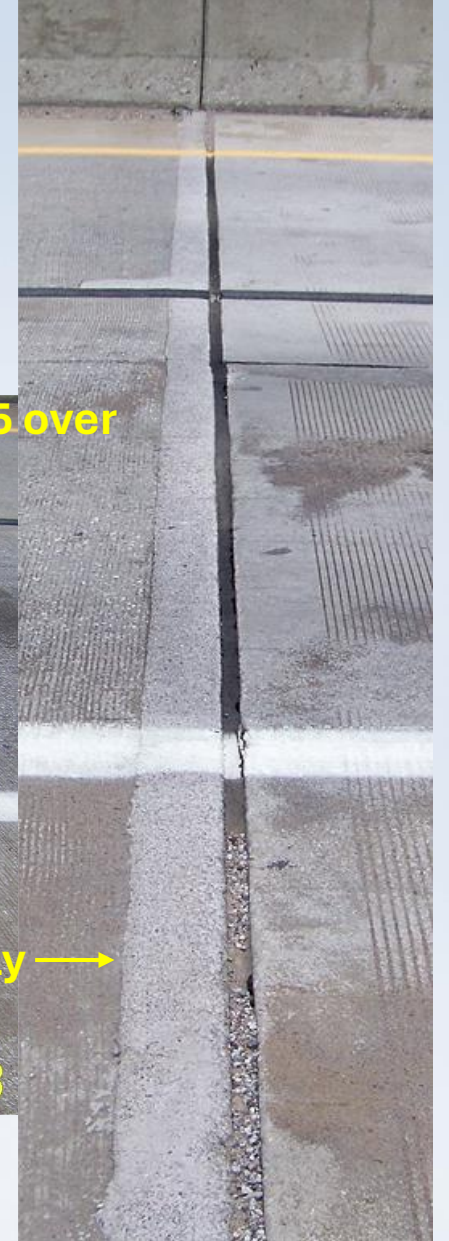
NBI 19986 & 19987, US-75 over
SH-117, Tulsa County

← **2' Failure**

Total 4
Headers
4 years old

← **MALP This Side Only** →

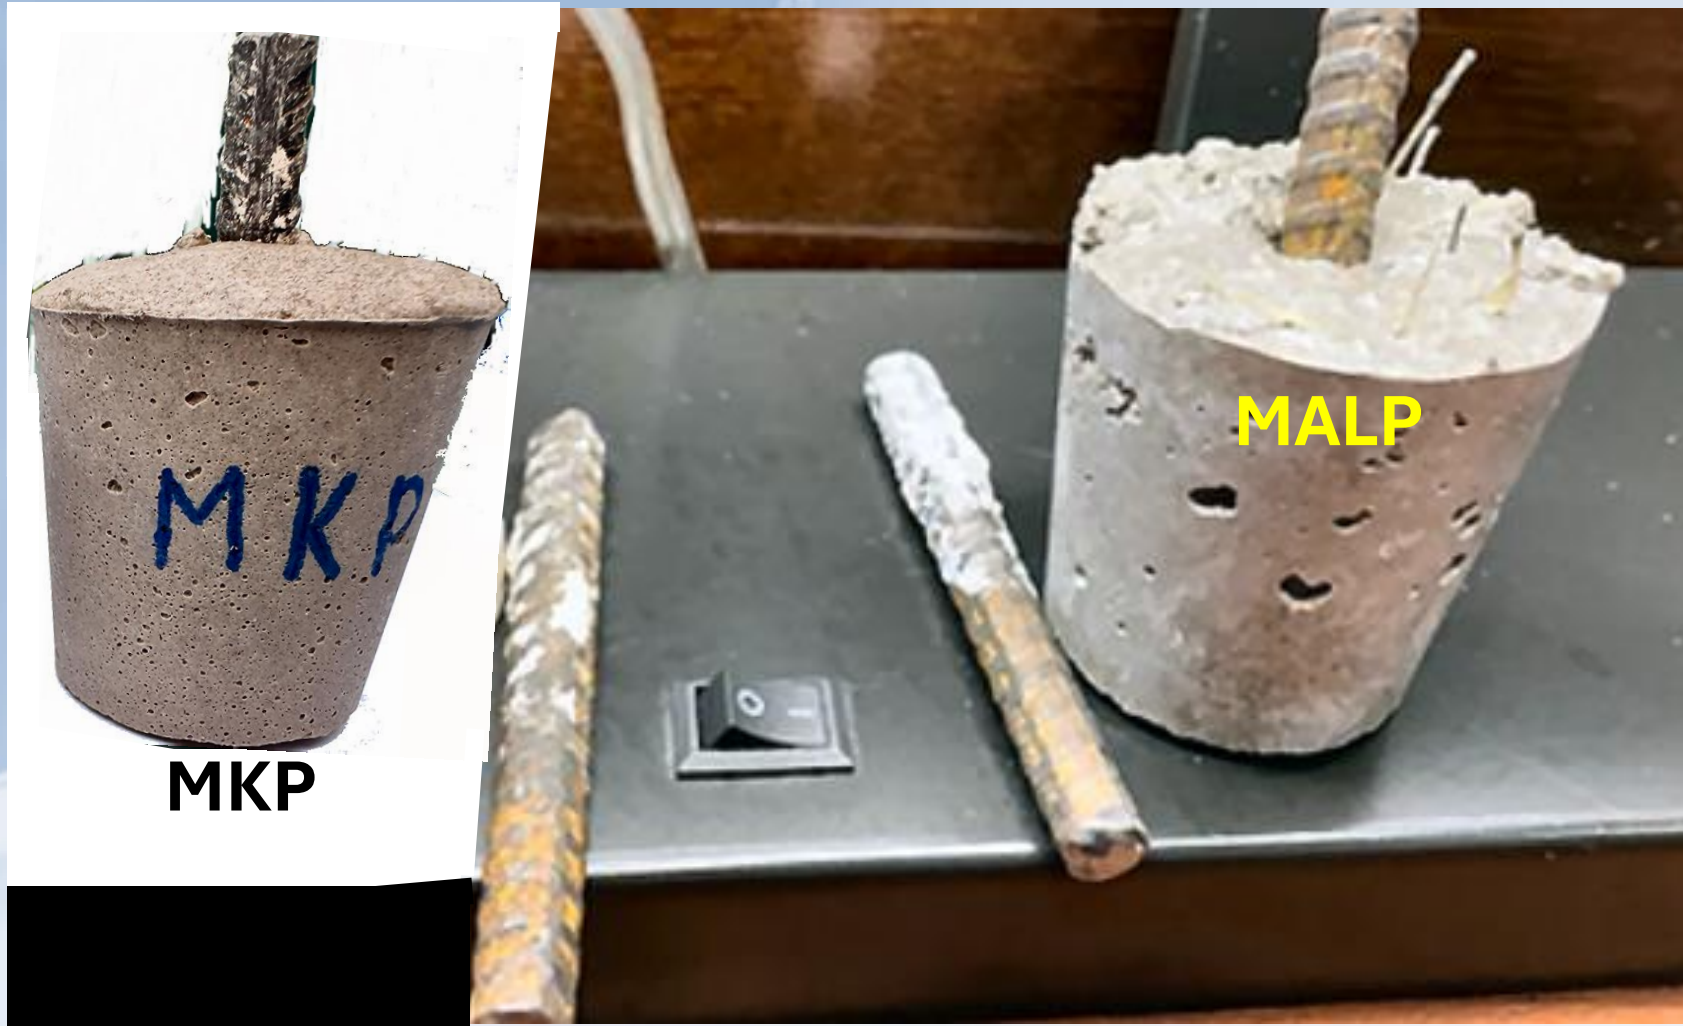
Removing MKP and MALP Materials from Rusty Rebar

This makes you wonder how well the products bond to steel. Note product was removed after approximately two hours.

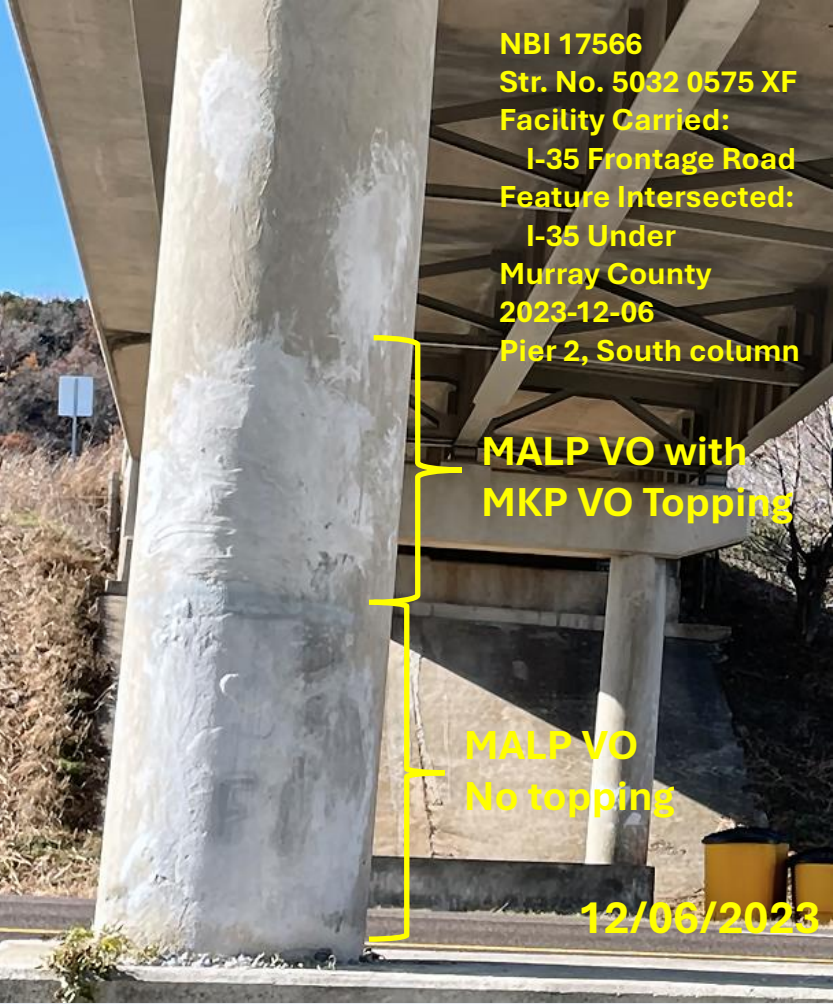
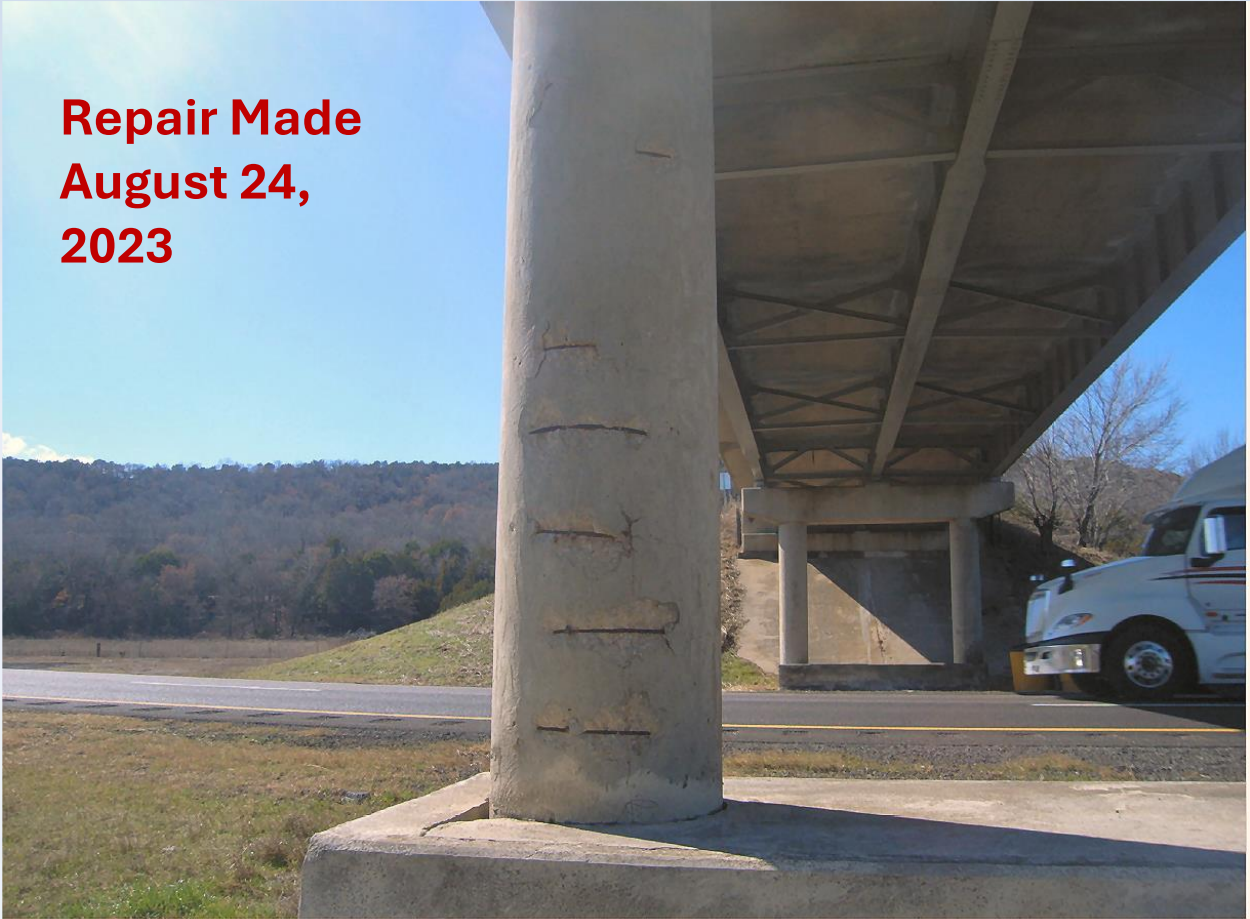
NBI #: 17566 Str #: 5032 0575 XF Facility Carried: I-35 FRONTAGE RD. 2023-02-09
 Murray I-35 Feature Int.: I-35 UNDER Pier 2

Repair with Combination of MALP VO and MKP VO, I-35 Frontage Road over I-35, NBI 17566, Murray County

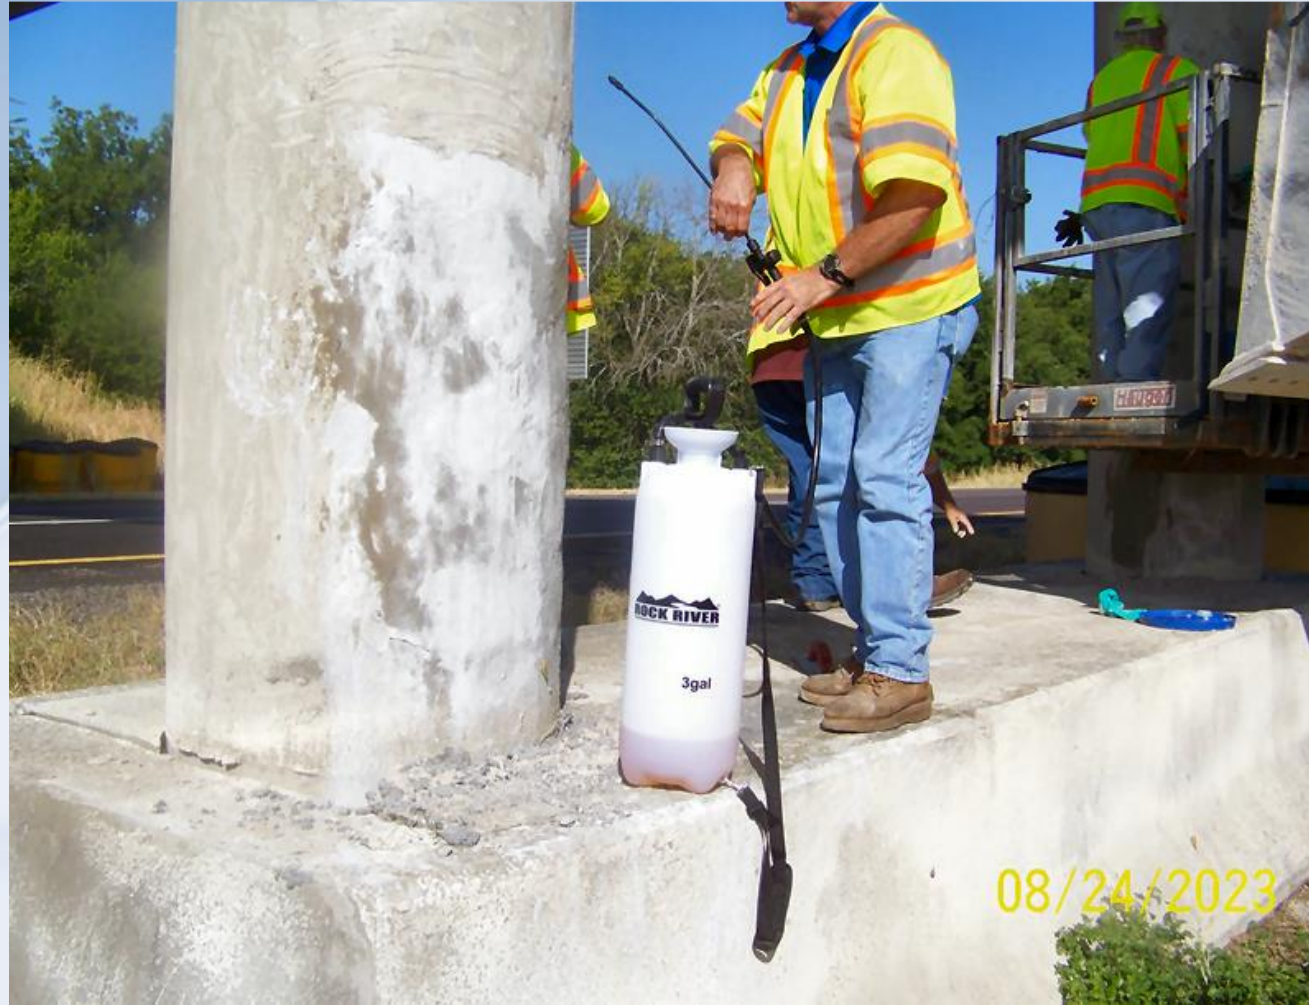
Repair Treated with SME-PS (Soybean product)
