# Investigation and Repair Design of Impacted Damaged Bridge Steel Superstructure in Nevada

# I-1255

Winnemucca Blvd (SR 289)  
Over Interstate 80

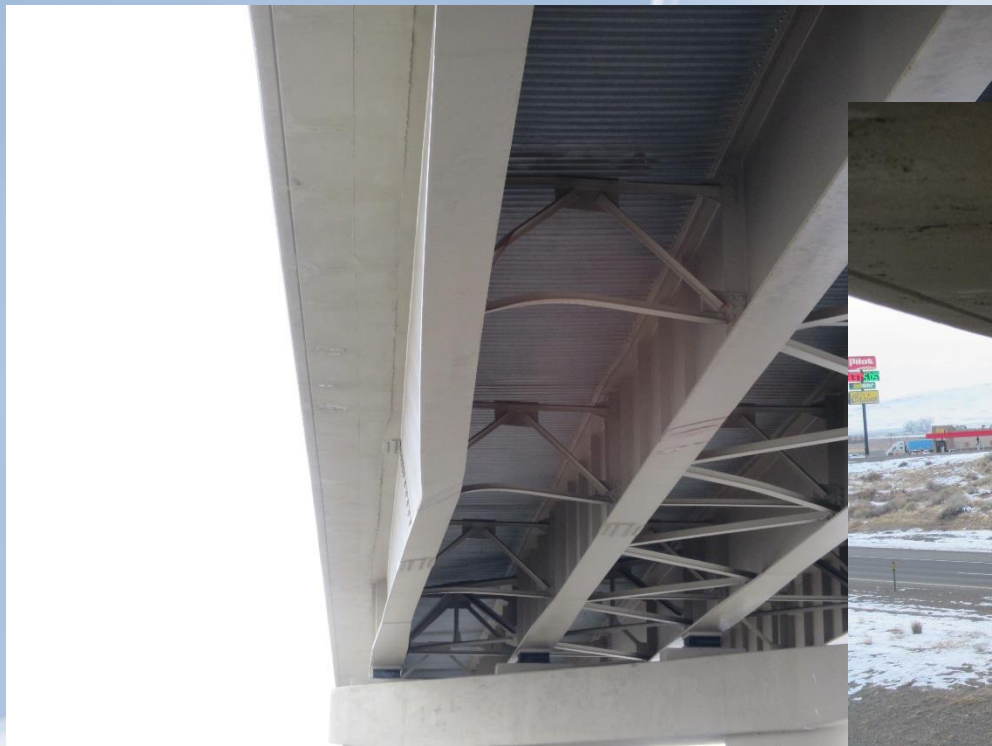
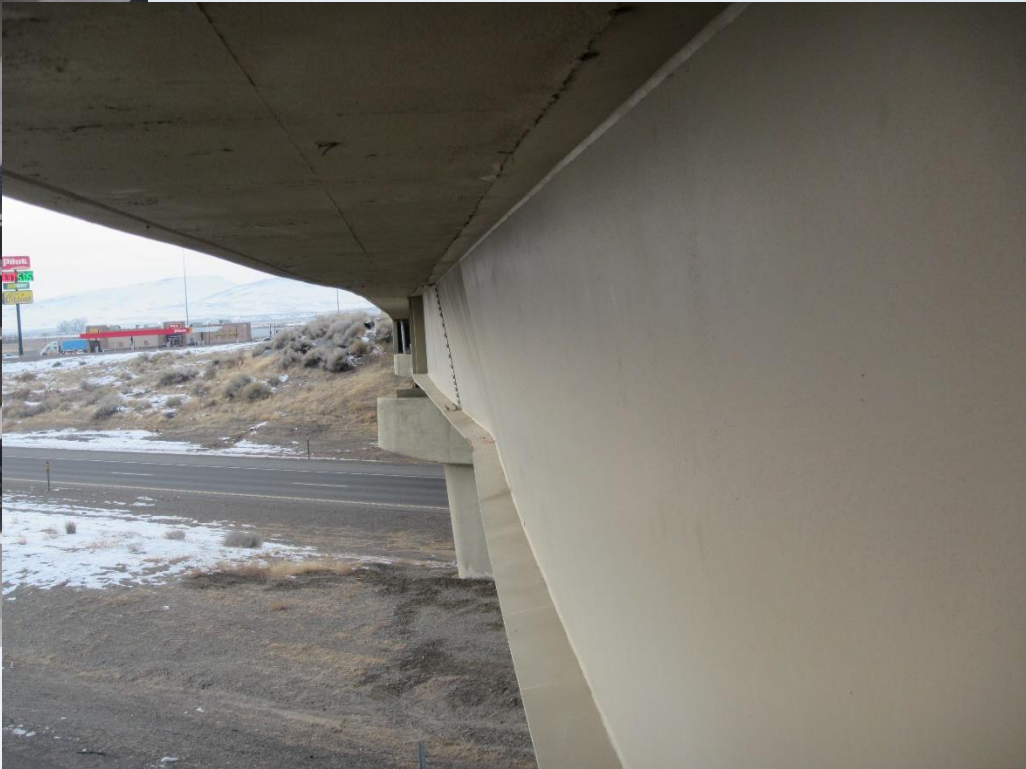
- Scrapes to Girders 1-4 bottom flange, Gouges in Girders 1 and 3 observed on top of bottom flange
- Girder 1
  - Deformation up to 14-13/16”
  - (14) buckled stiffeners
  - Crack at Diaphragm 5

- Heat straightening Girder 1, web and bottom flange.
- Heat straightening Girder 1 vertical stiffeners.

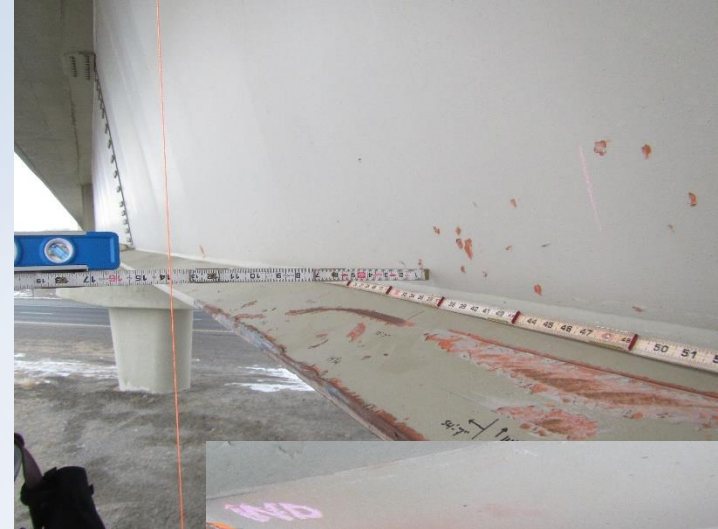
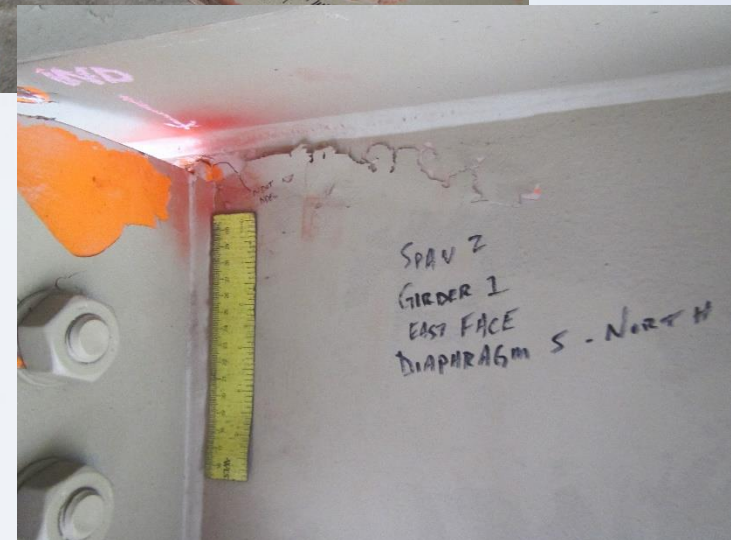
- Girder 3
  - Crack at Diaphragm 4
  - Crack between Web and Floorbeam
- Diaphragms
  - Buckled in Bay 1 and along impact line in Bays 2 and 3

- Remove and replace Diaphragms 2-6 in Bay 1 after Girder 1 heat straightening.
- Heat straighten Diaphragm 4 in Bays 2 and 3.

- Girder 1 Cracking.
  - Girder 1, Diaphragm 5, Bay 1, at the top
- Girder 3 Cracking.
  - Girder 3, Diaphragm 4, Bay 2 at the bottom
  - Girder 3, Diaphragm 4, Bay 3, near diaphragm stiffener

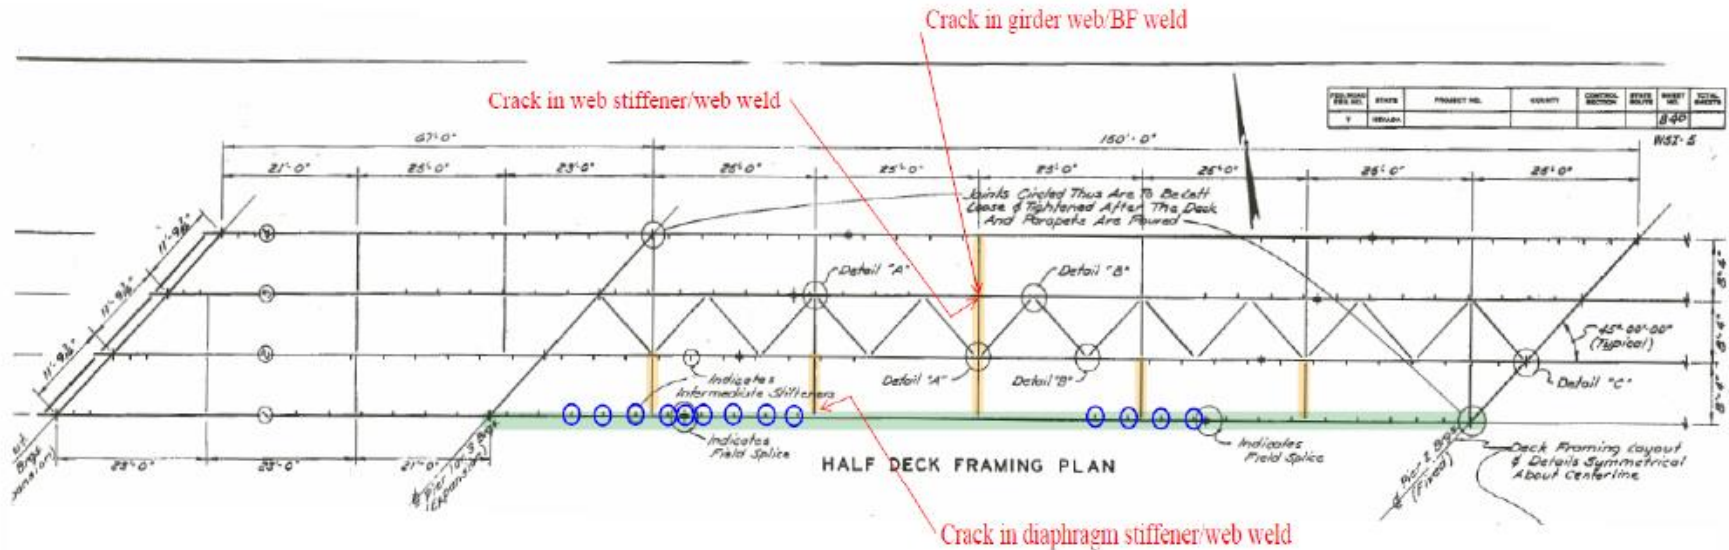
Figure 2: Affected Elements

- 1. Deflection/deformation of Girder 1
  - a. Shaking of Girder 1 under load
- 2. Diaphragm buckling
- 3. Vertical Web Stiffener buckling
- 4. Crack - Girder 1, Diaphragm 5, Bay 1, Web Stiffener, Top
- 5. Crack - Girder 3, Diaphragm 4, Bay 2, Web Stiffener, Bottom
- 6. Crack - Girder 3, Diaphragm 4, Bay 3, Web-Bottom Flange weld

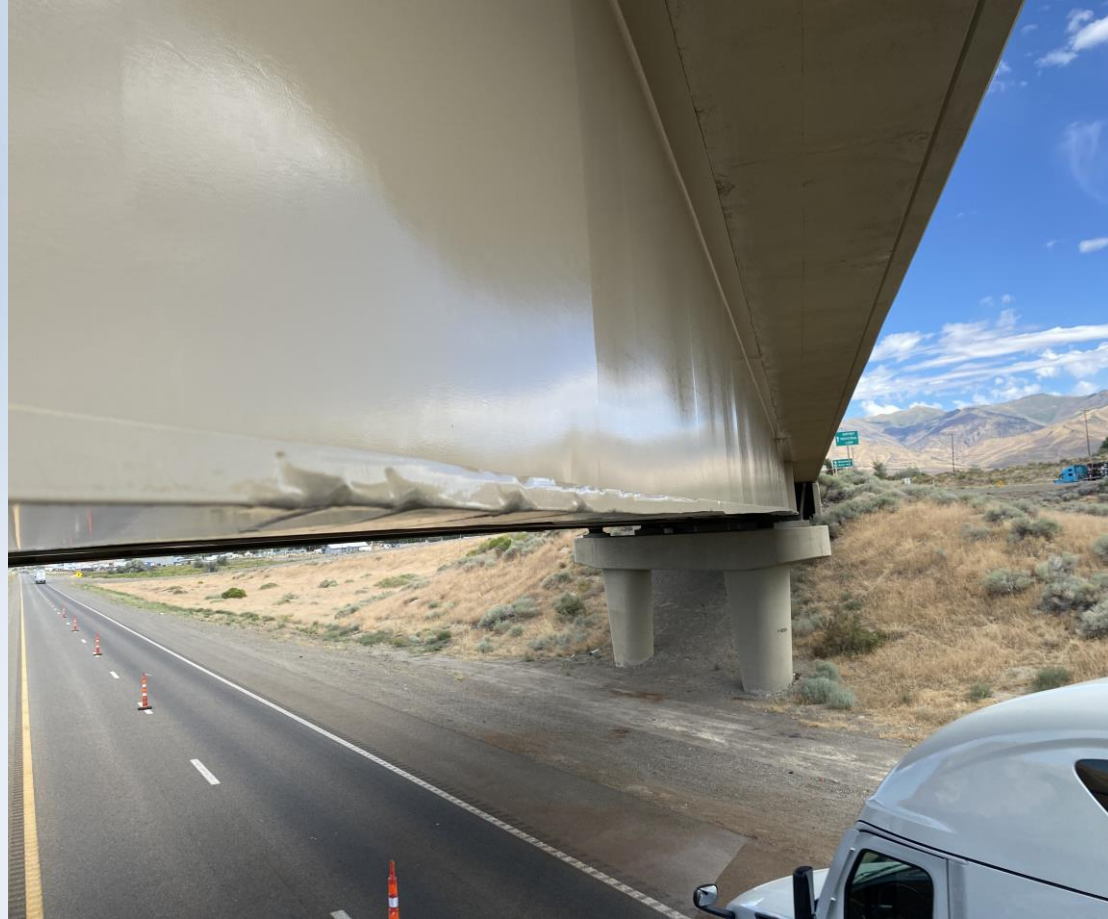
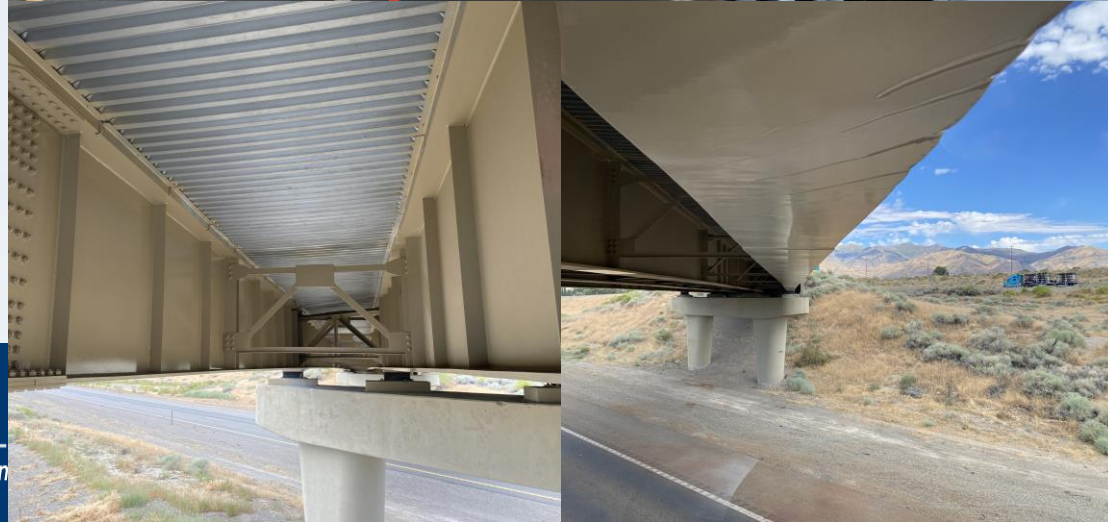
- Special Inspection performed during January Repairs
- August 2024 Special Inspection Verified Repairs have been completed and repainted.
