# US 17 Over the Waccamaw River

A \$49 Million Emergency Repair due to an Underwater Inspection

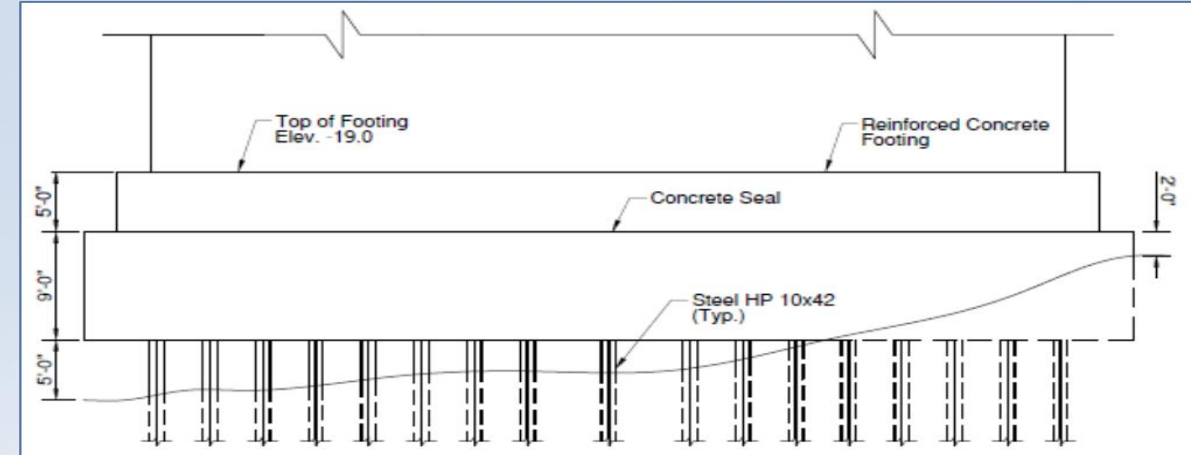
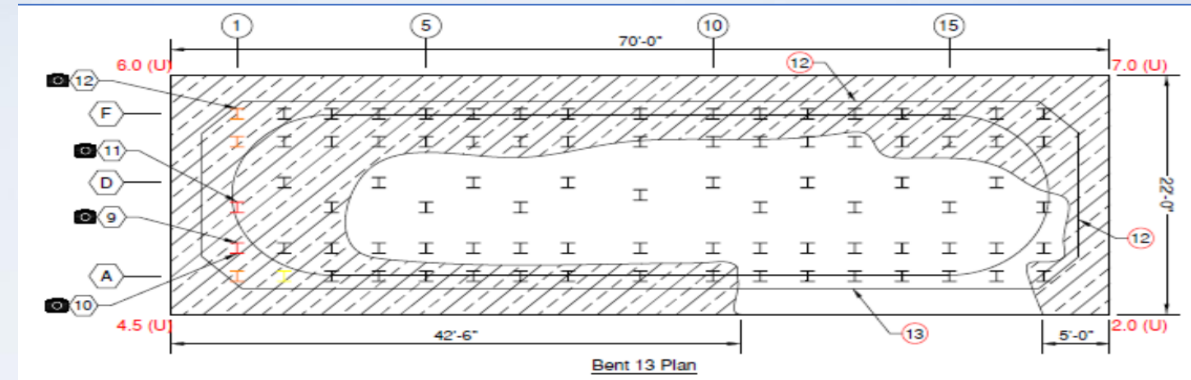
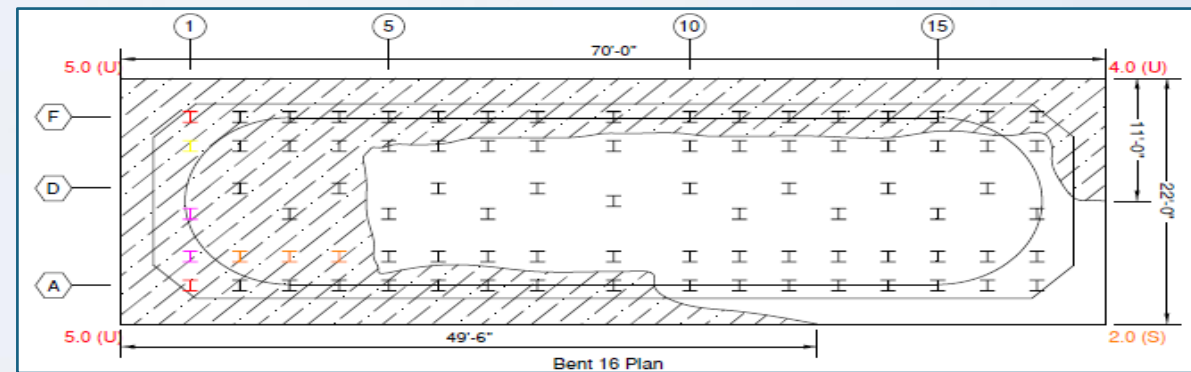
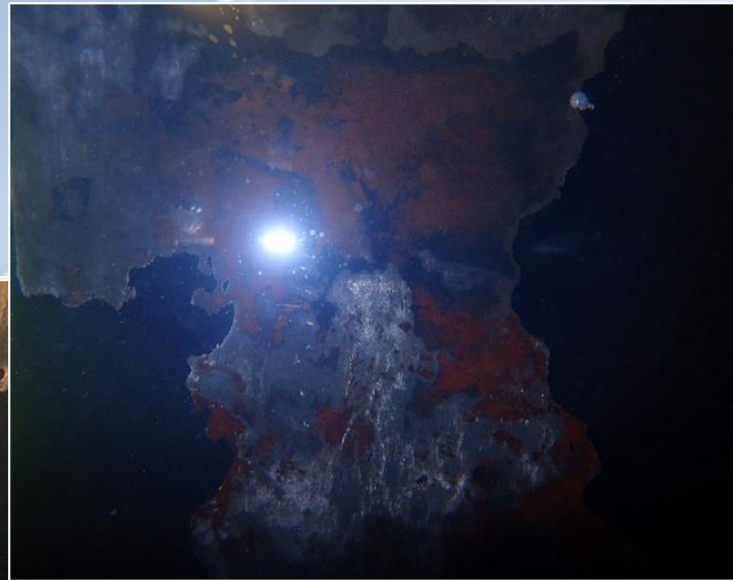
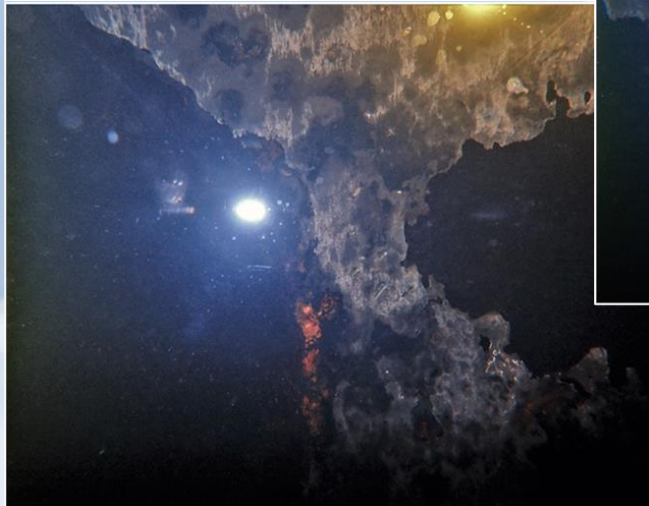
# Unexpected Findings

- Steel piles, not timber piles
- Significant deterioration of the steel piles
- Up to 100% section loss of the flanges

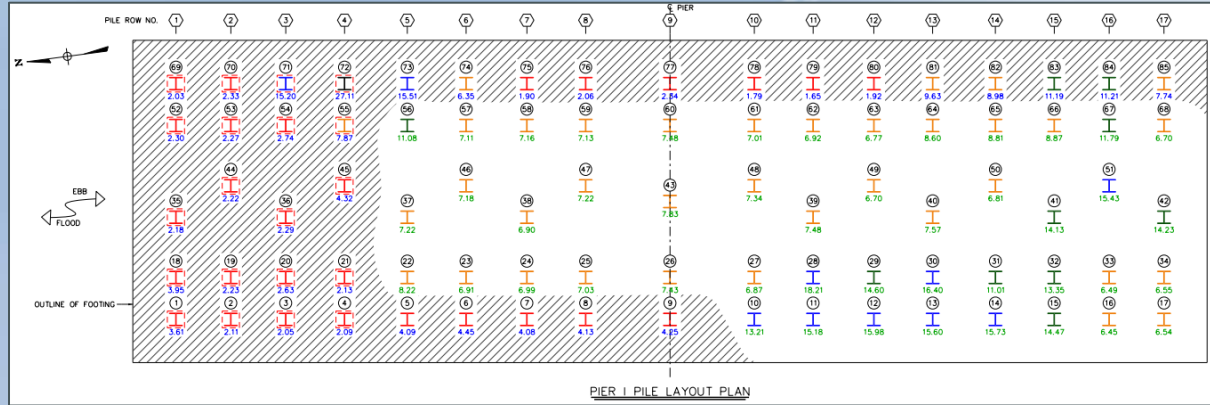
# PILE EMBEDMENT PLAN VIEW

(2021 UW Inspection)
