WESTOVER BRIDGE REHABILITATION

Nimal Suhir, P.E.

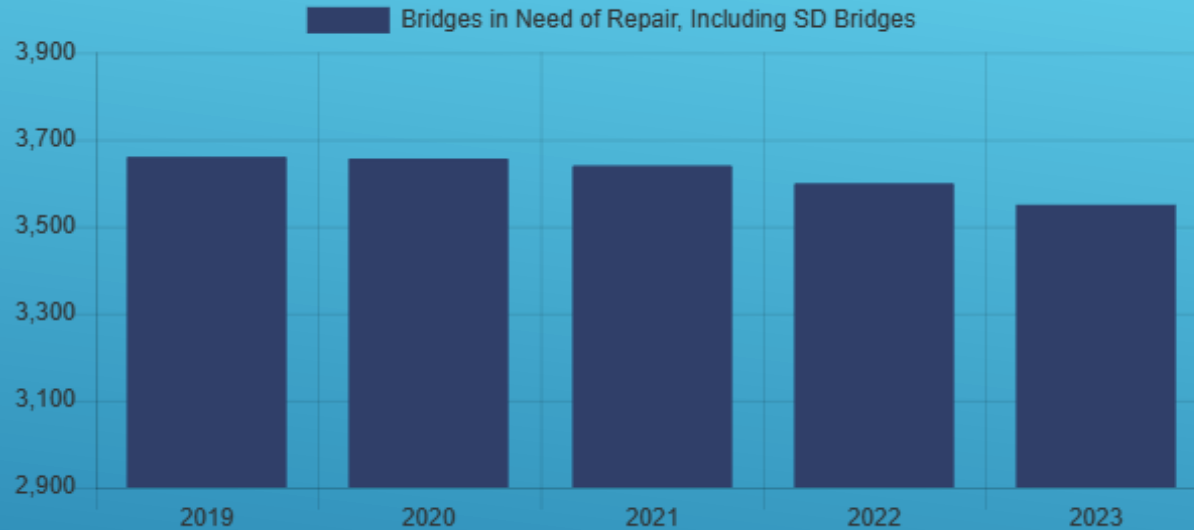
Number of Structurally Deficient bridges

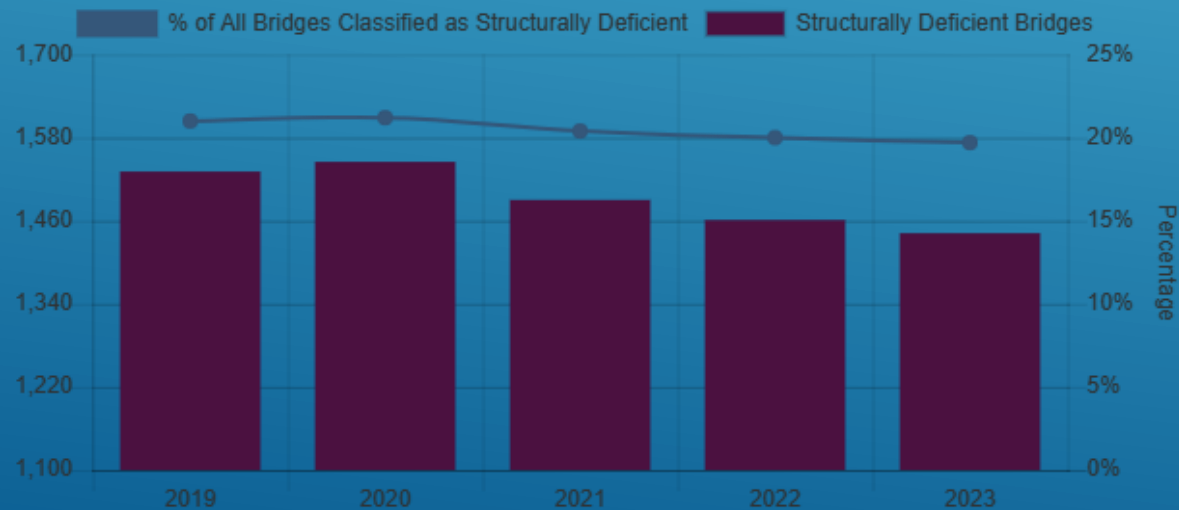
NEW RIVER GORGE BRIDGE

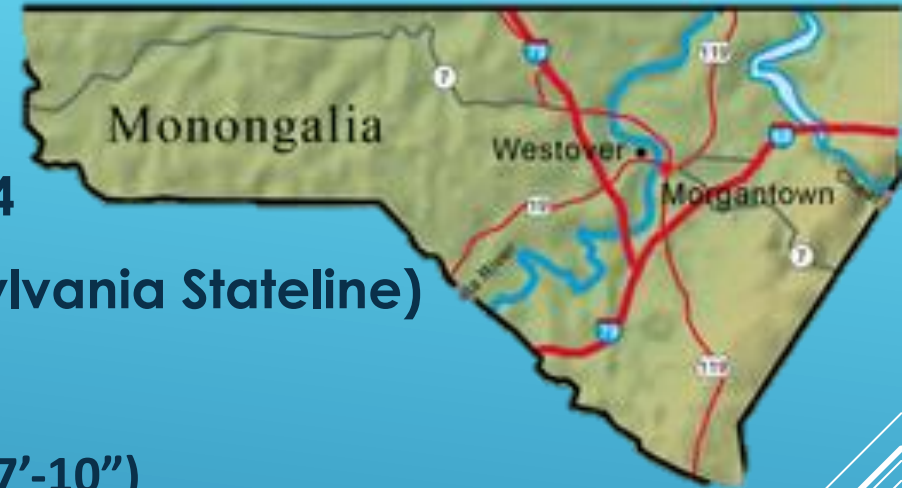
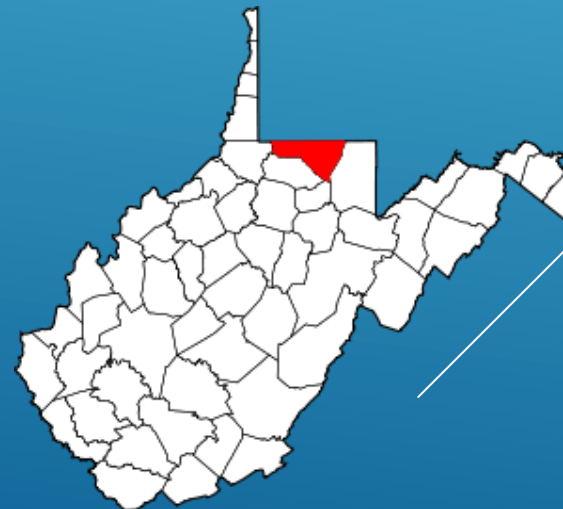
- Located in Town of Westover, Monongalia County, District 4
- I-79 Overpass Structure at Exit 152 (3rd Exit from the Pennsylvania Stateline)
- Structure Specifics ~
 - 4 Span Steel Girder Twin Structure (Total Length of Structure: 457'-10")
 - 8 Inch Concrete deck
 - Concrete abutments on spread footing supported on 2 rows of piles (front row battered)
 - Multi-Column Piers
 - Rocker bearings on the Piers
 - Structure built in 1969 (approximately 55 years old)
 - Design Consultant on Record: Michael Baker

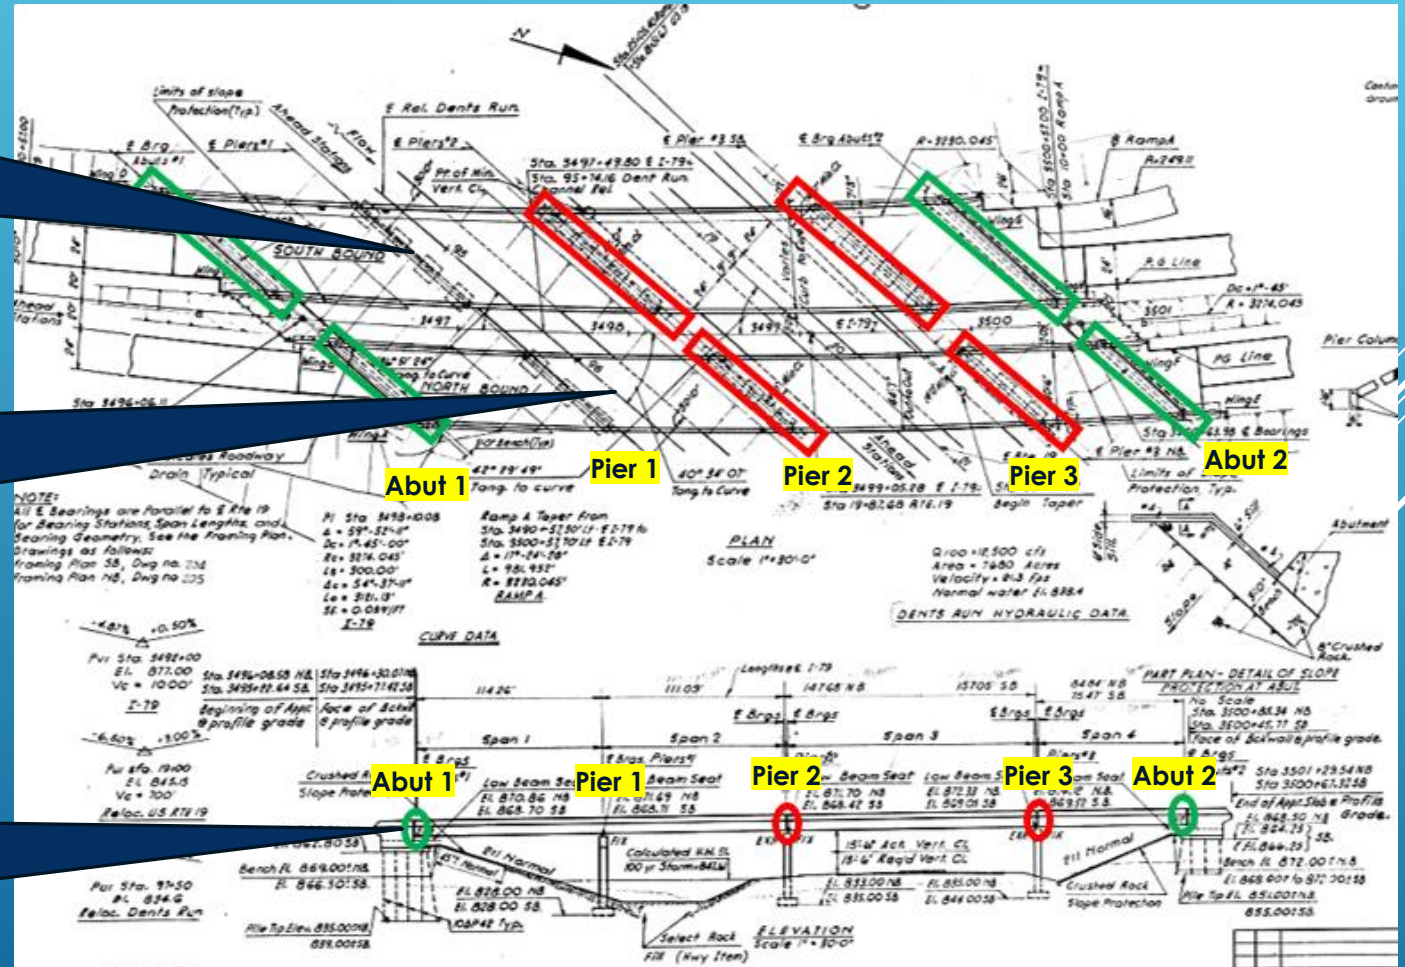
BRIDGE CONDITION – PIERS

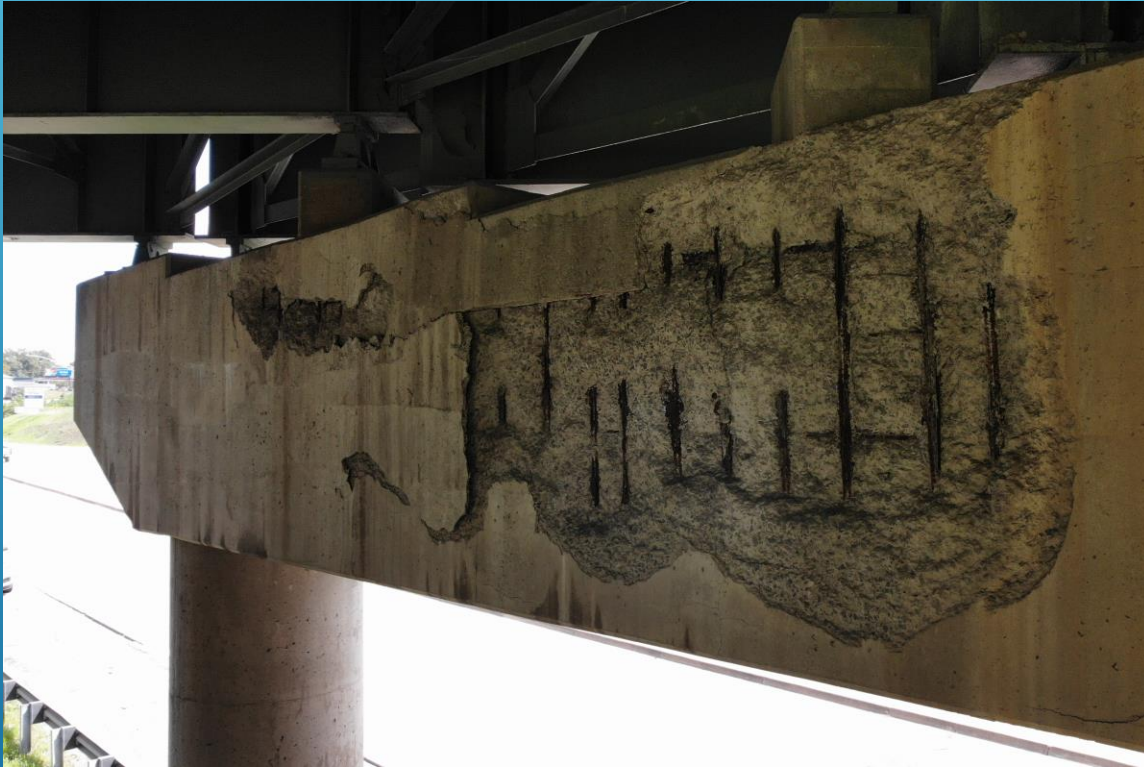
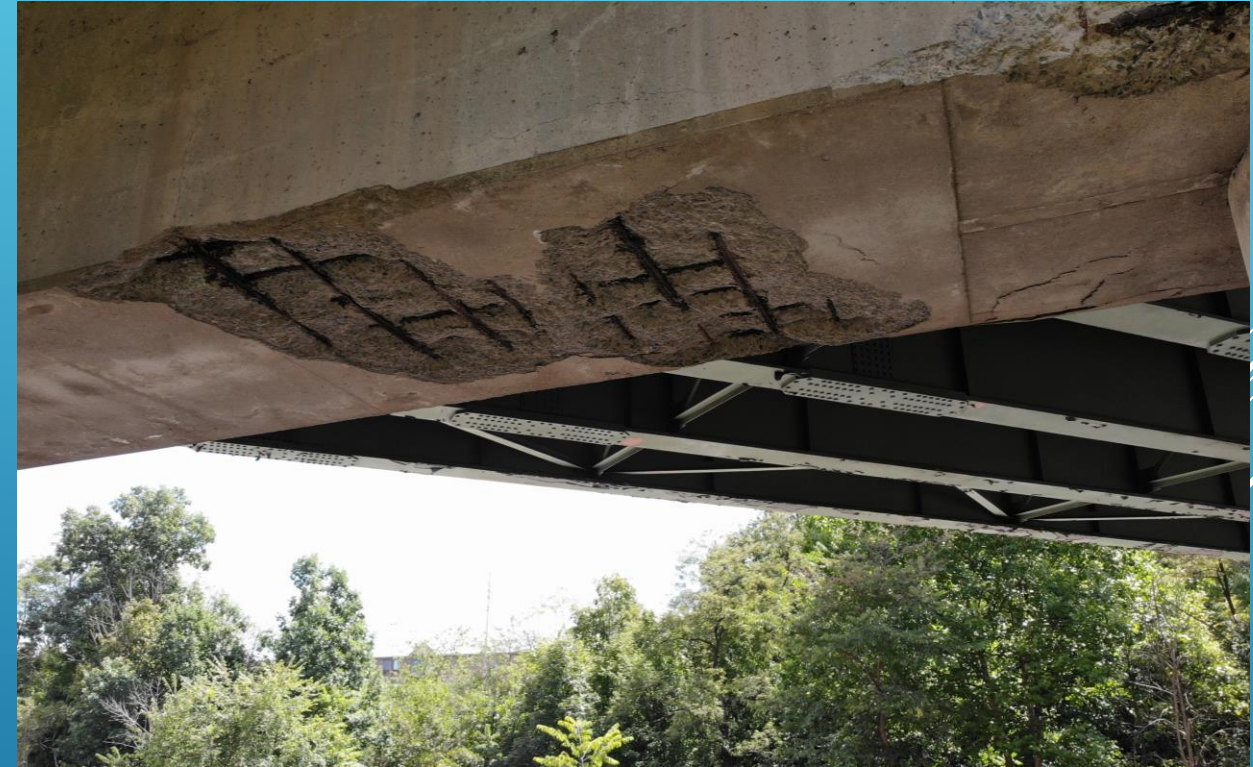
- Pier Caps exhibited Severe Spalling, exposed rebar with significant corrosion and section loss,
- Four out of the six piers in the twin structure were in a state of severe disrepair.
- Leaking expansion joints above these piers caused **De-icing Salt Saturation of concrete.**

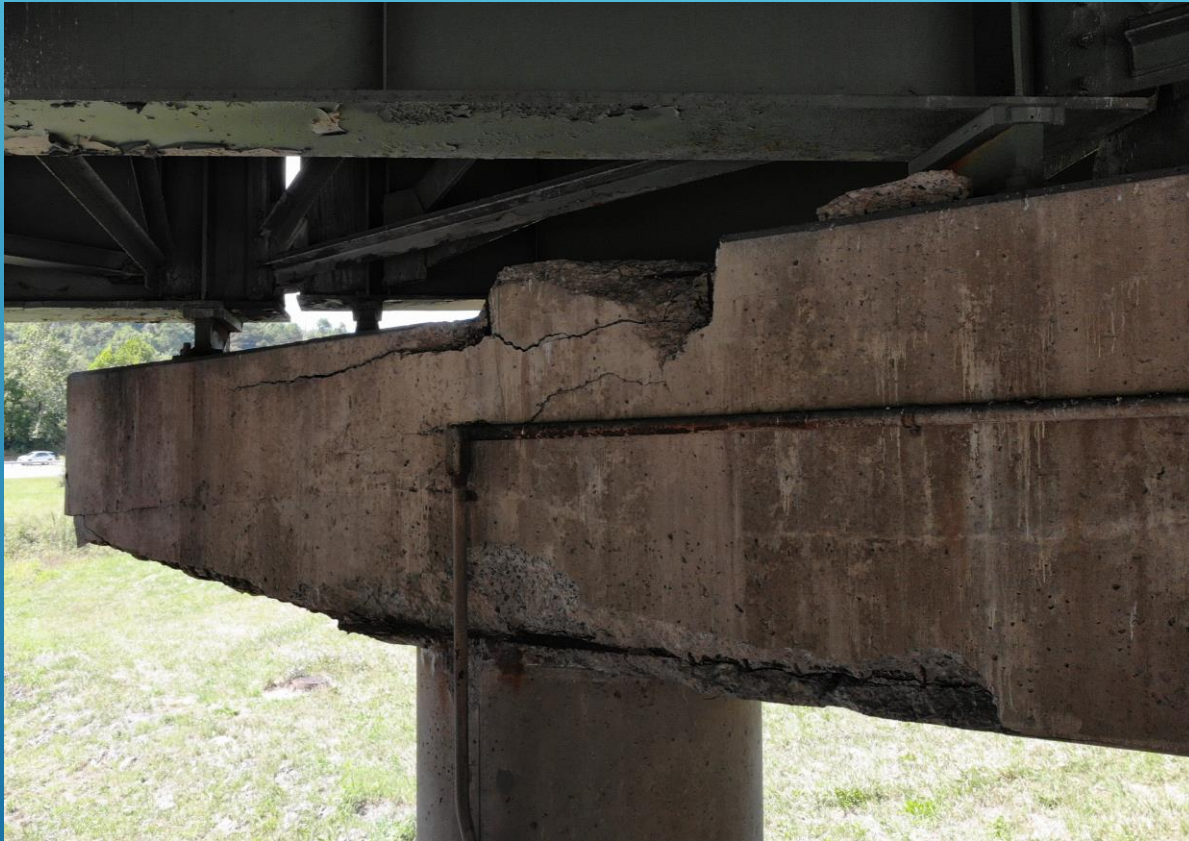
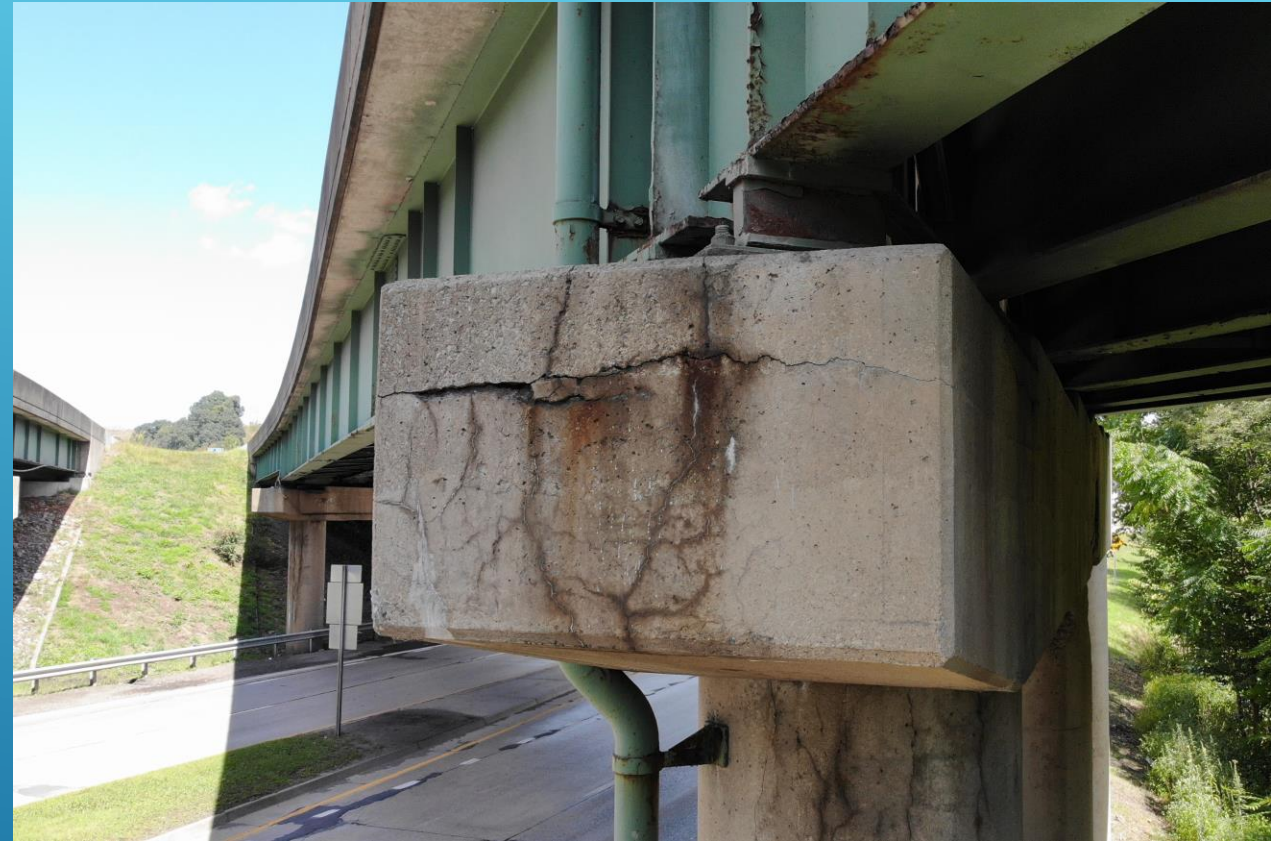
- ◆ More of the same: Spalls, cracks, delamination, exposed rebar.
- ◆ Piers 2 & 3 were in very poor condition
- ◆ Pier 1 was in good condition. Why?

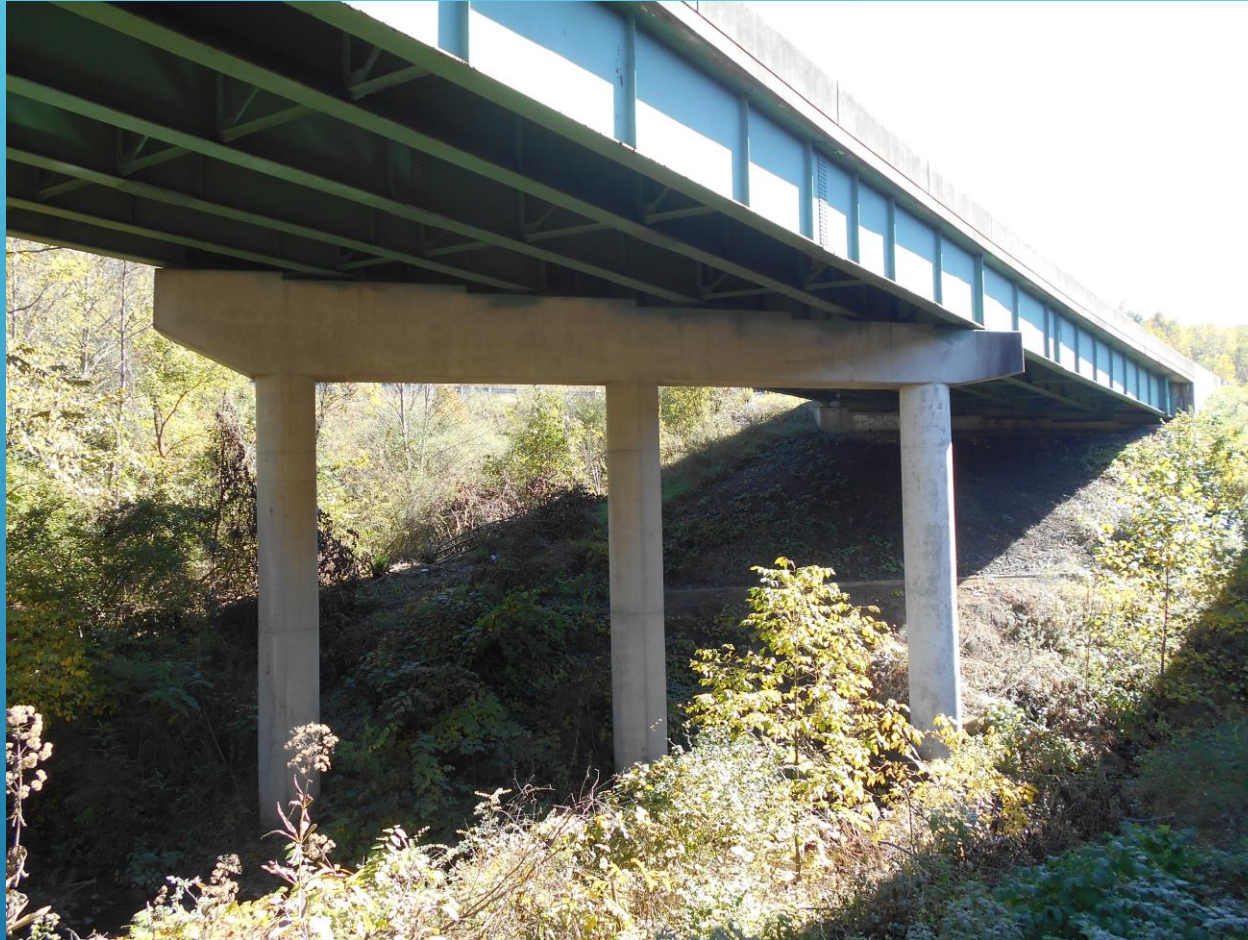
Pier 1 in NB & SB Structures are in pristine condition. Why?

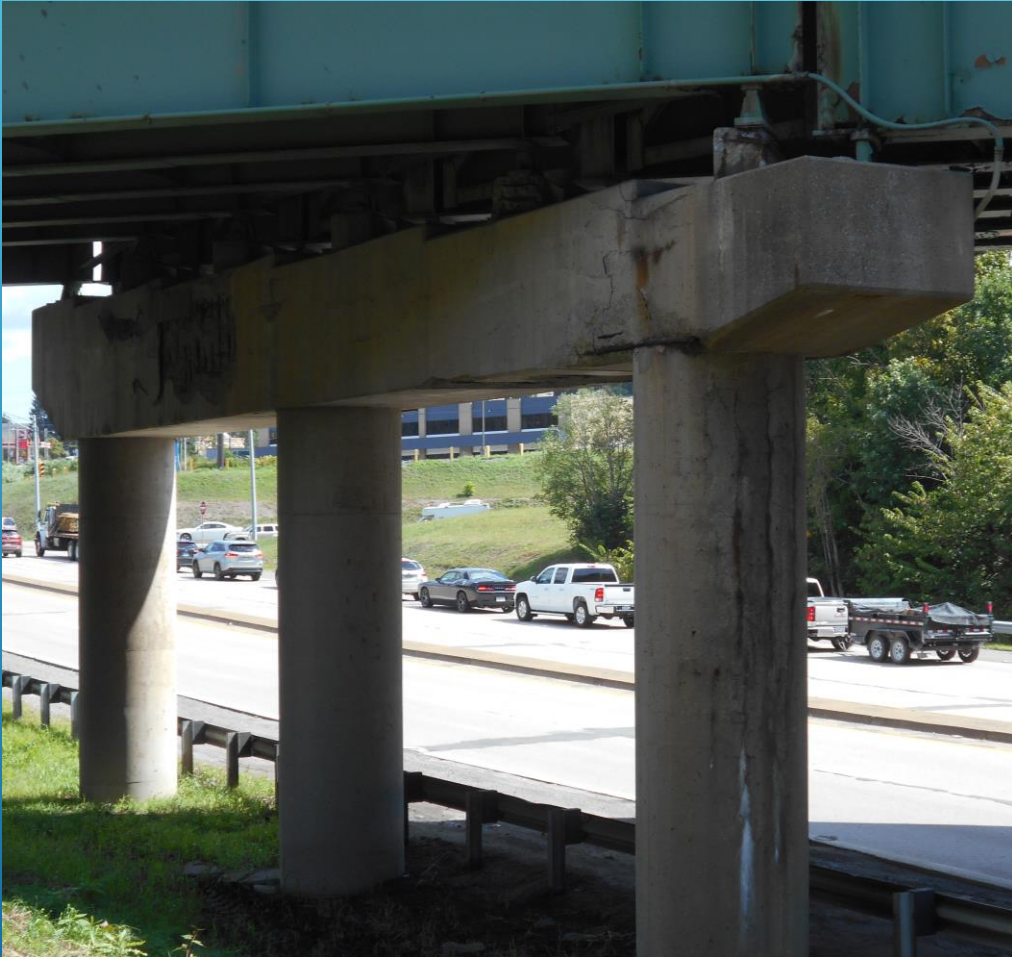
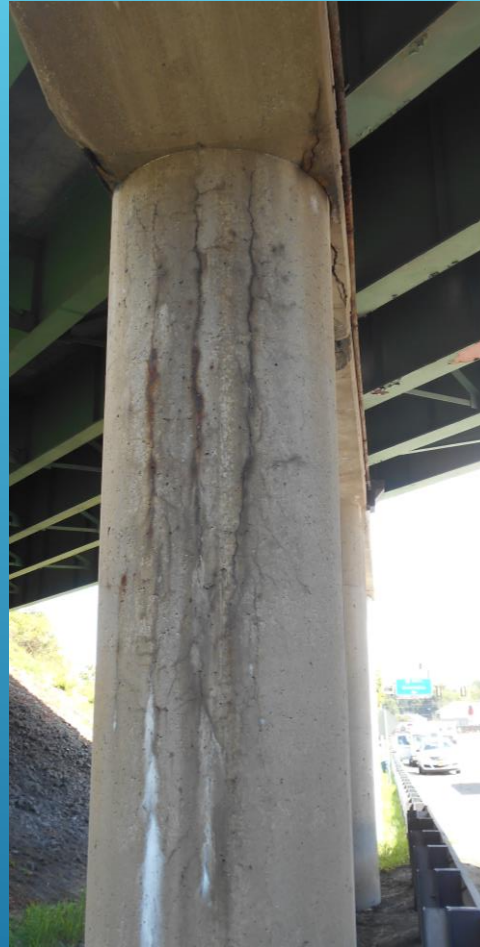
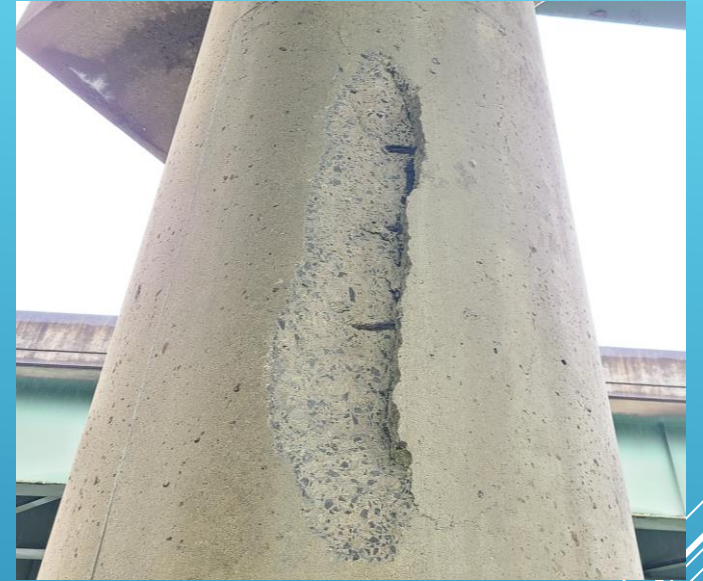
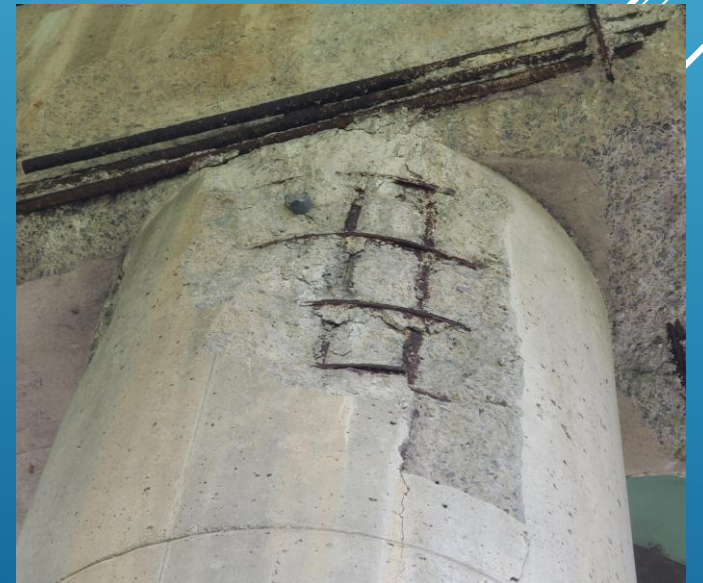
Pier columns, even though they are at a lower elevation, were not spared. Cracks, large spalls and extensive delam were detected in several columns.

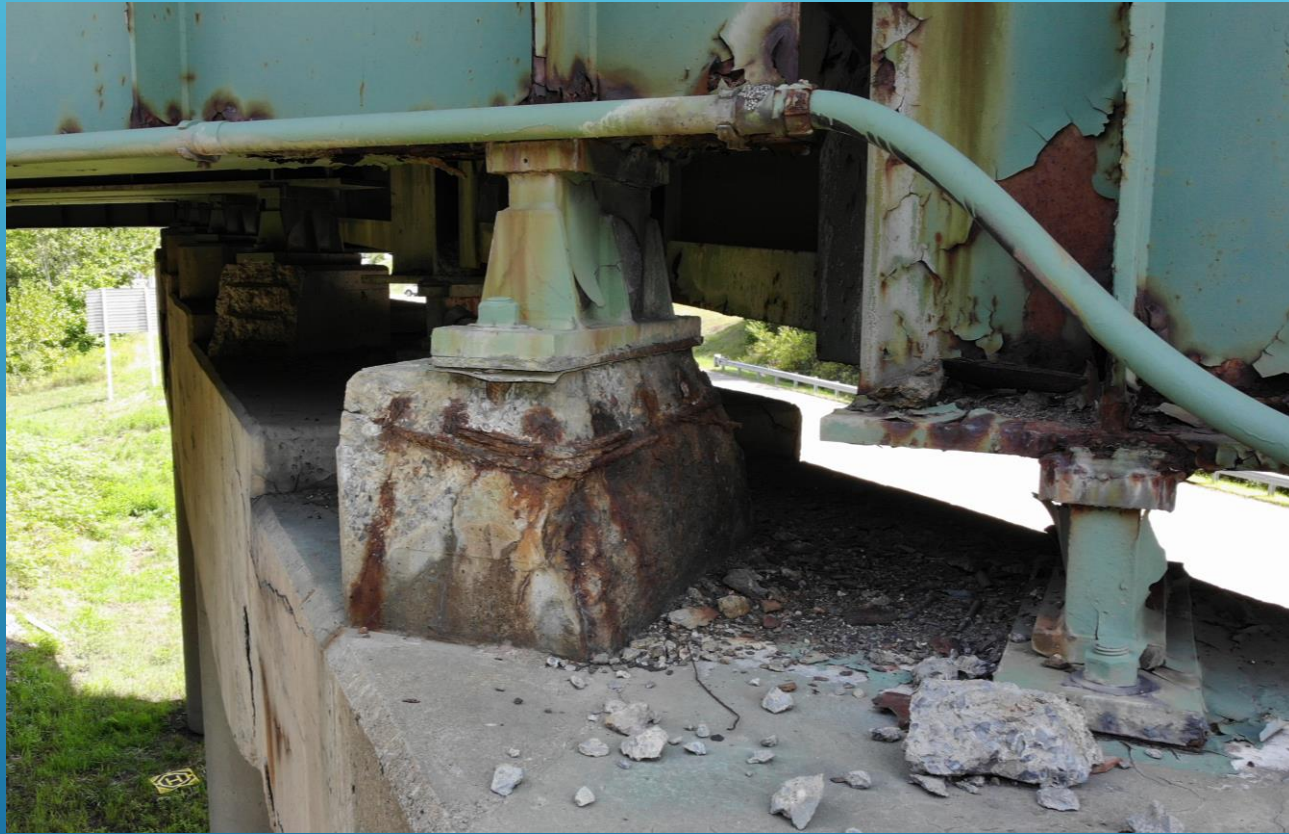
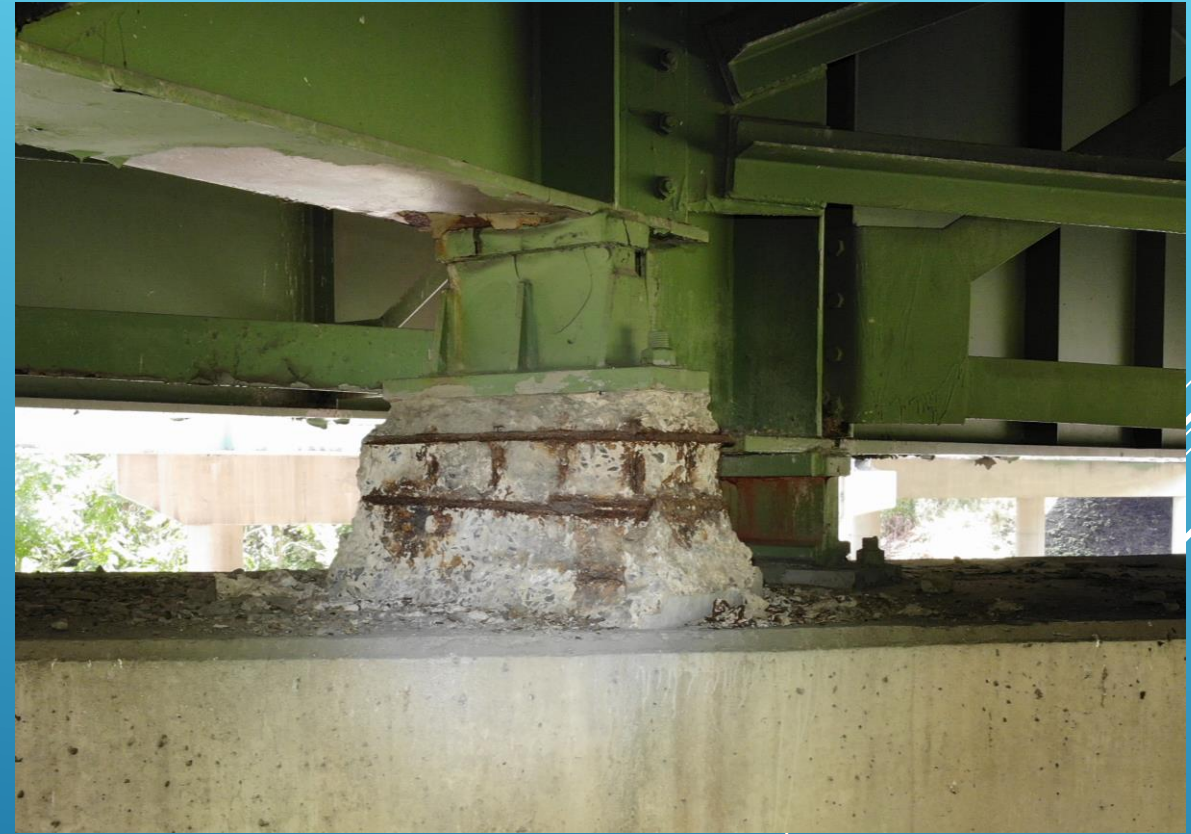
- ◆ Severe deterioration of Bearing Pedestals.
 - ◆ Several of these had to be recast.
- ◆ To recast Pedestals, the girders had to be jacked individually under full traffic loading &
 - ◆ Rocker bearings reset etc.

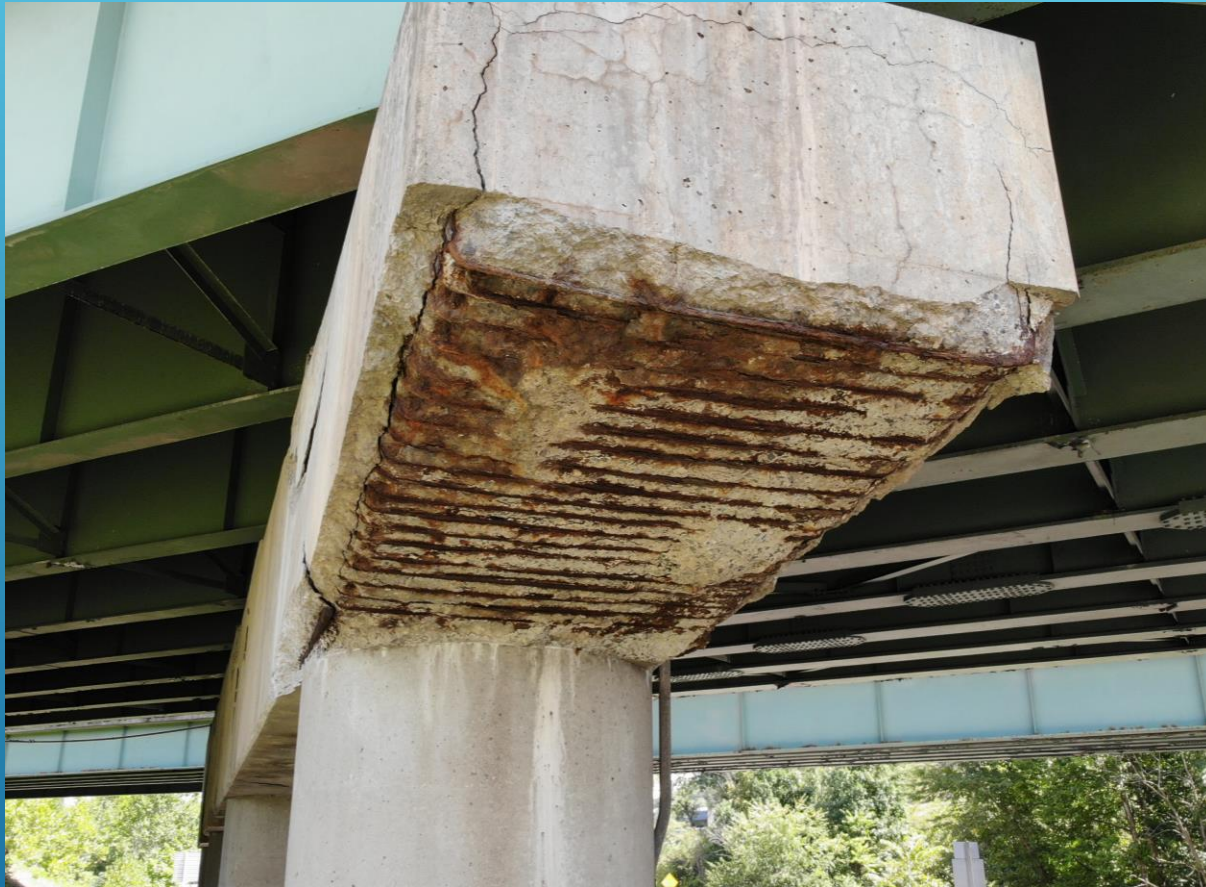
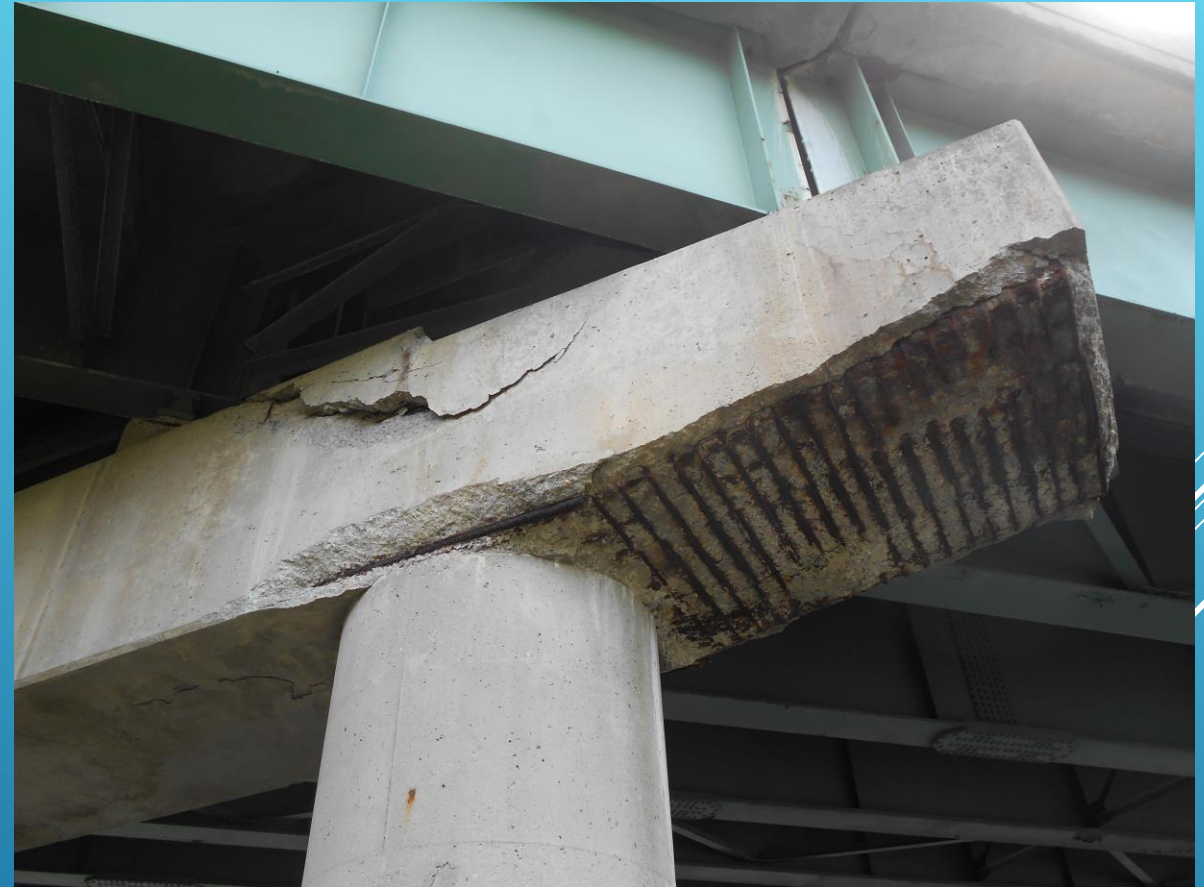
- ◆ Completely deteriorated Pier Cap Cantilever in Pier 3 of the SB Structure (West Side cantilever).
- ◆ Cantilever supported the exterior beam that carried a significant percentage of the load on the entrance ramp to the I-79 SB Structure.
- ◆ Something had to be done. We decided to recast the cap overhang. To do that safely the beam would have to be jacked and a jacking frame needed to be built.

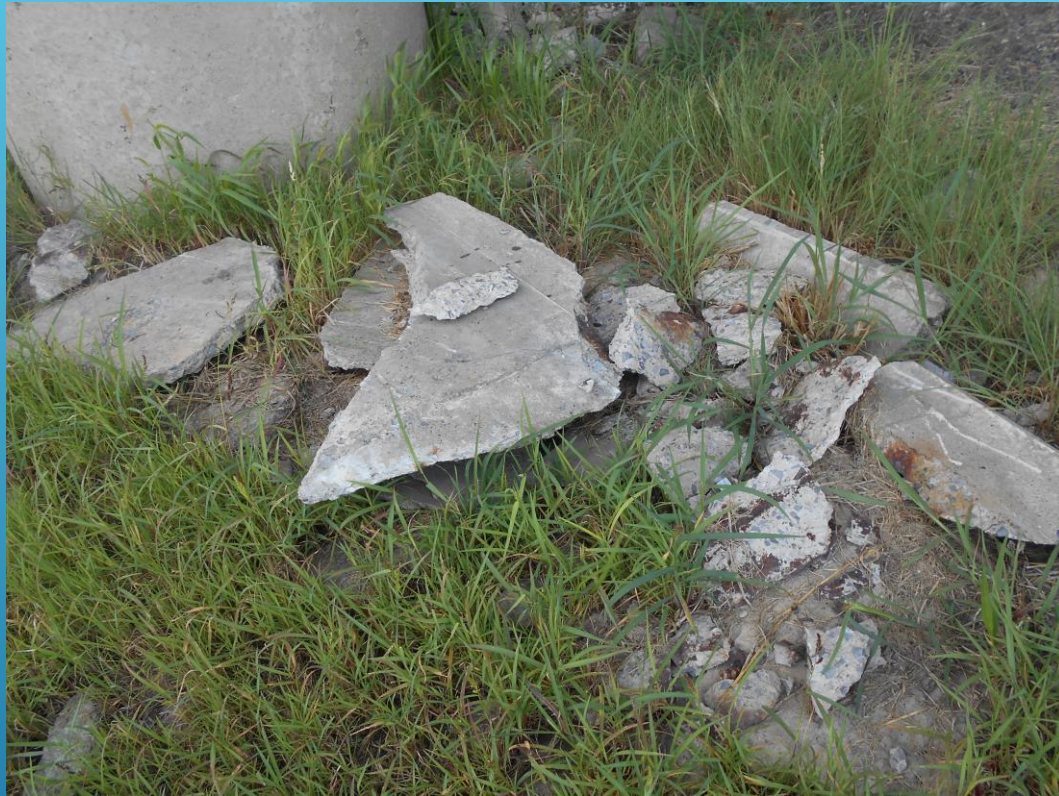
- ◆ The ground was littered with broken pieces of concrete from these spalls and defects we have seen so far.

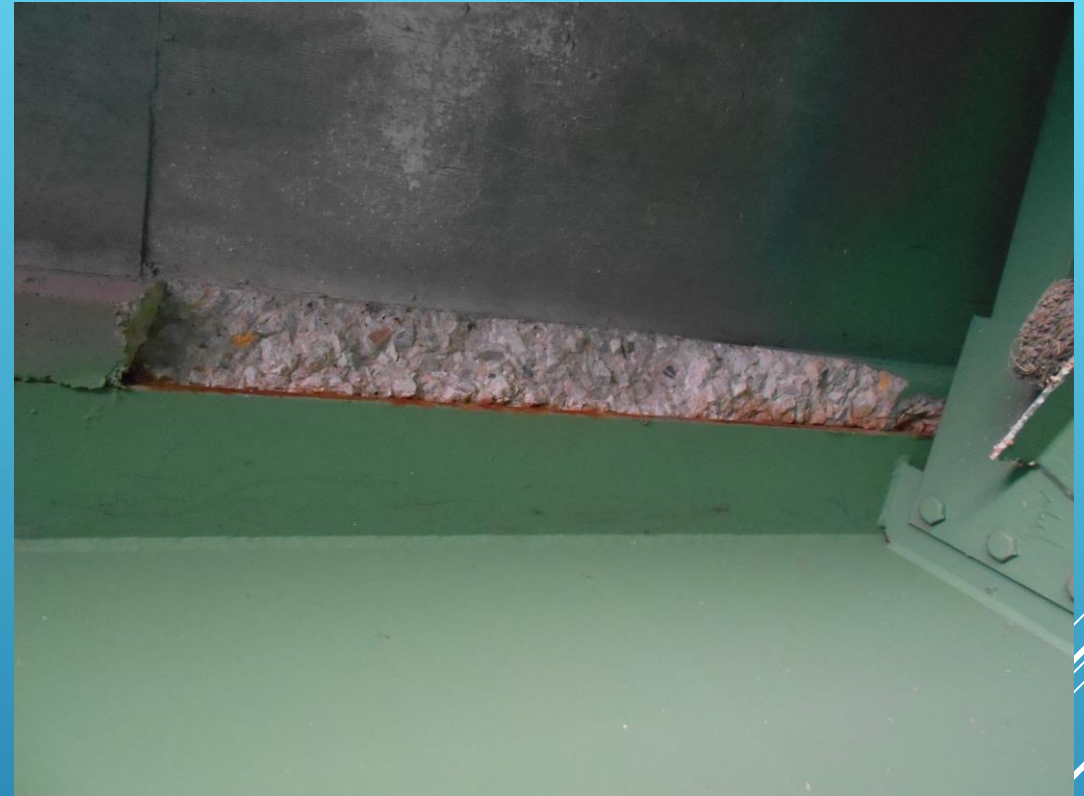
- ◆ Broken haunch. A safety hazard to vehicles on the underpass (US 19).
- ◆ Lack of reinforcing causes them to break apart and fall.
- ◆ If you see any during a routine inspection, just break off all loose pieces of haunch, just for the safety of the travelling public.

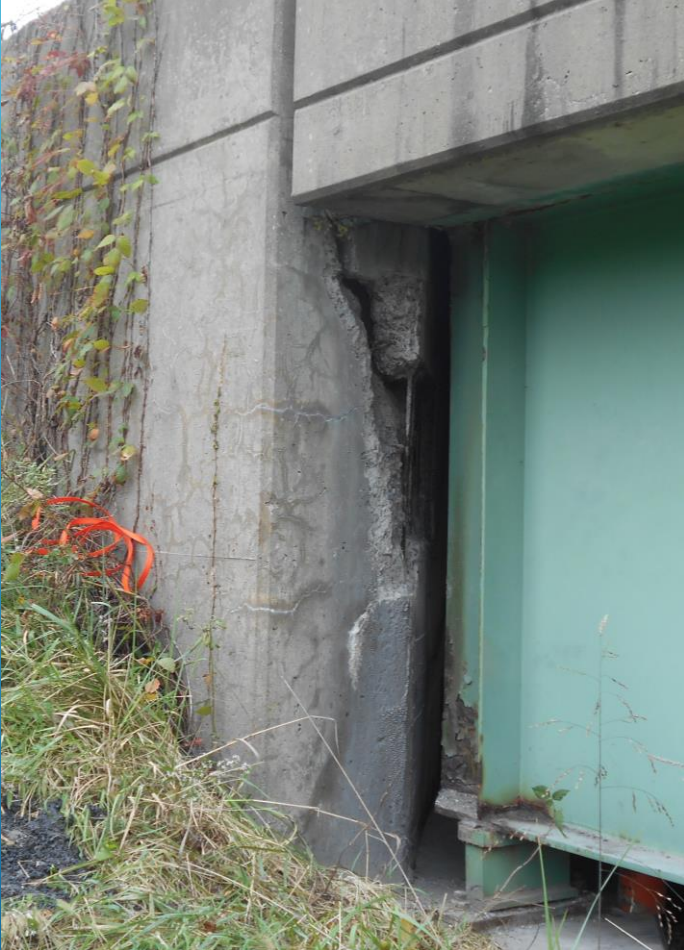
Large spall - A huge chunk of concrete cracked and about to fall off at the corner of Abutment 2, SB structure. Spalls found on all Abutment backwalls in general.

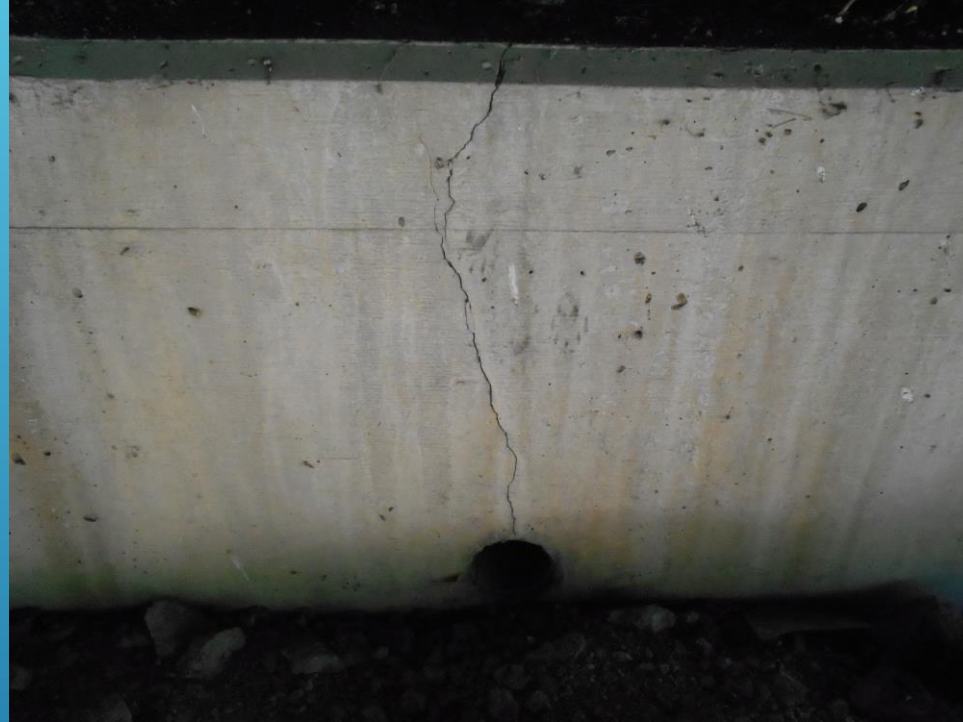
Numerous cracks. Cracks over .03 inches in width were sealed by an epoxy crack sealant.

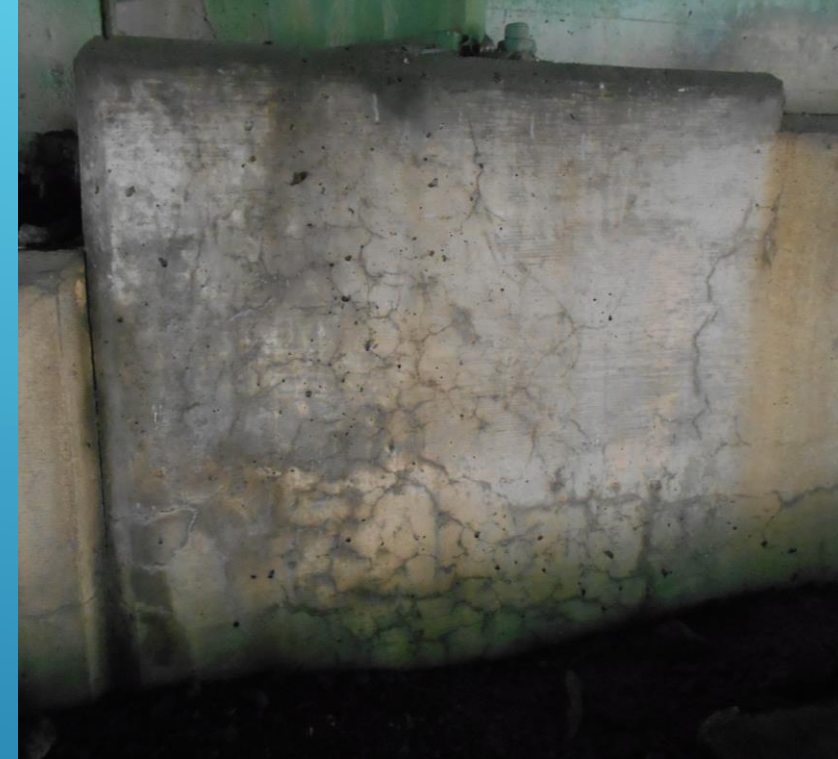
Map cracking. Cracks were sealed off with concrete protective coating

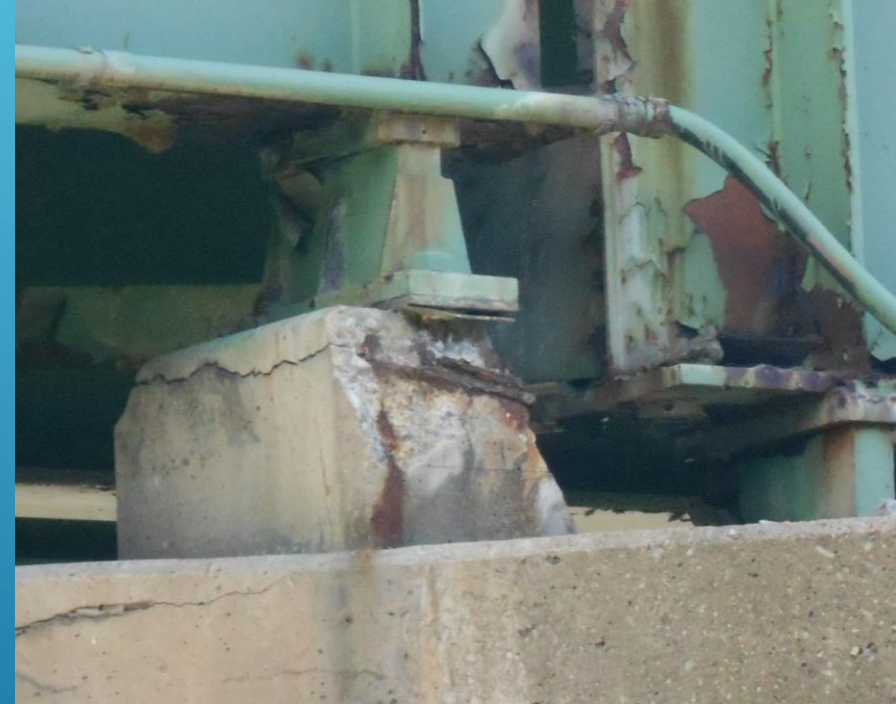
Steel members (girders, crossframes, diagonals etc.) at the supports where expansion joints are located showed surface rust and section loss.

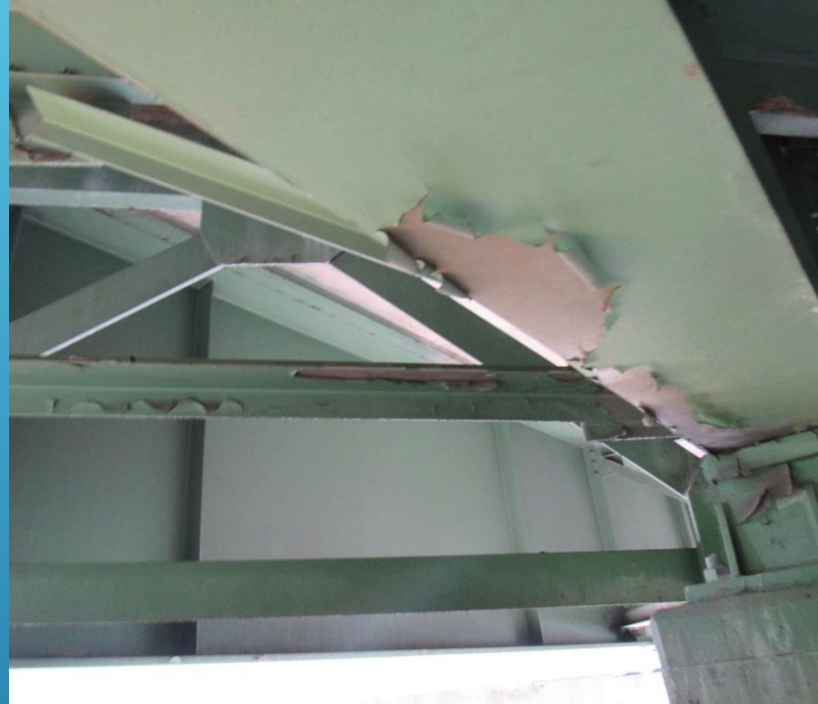
Peeling topcoat on the beam bottom flanges and diagonals. (Pier location)

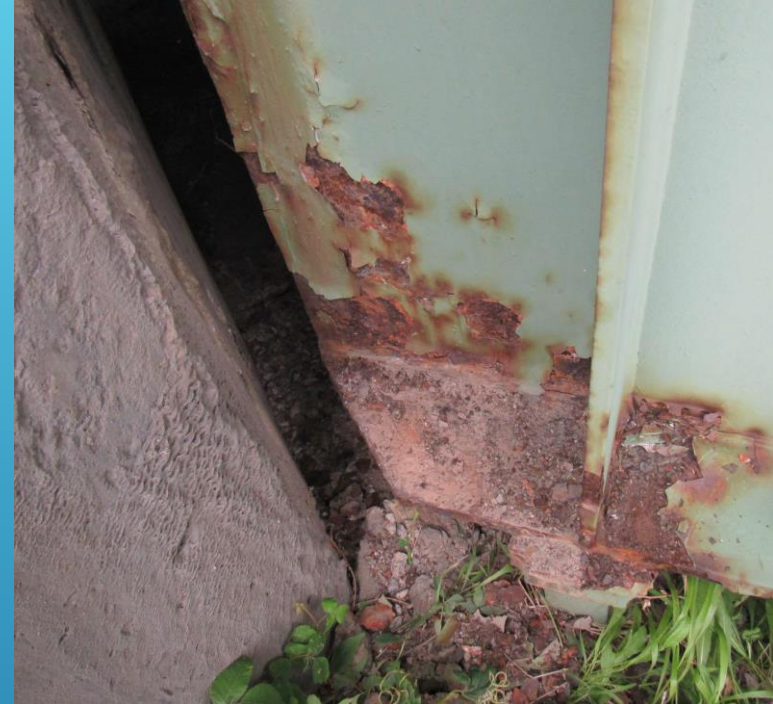
Surface rust and minor section loss at Abutments.

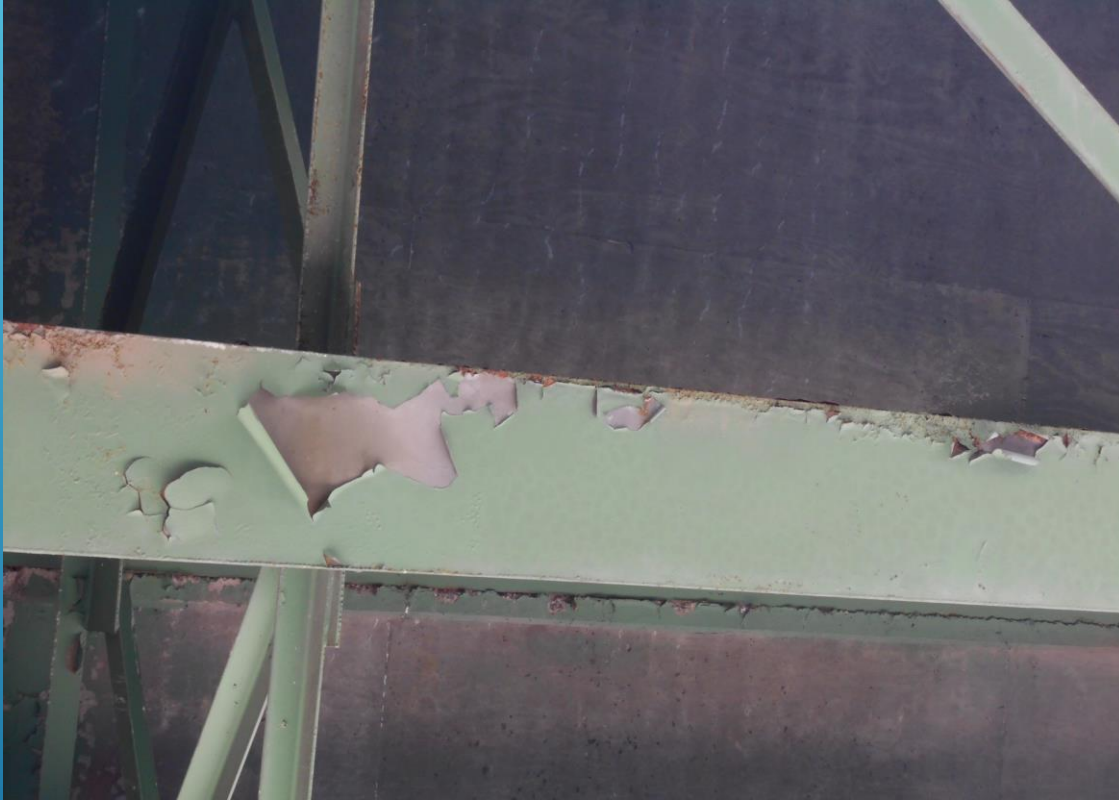
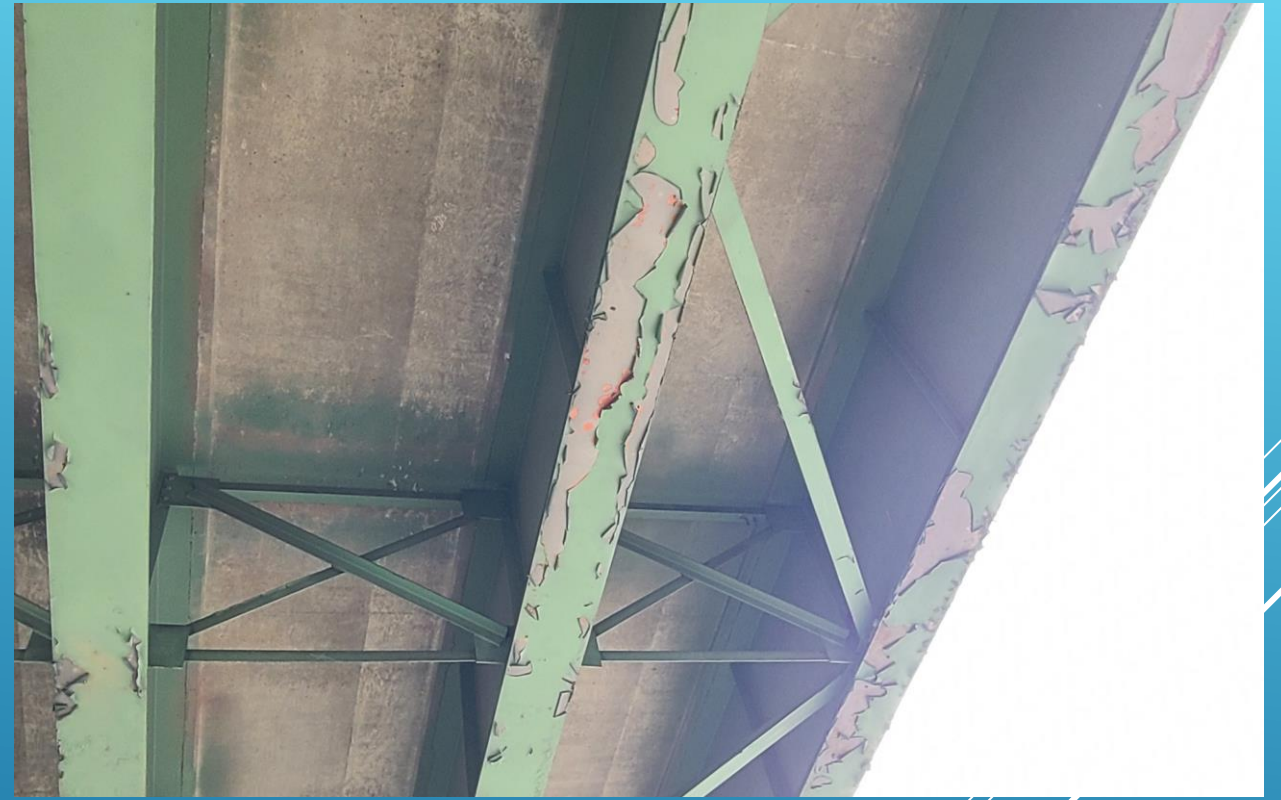
- ◆ Paint Peeling off in the bottom flanges of the girders in Span 3 (the span over the US 19). Quite extensive.
- ◆ Exhaust fumes from trucks travelling underneath on US 19 underpass probably had something to do with it. We decided to clean and paint at least the bottom flanges in span 3 and sections at the supports.
- ◆ Limited Cleaning and painting in this contract is a *temporary measure*. Bridge is due for a full clean and paint project.
