WESTOVER BRIDGE REHABILITATION

Nimal Suhir, P.E.

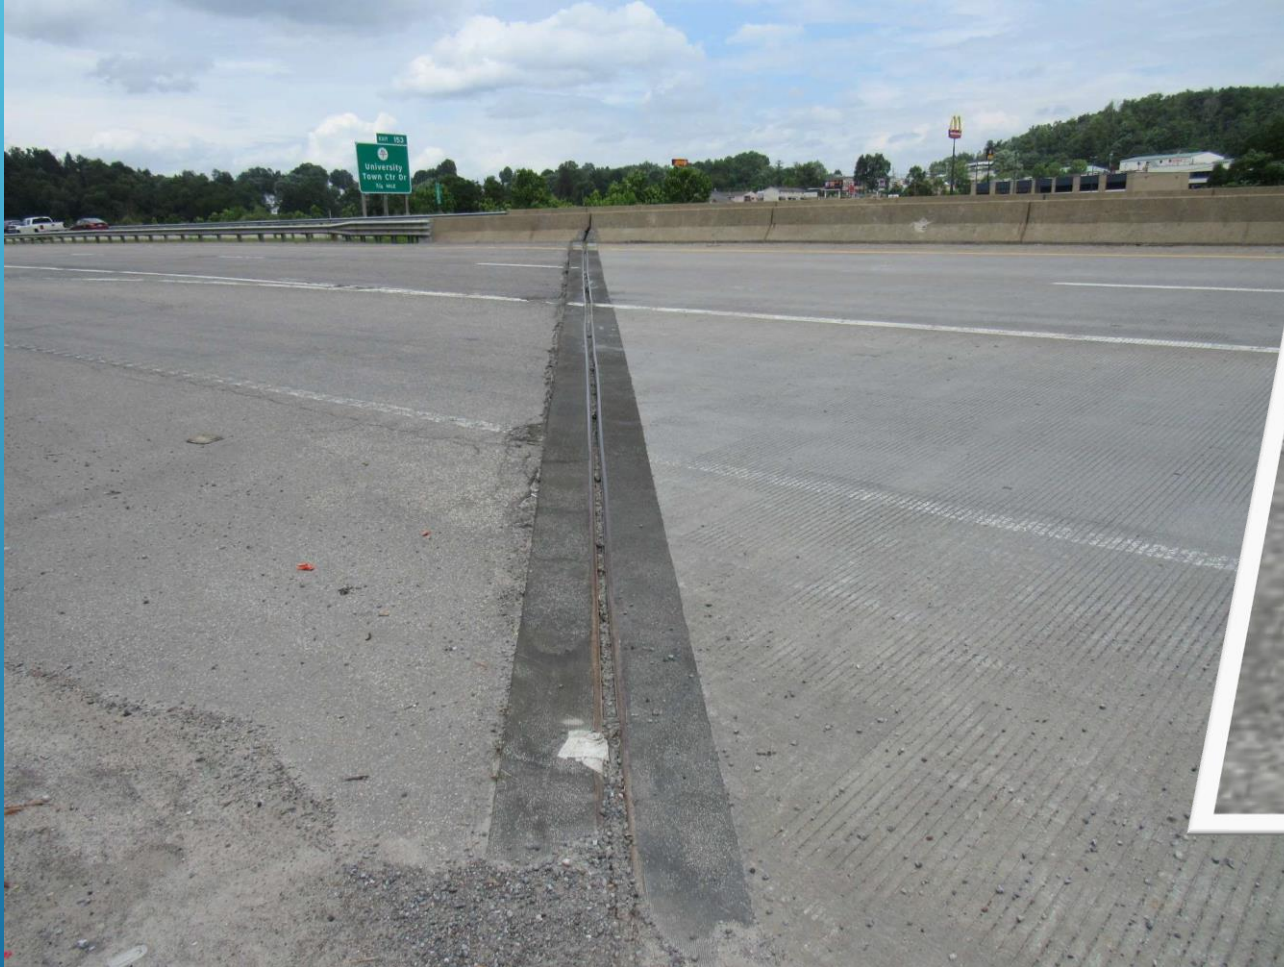
Typical Strip Seal Expansion Joint in this bridge.

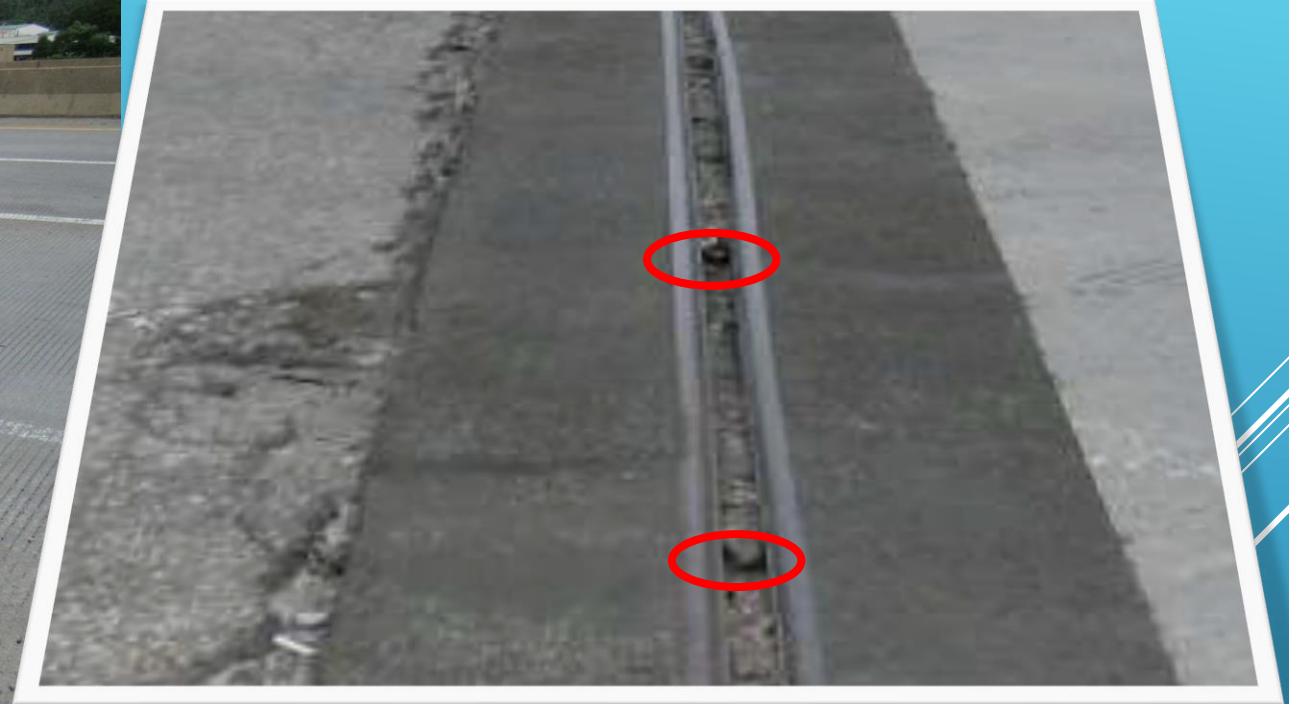
- ◆ Closeup View of Strip Seal. Holes in them caused the joint to leak.
- ◆ The seals are not meant to last the life of the bridge. They have to be replaced when they are worn out

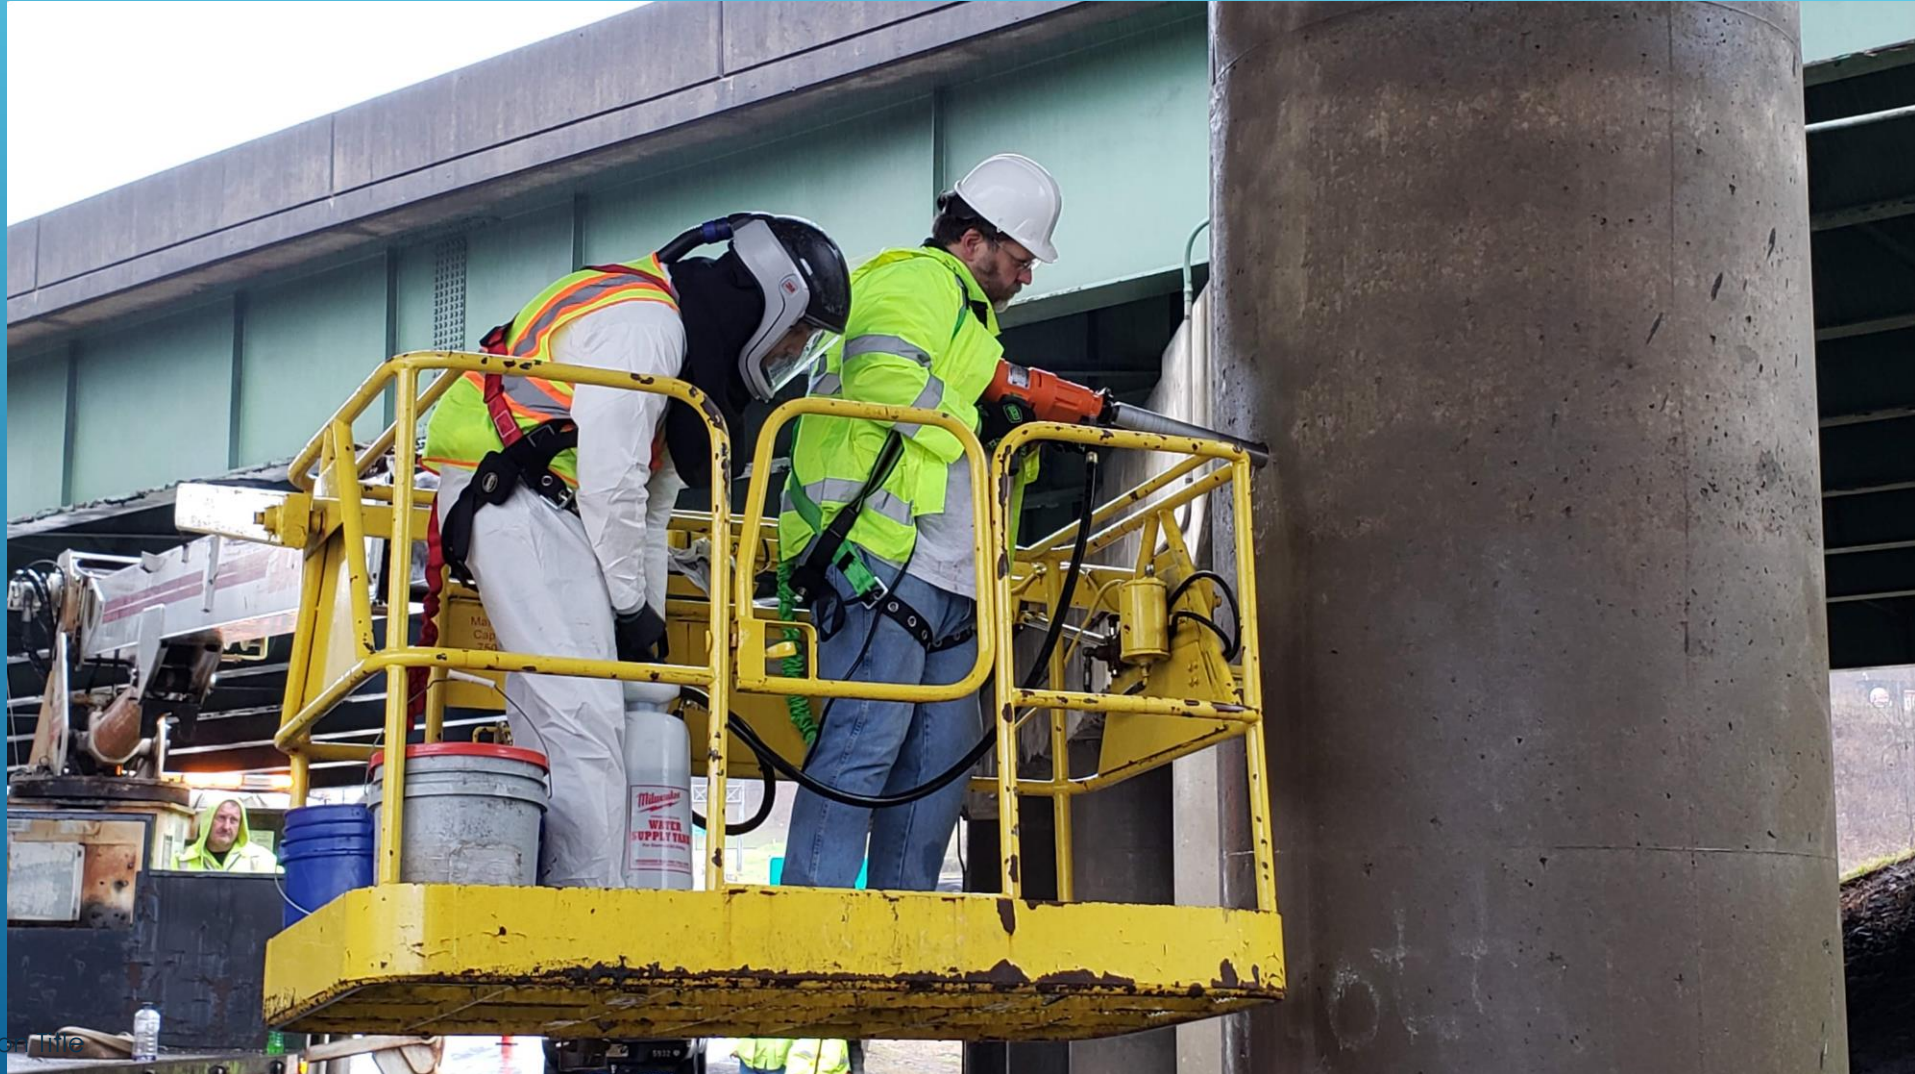
OBTAINING CORE SAMPLES TO CHECK FOR SALT CONCENTRATION IN PIERS

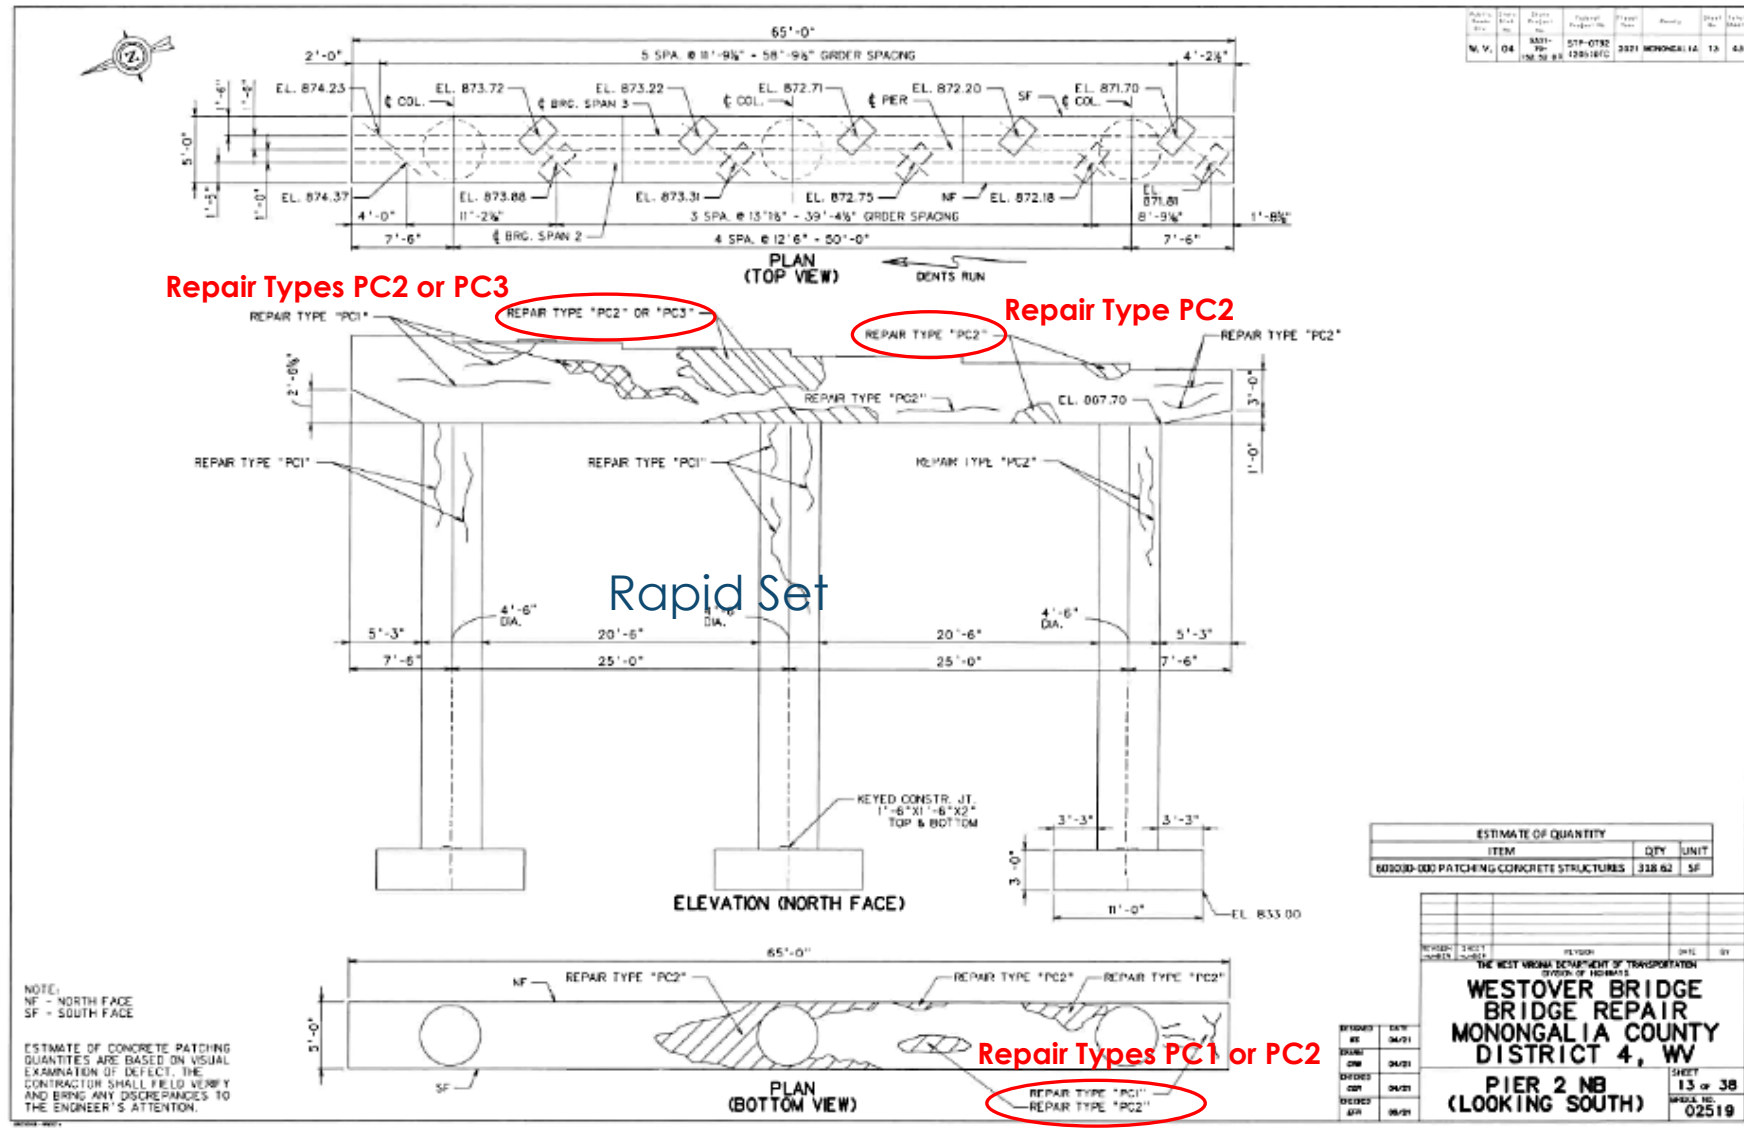
Example Pier Repair Plan Sheet

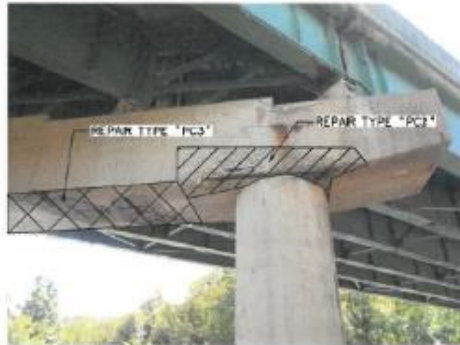
NB PIER 3, NORTH FACE

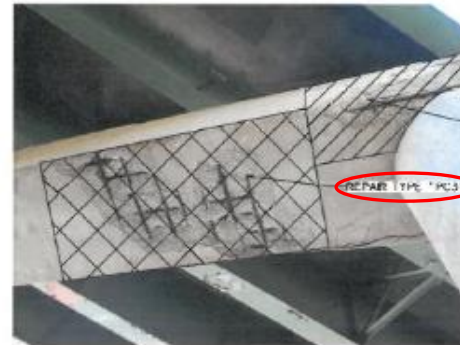
NB PIER 3, BOTTOM OF PIER CAP BETWEEN MIDDLE COLUMN AND WEST COLUMN

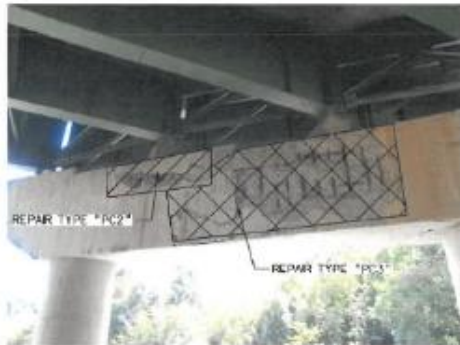
NB PIER 3, NORTH FACE

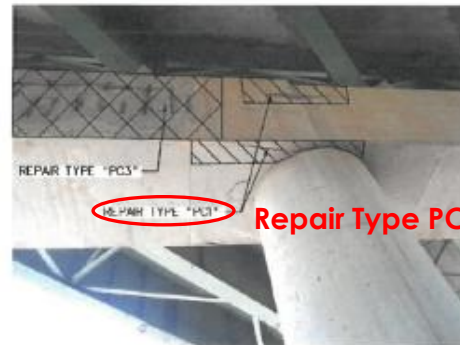
NB PIER 3, BOTTOM OF PIER CAP BETWEEN EAST COLUMN AND MIDDLE COLUMN

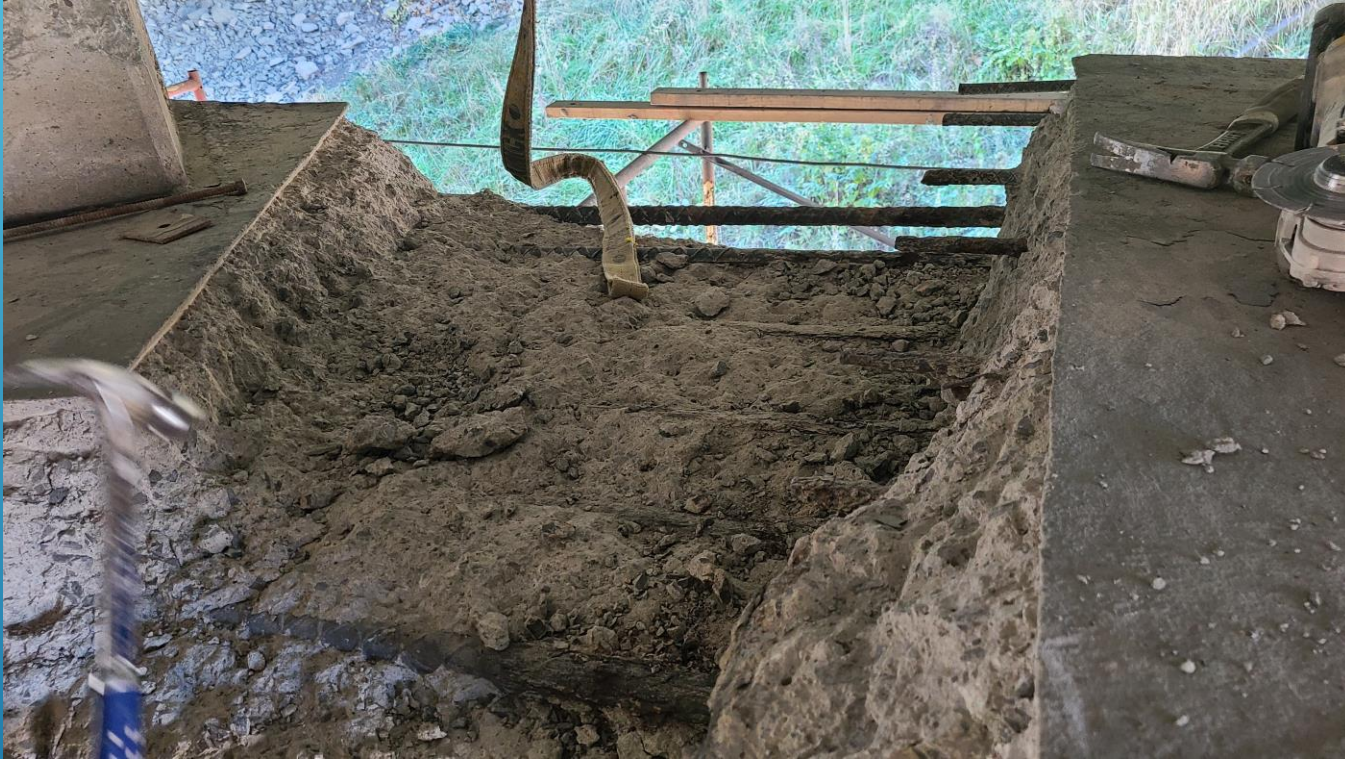
Removal of Unsound Concrete

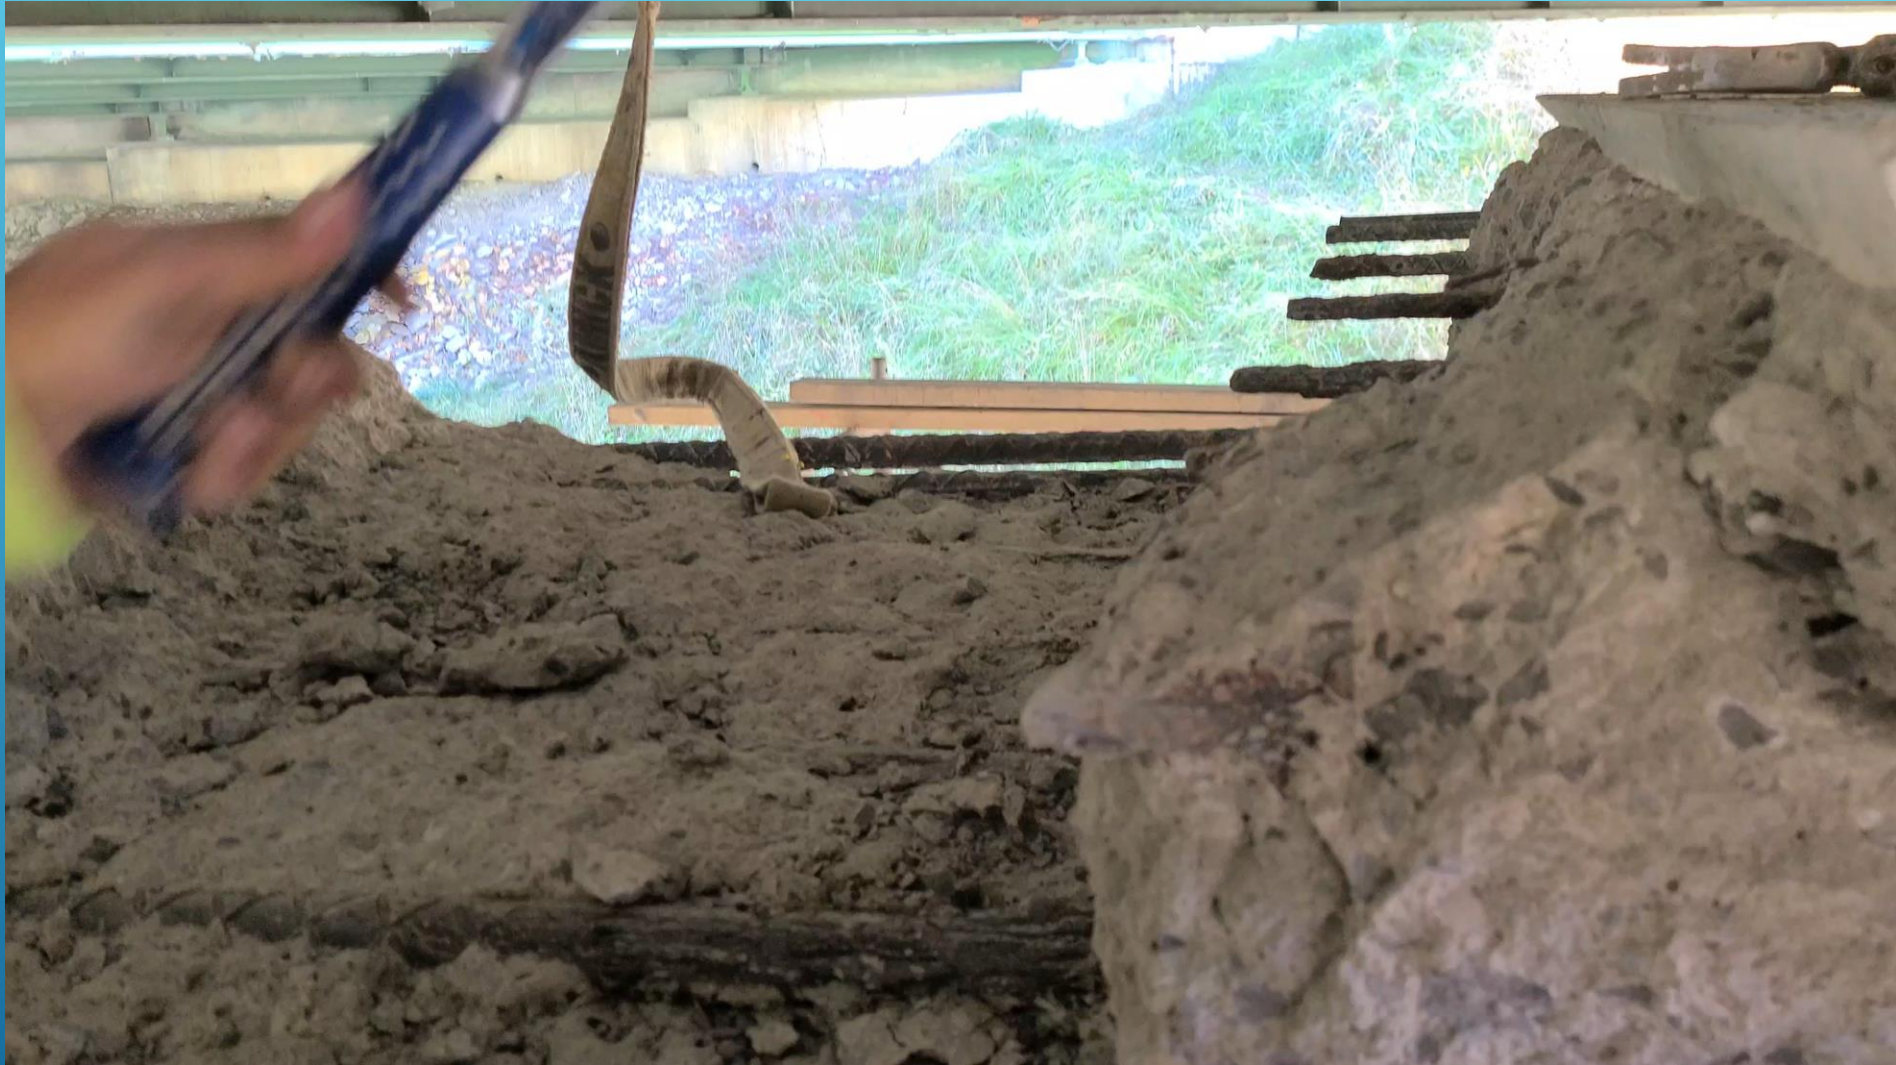
Detection and Removal of Unsound Concrete in Pier Cap

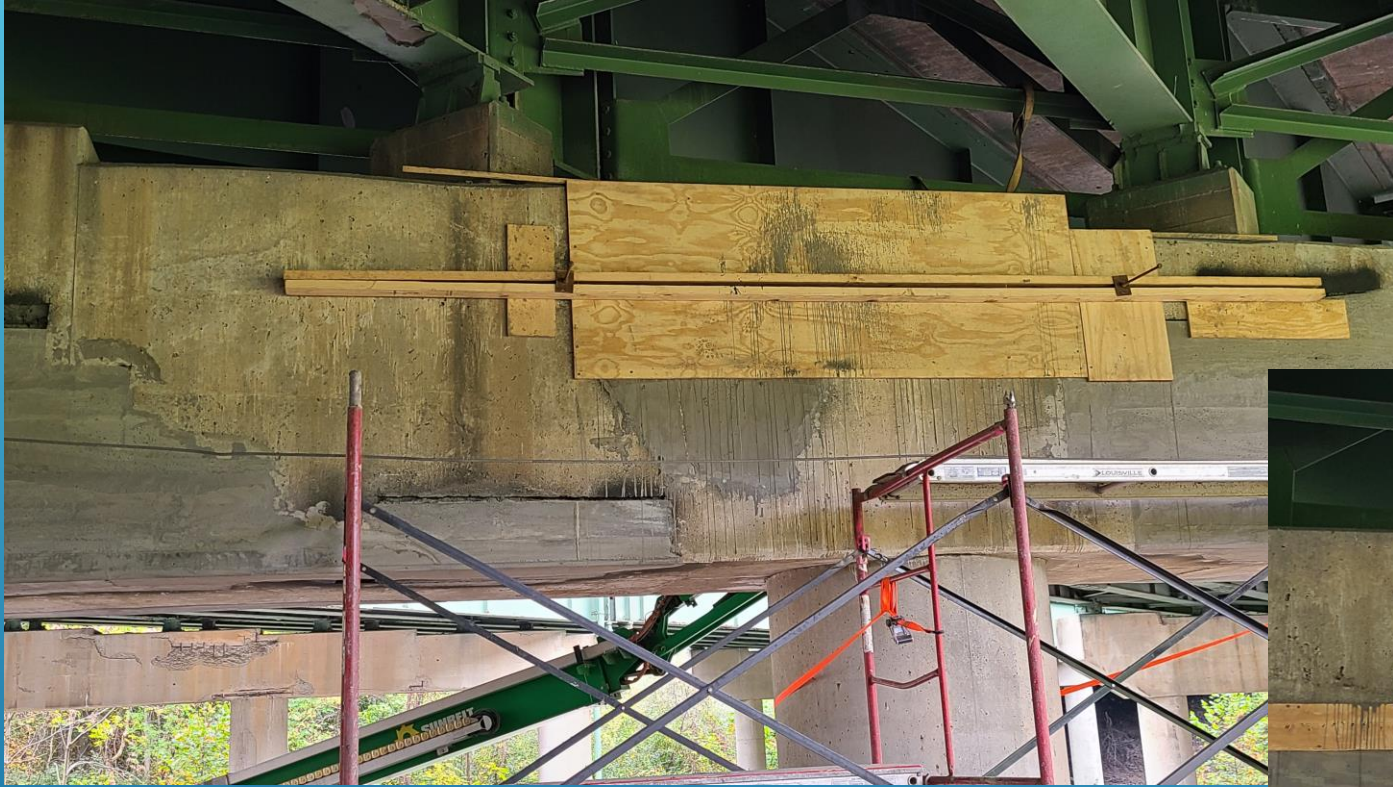
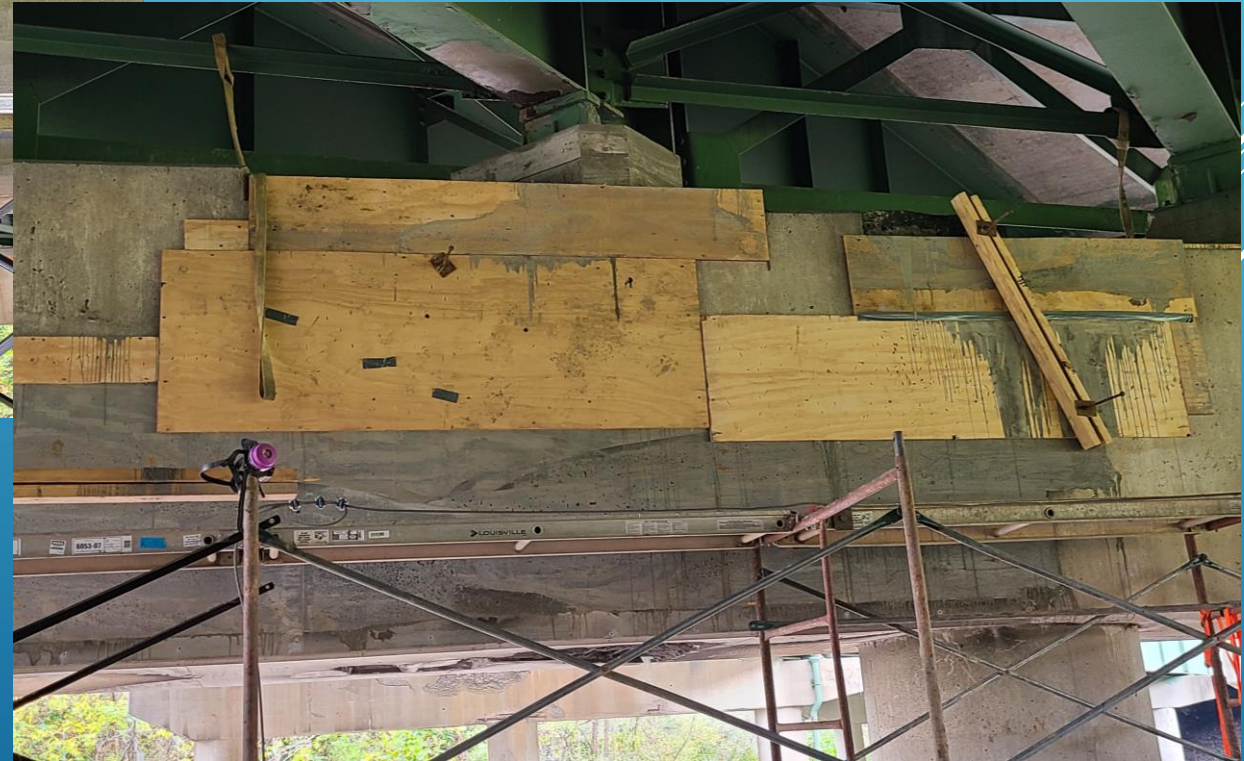
Formwork to Place Rapid Set Cementitious Patching Material in Pier Caps

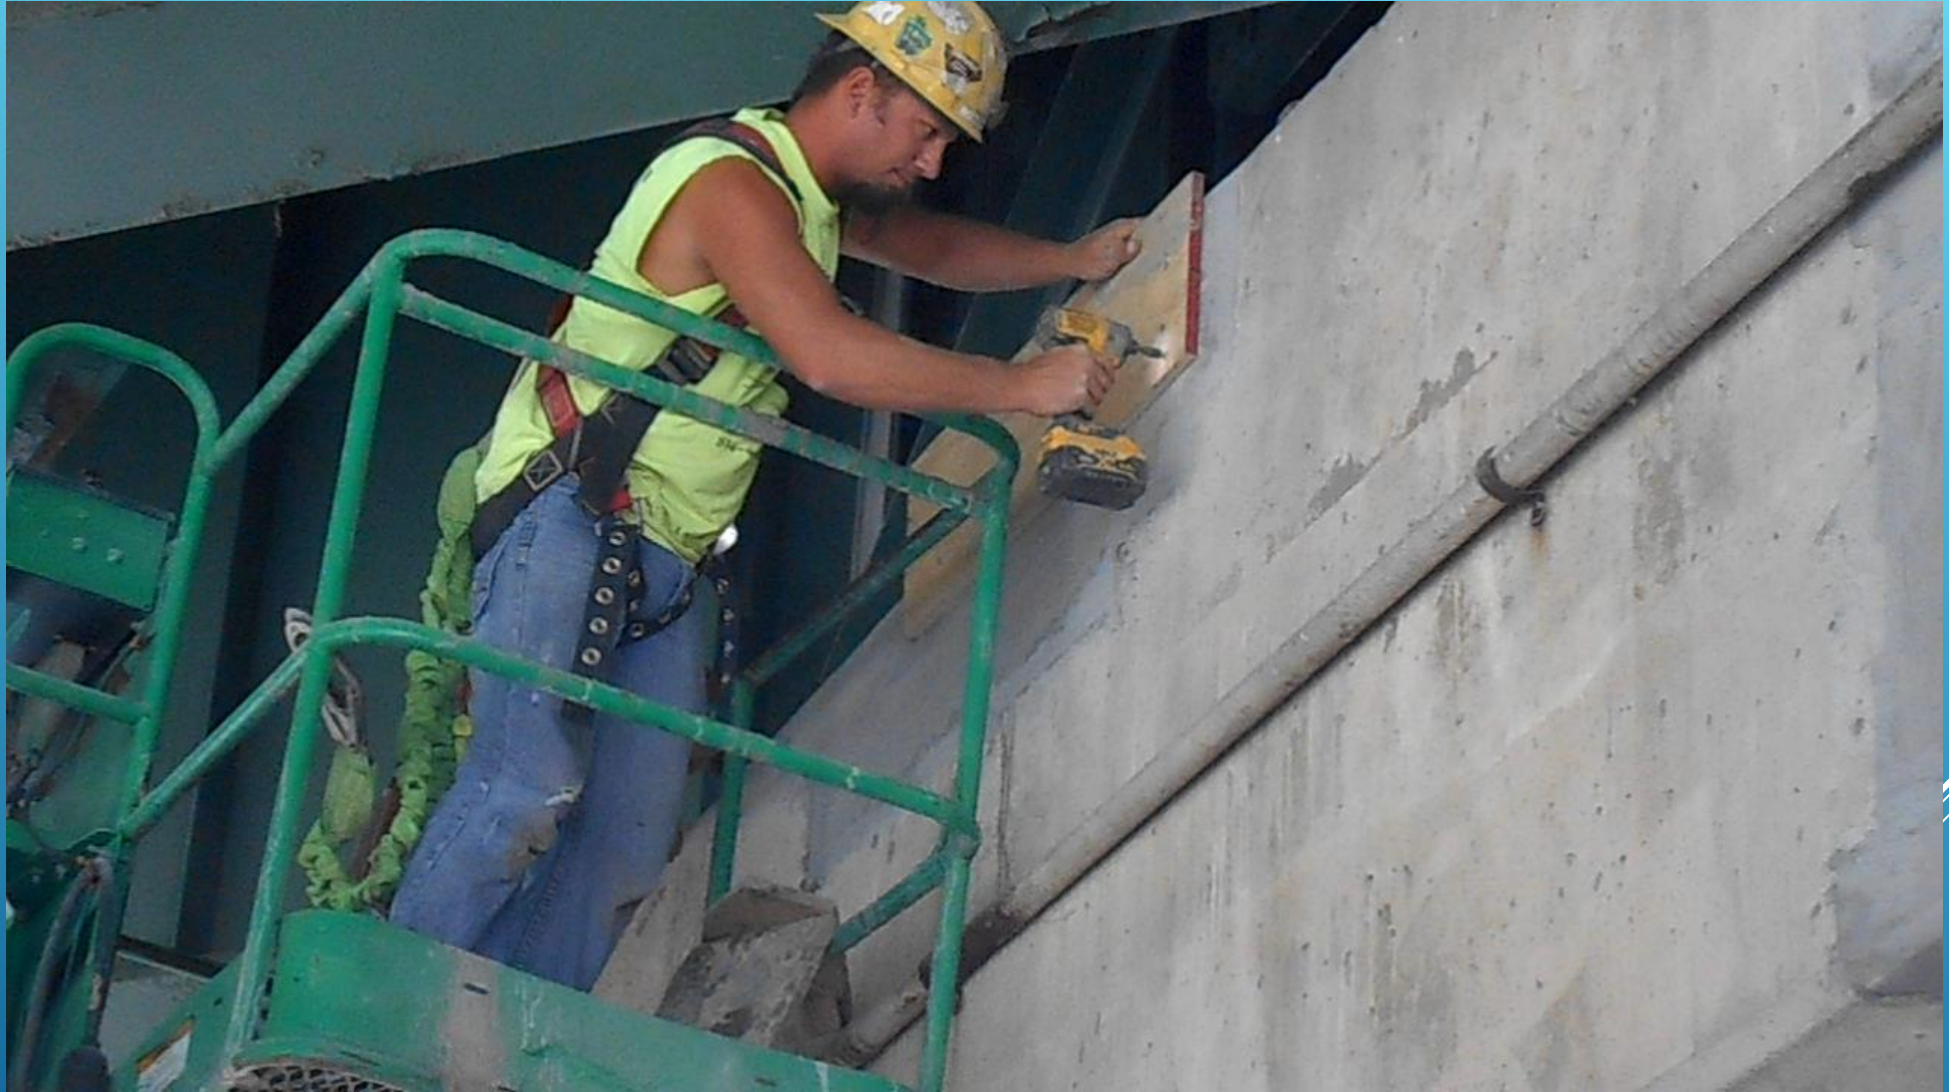
Forming to pour Rapid Set Cementitious Patching

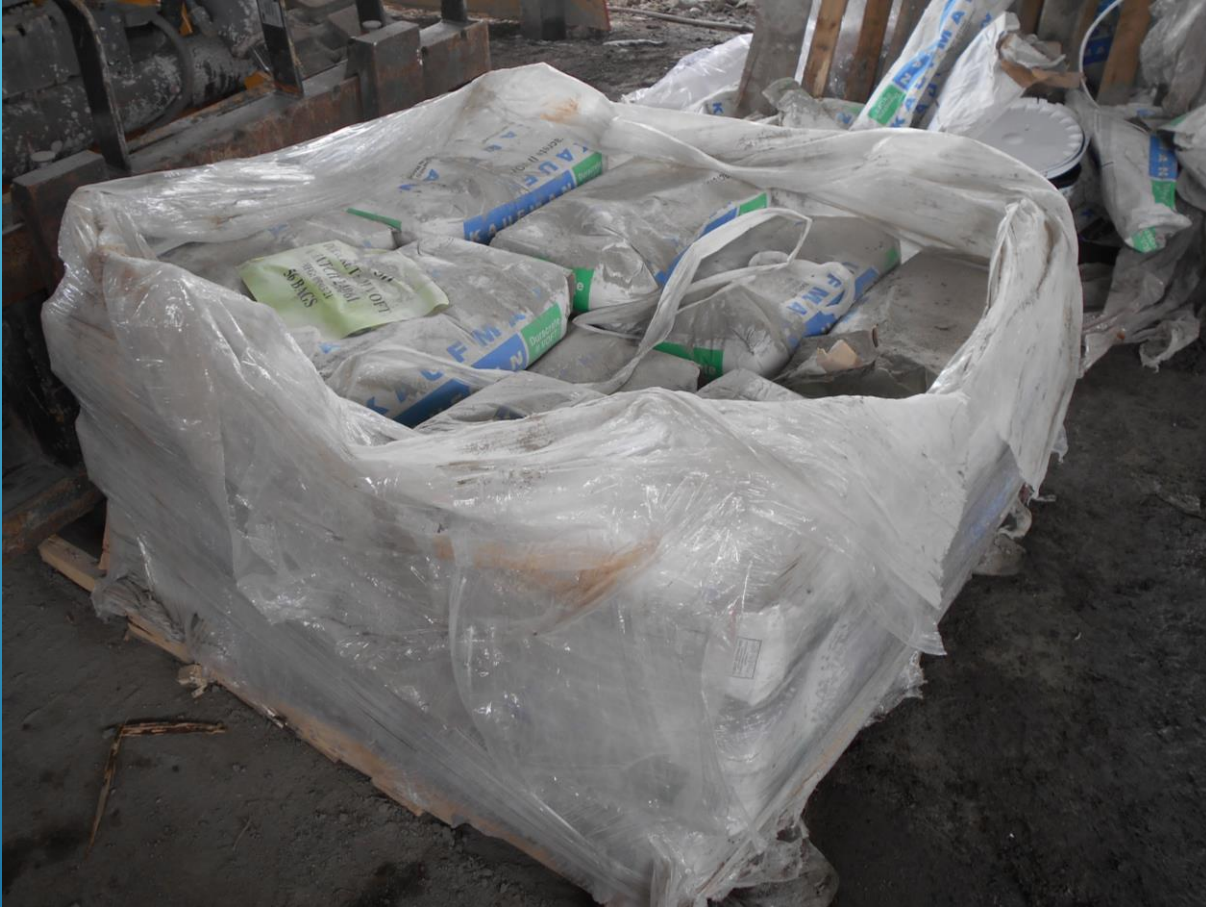
Rapid Set Cementitious Mix

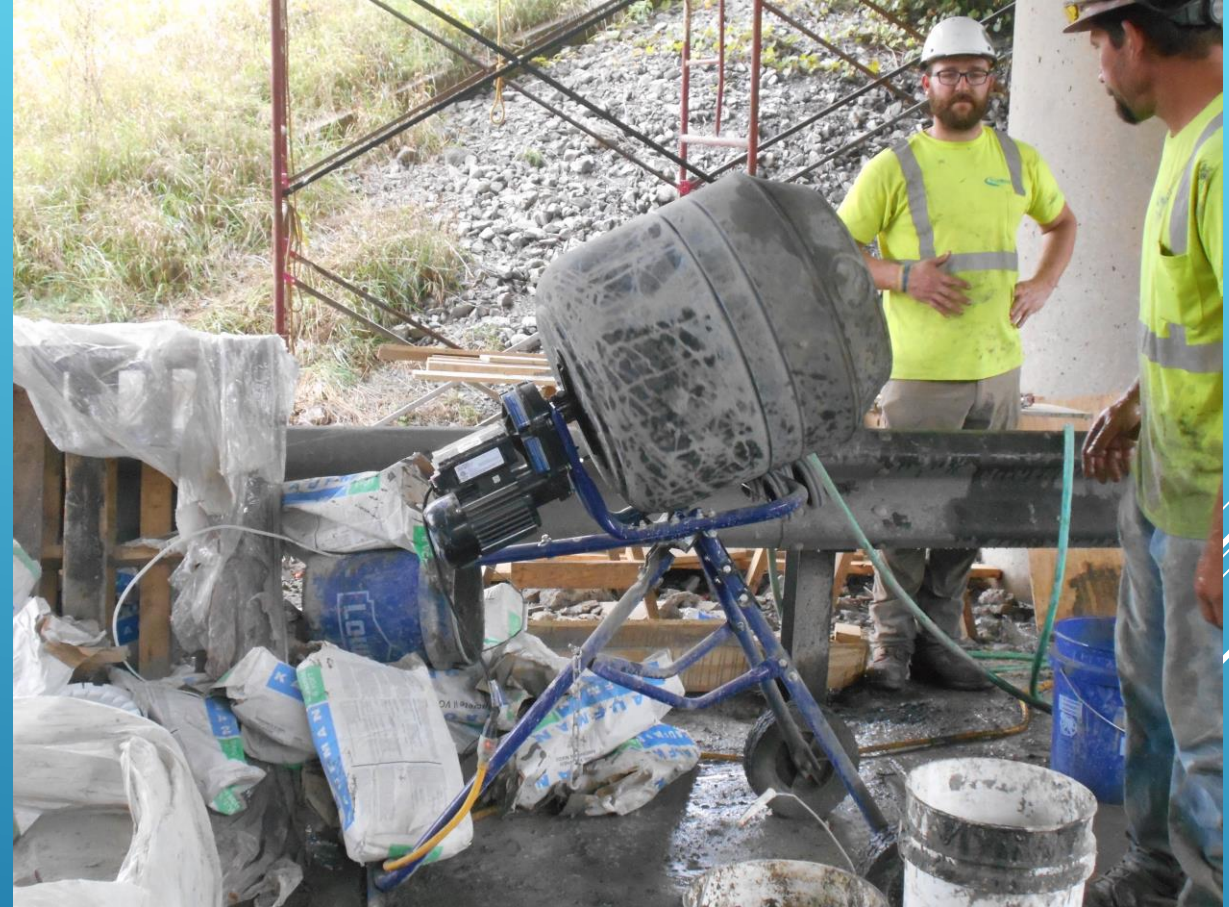
**Mixing Rapid Set Cementitious Patching Material
(on Site)**

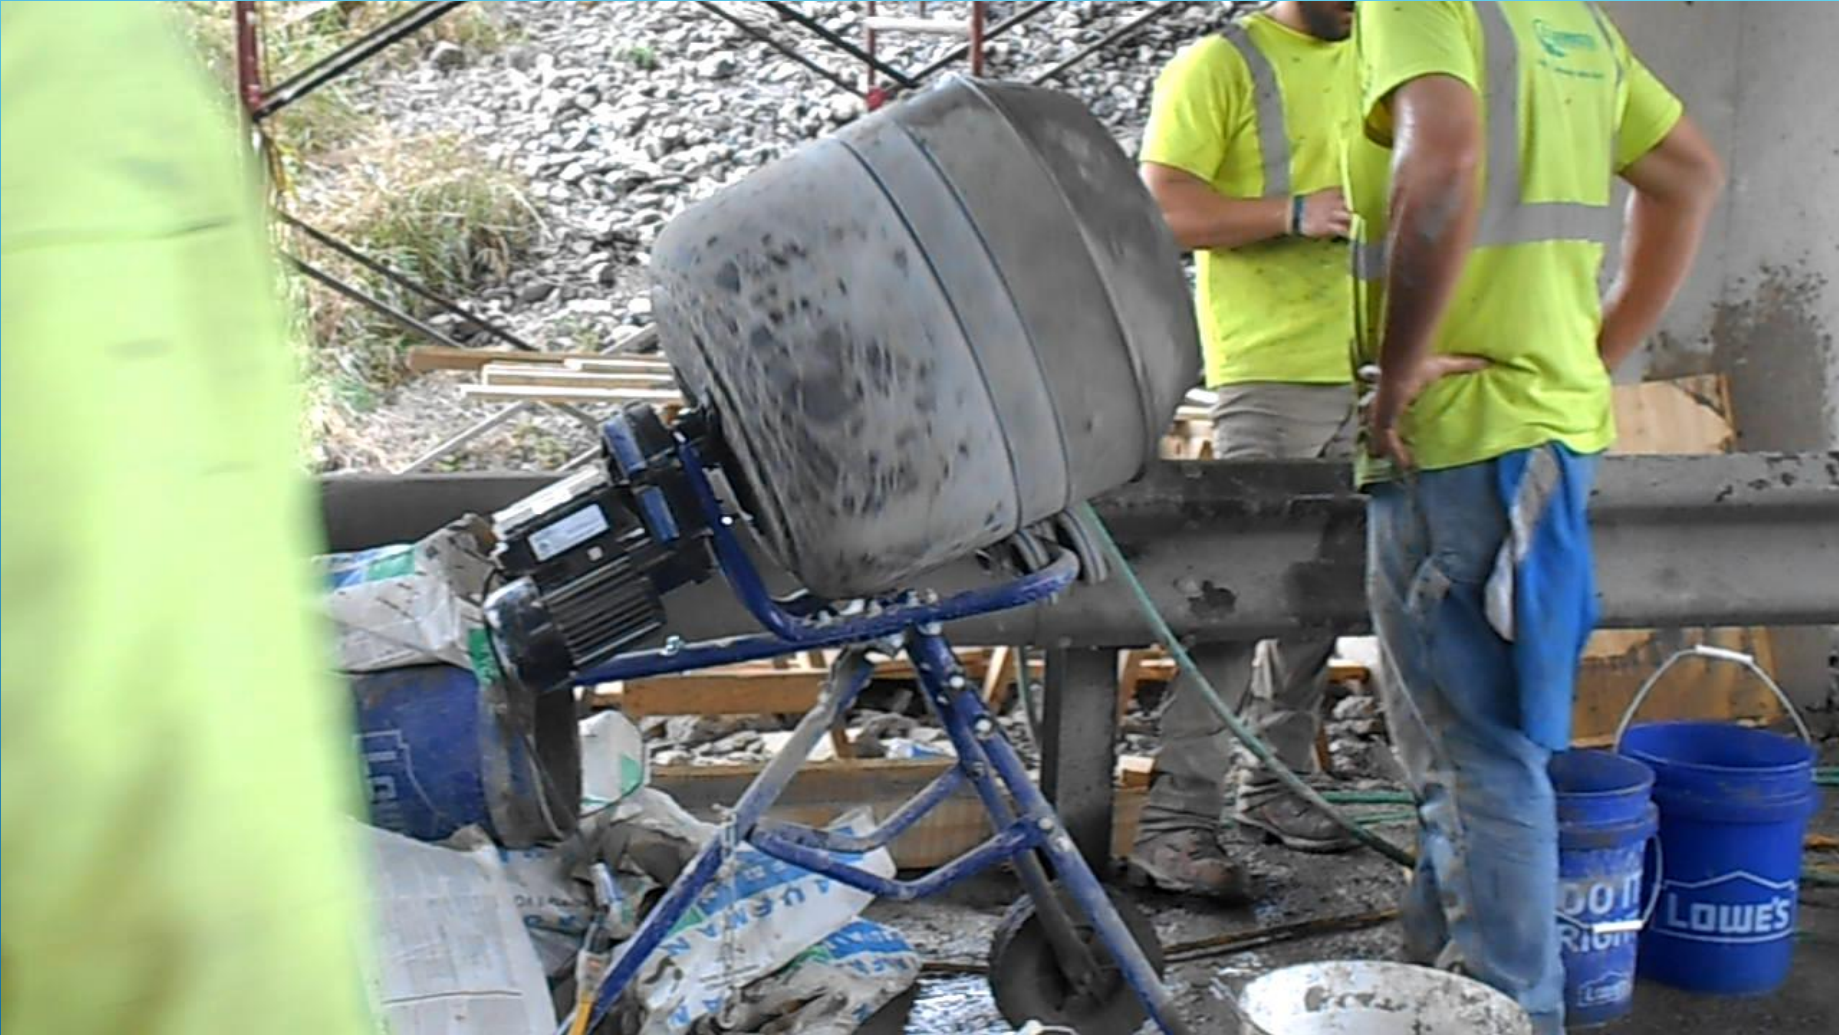
Site Mixing of Rapid Set Cementitious Patching Material

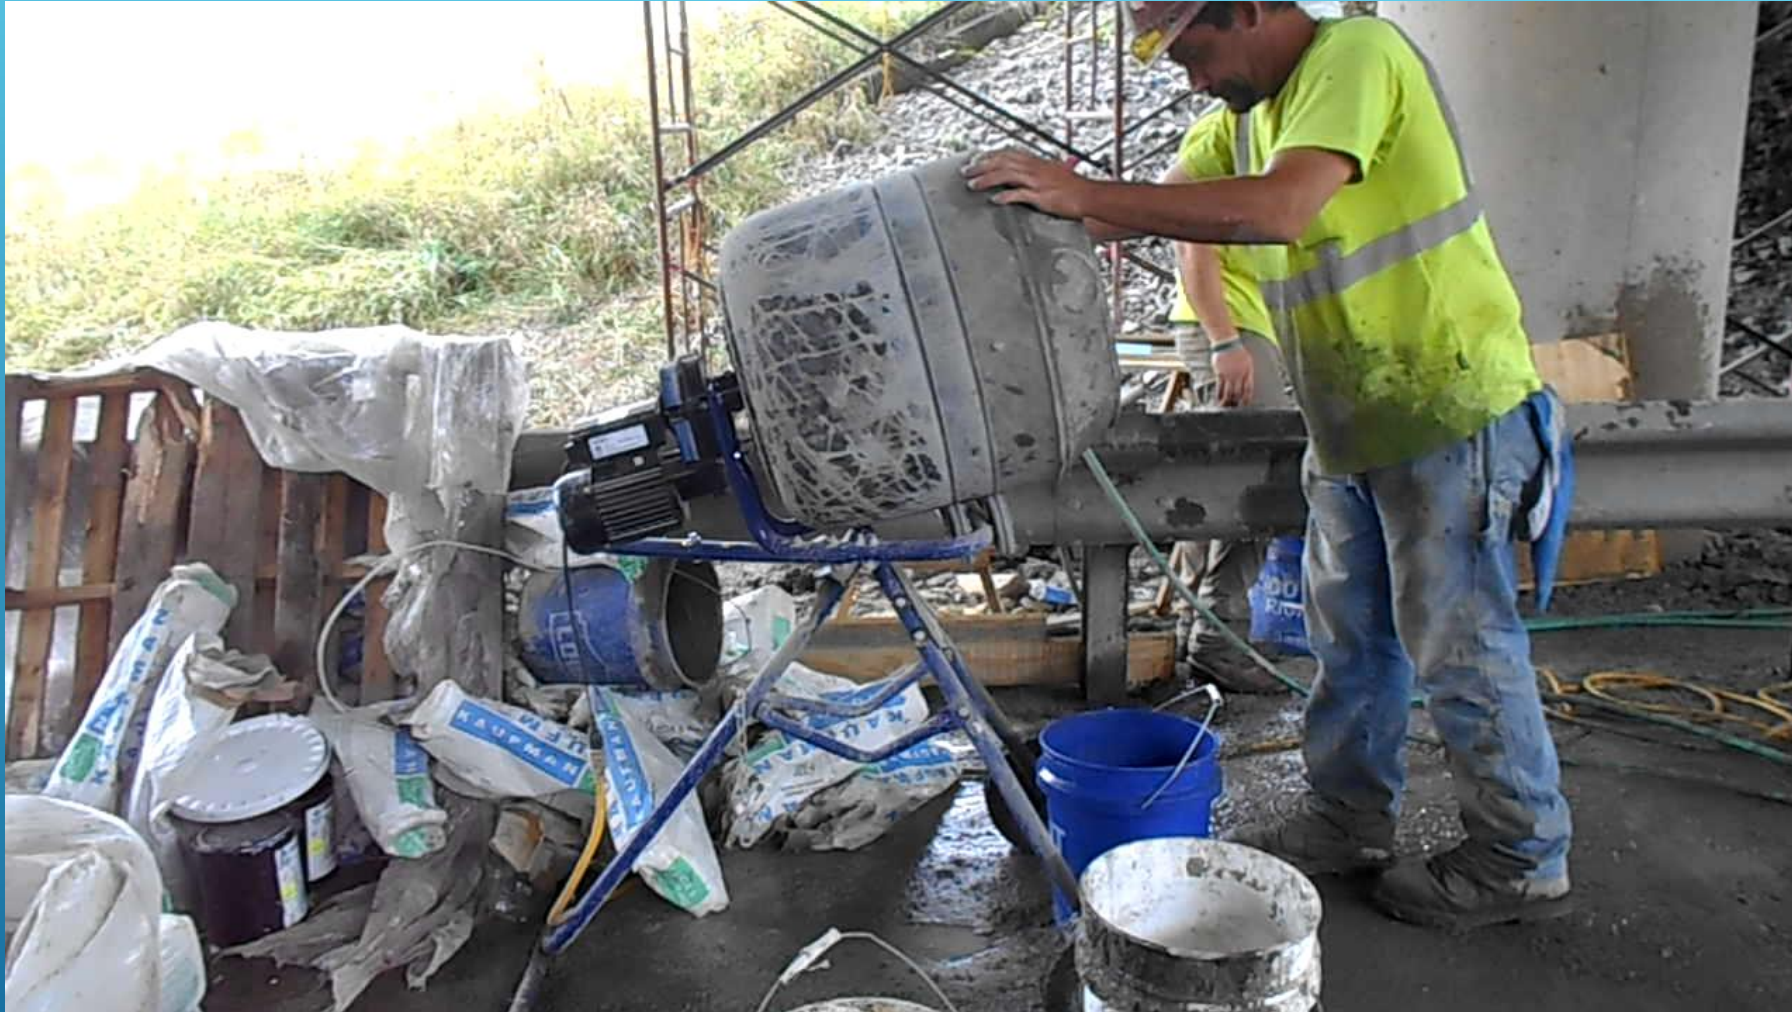
Site Mixing of Rapid Set Cementitious Patching Material

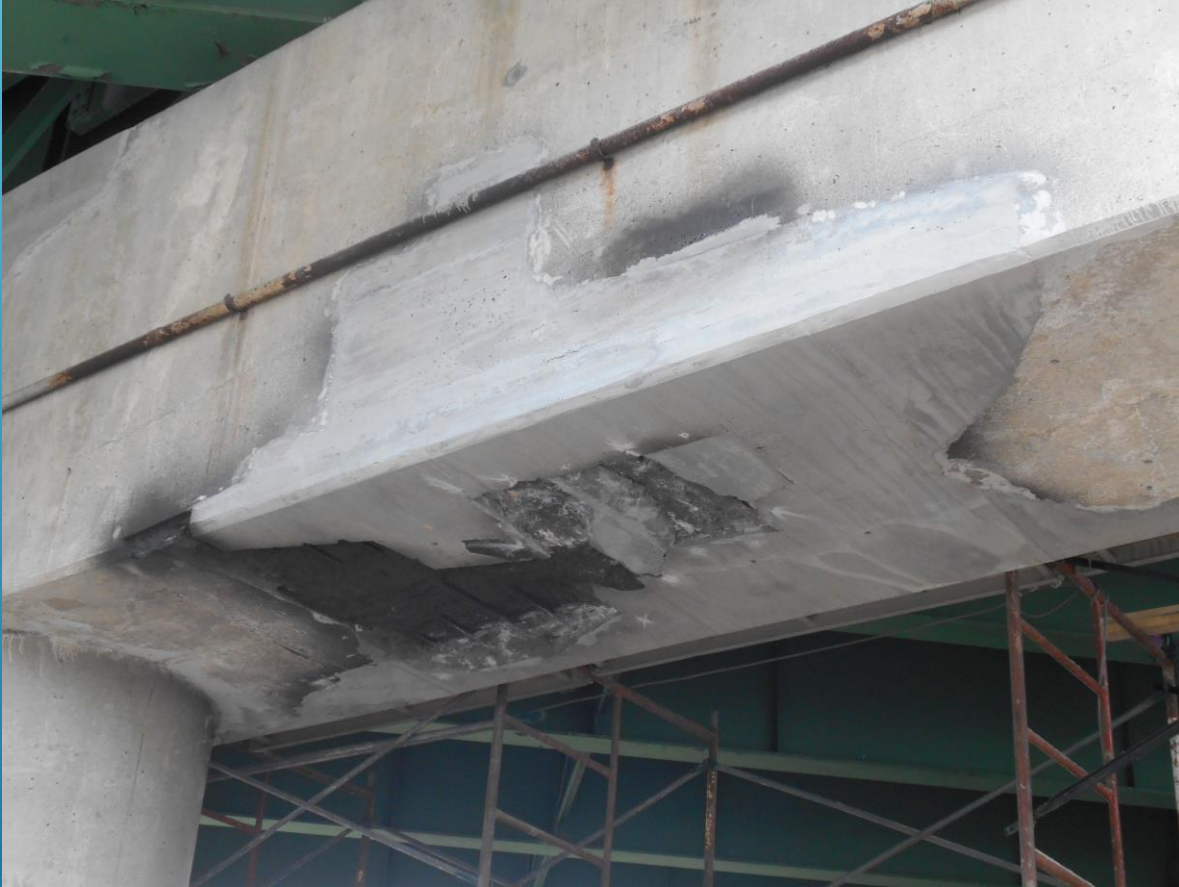
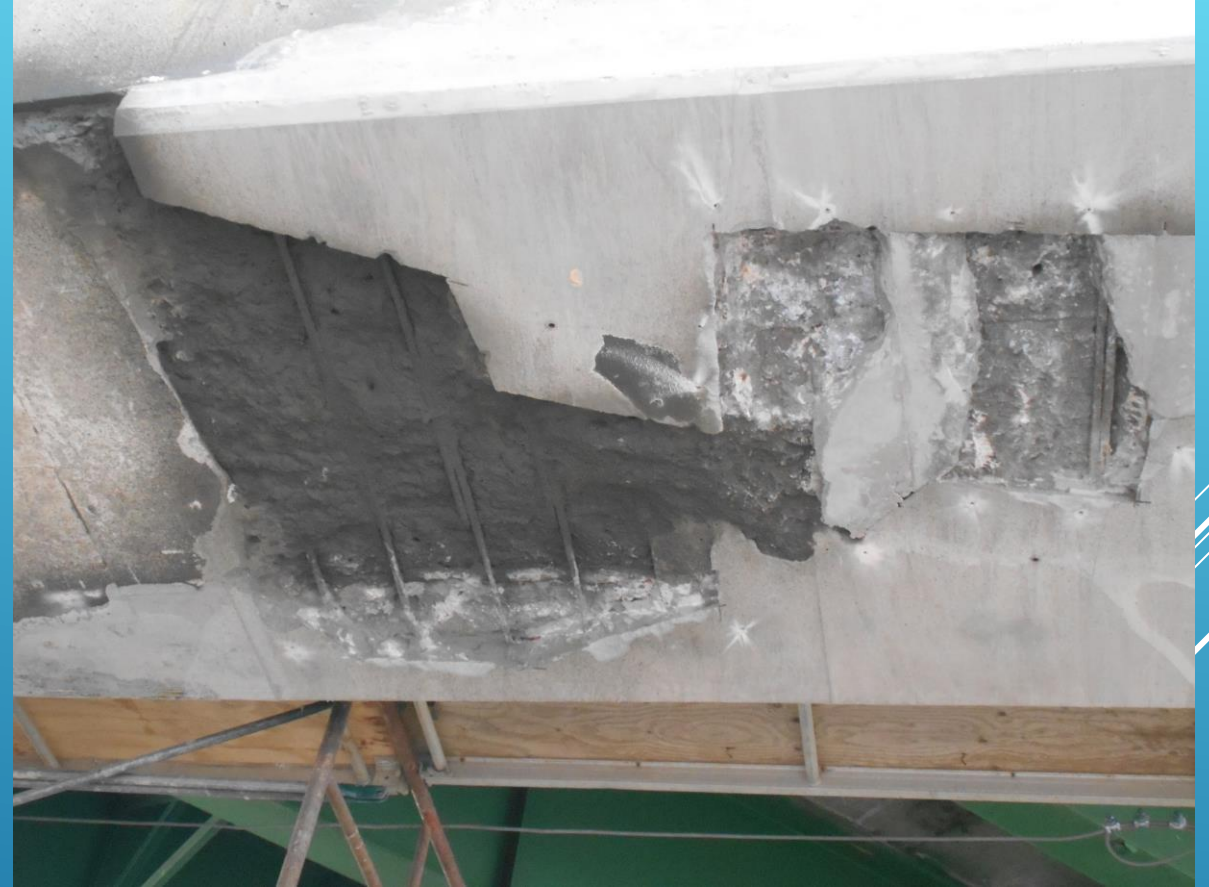
Problems with the Rapid Set Cementitious Mix caused sections of the patchwork to crumble. The District Construction Supervisors on the job rightly asked the contractor to take them off and reapply.
