WESTOVER BRIDGE REHABILITATION

Nimal Suhir, P.E.

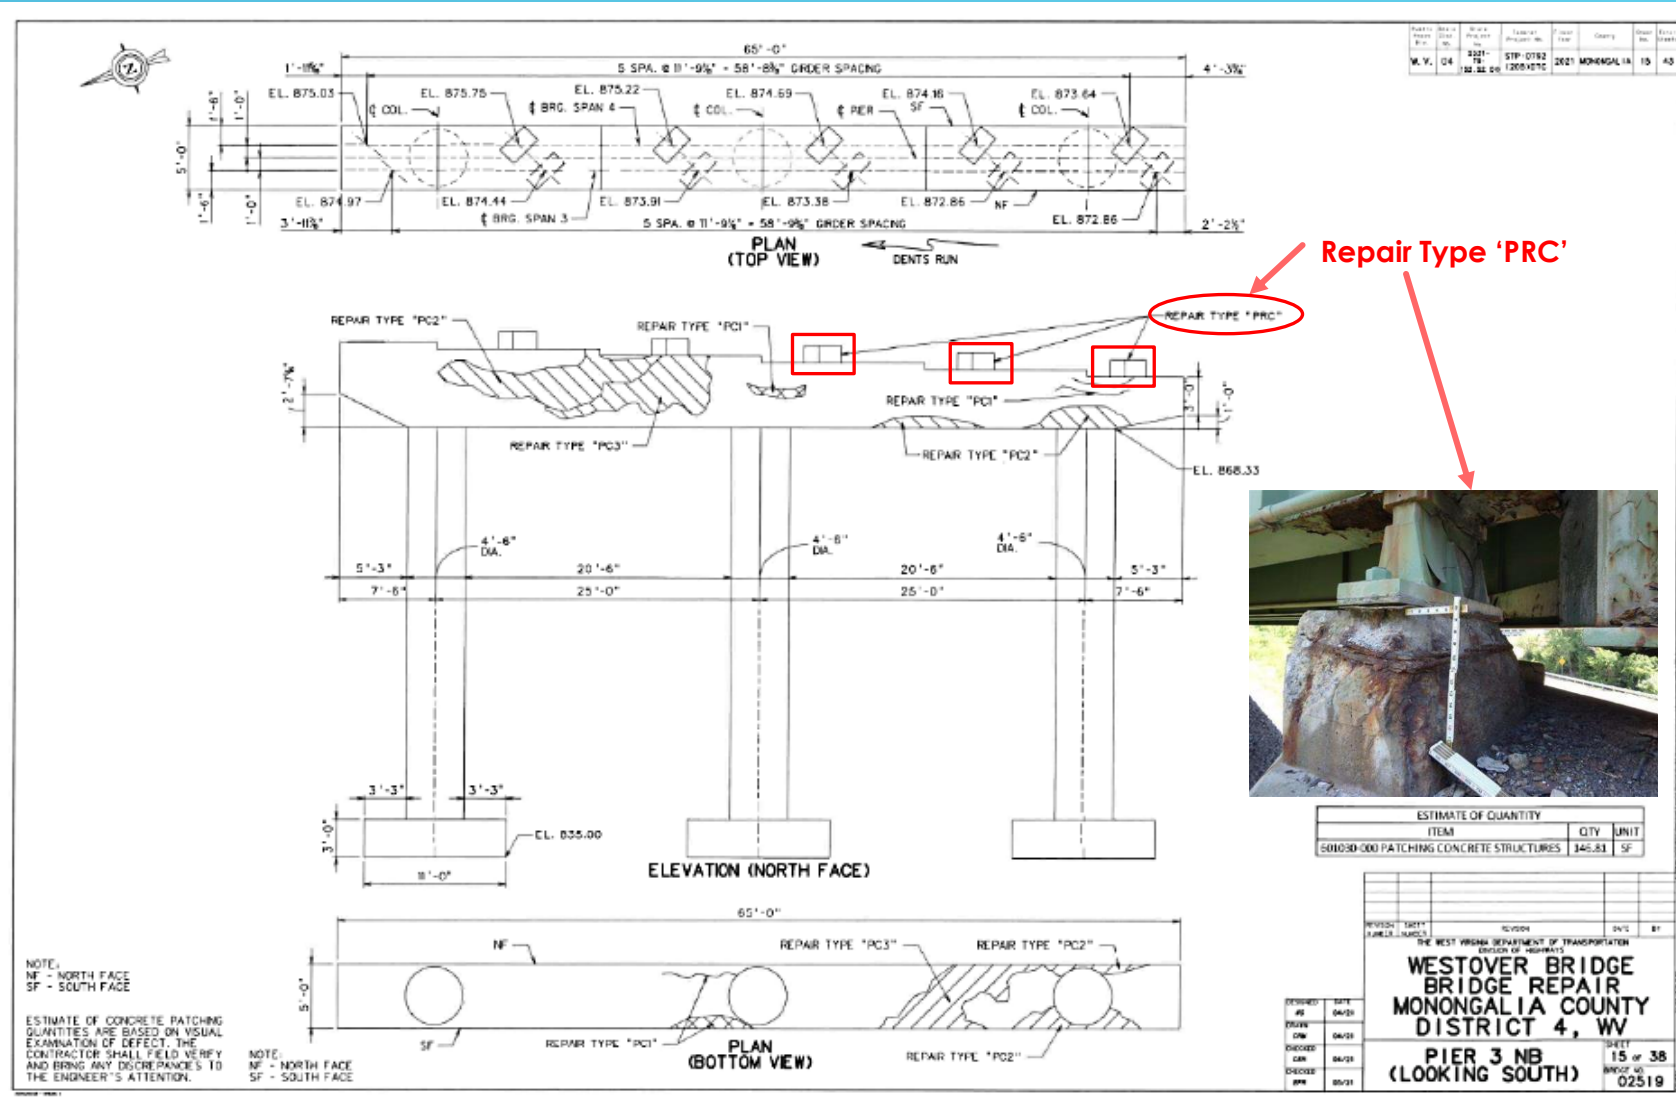
Pedestals on Pier 3 NB & SB

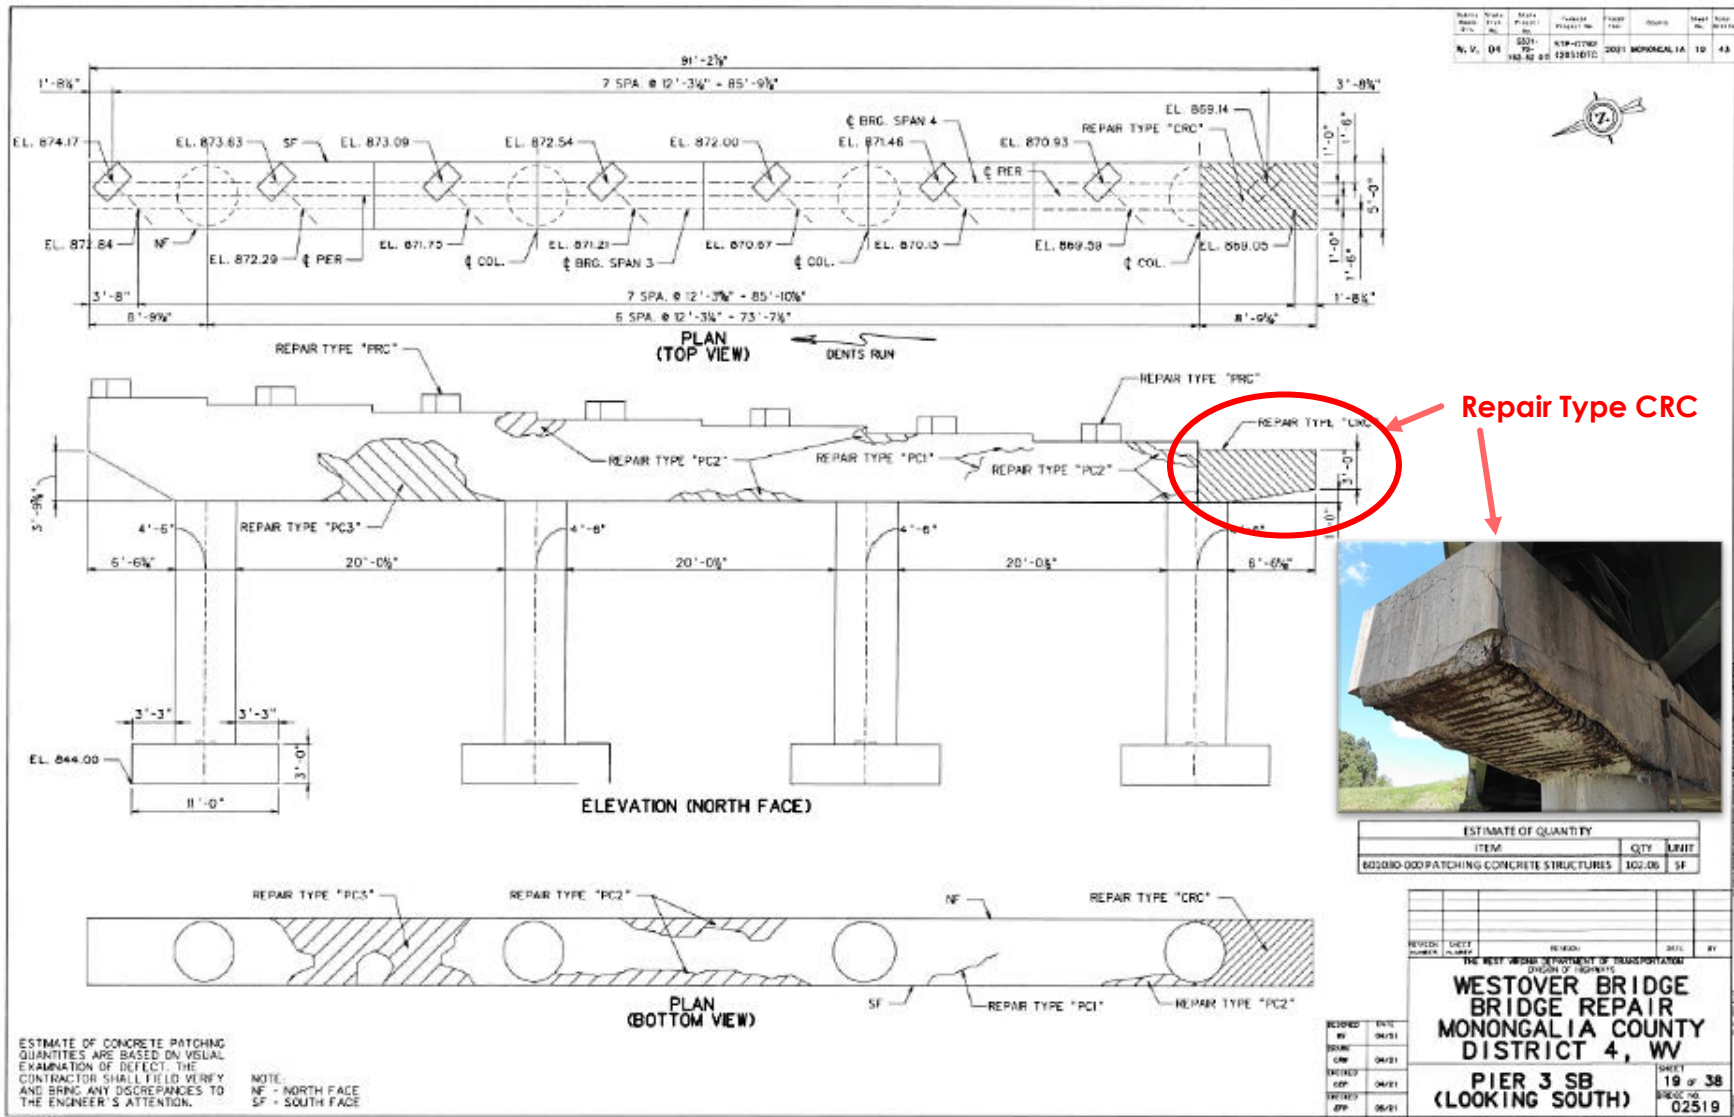
SB Pier 3 West Side Cantilever

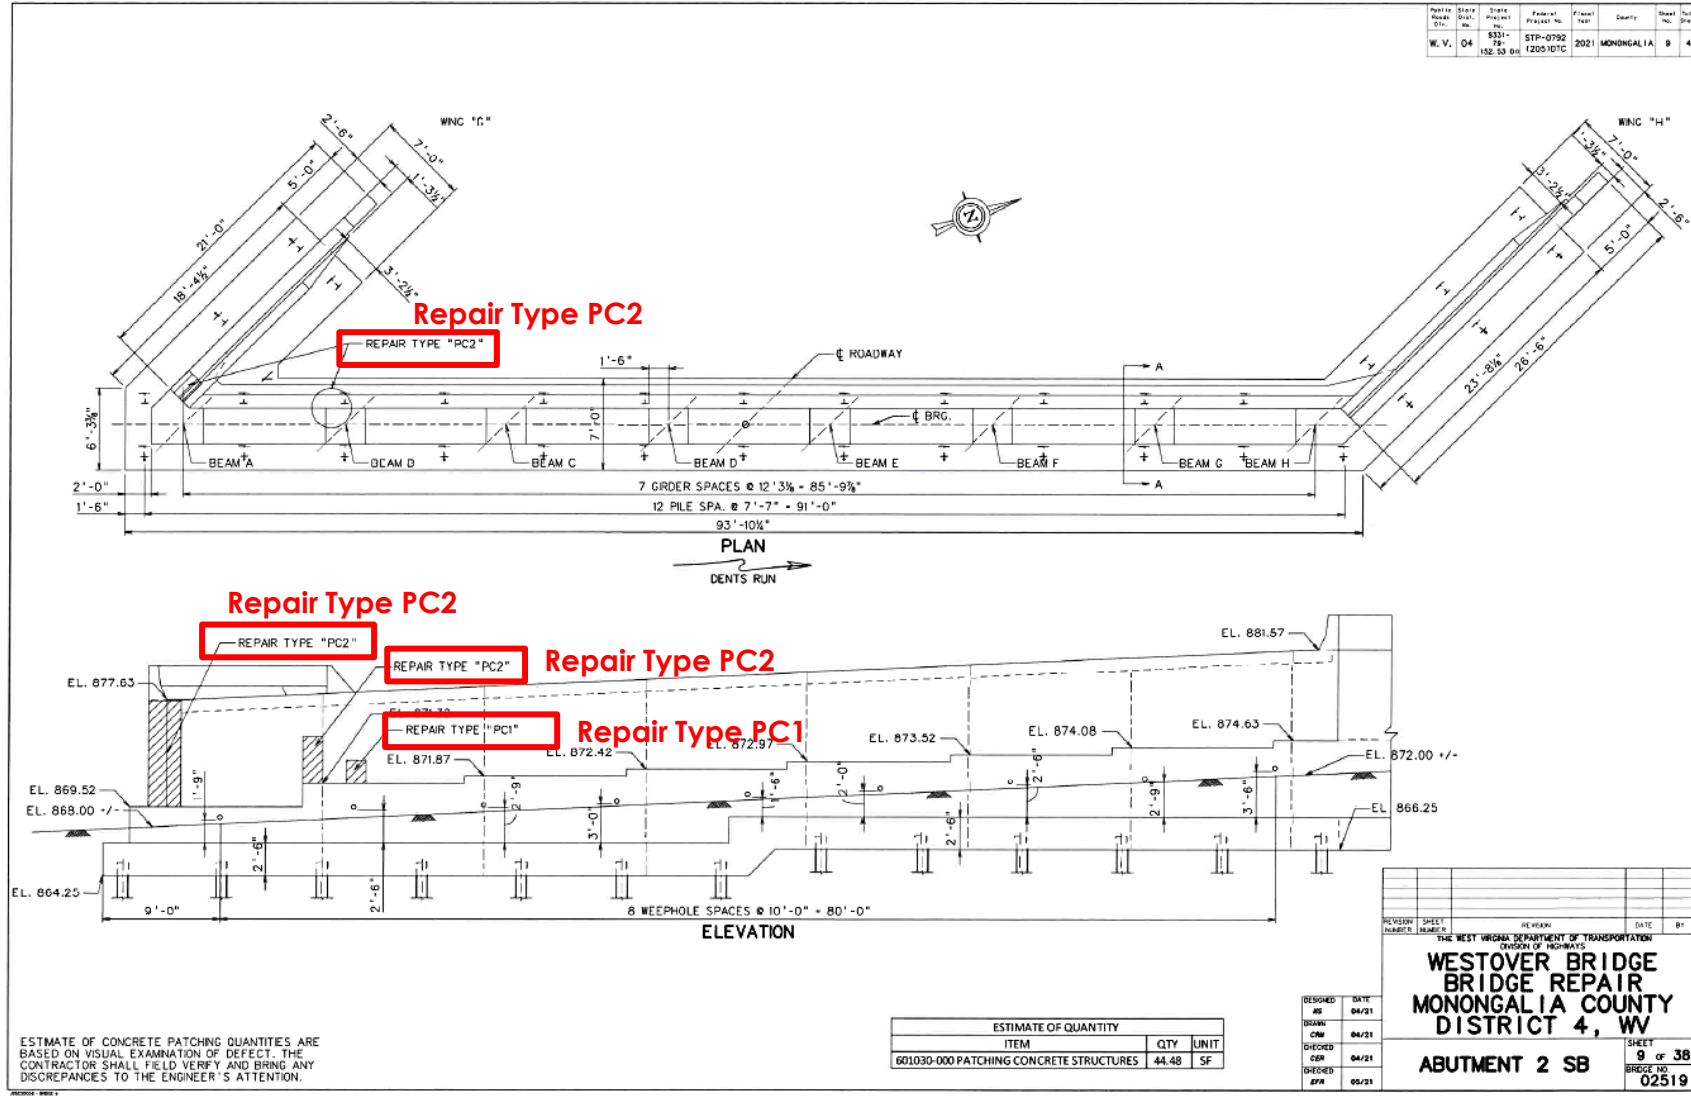
PC3 – Large or full depth spalls with exposed rebars (Severe Defect)

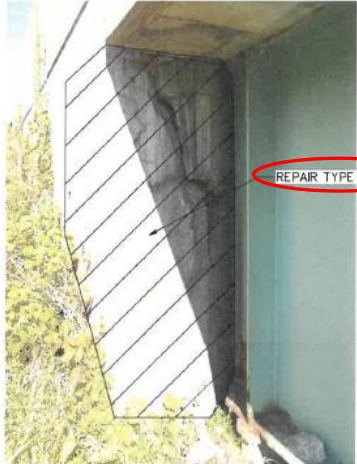
Public Works Div.	State Dist. No.	Date Project No.	Federal Project No.	Fiscal Year	County	Sheet No.	Total Sheets
W. V.	04	5211-79-182.52	STP-0752 (2005)OTC	2021	MONONGALIA	10	43

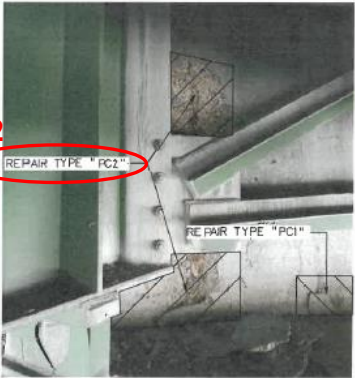
ABUTMENT 2 BACKWALL (at BEAM B) SB STRUCTURE

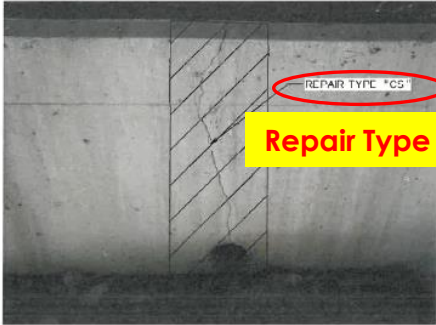
Public Road Dist. No.	State Dist. No.	State Project No.	Federal Project No.	Fiscal Year	County	Sheet No.	Total Sheets
W. V. 04	531-79-152.52 00	STP-0792 (205) DTC		2021	MONONGALIA	11	43

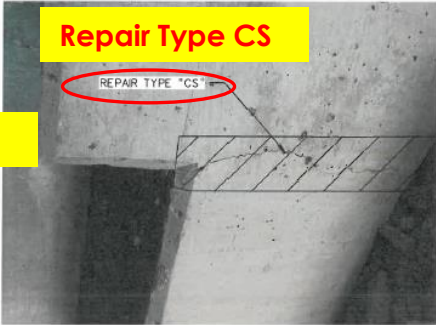
ABUTMENT 2 - NB (TYP.)

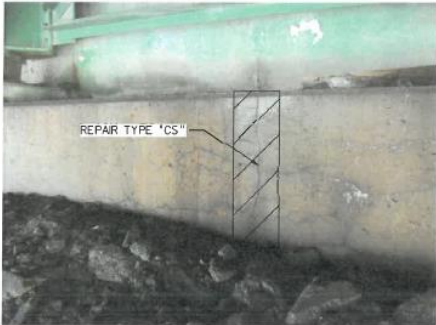
ABUTMENT 2 - NB (TYP.)

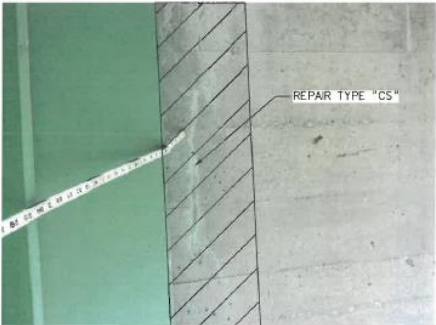
HAIRLINE MAP CRACKING IN ABUT. 1 BREASTWALL (SB STRUCTURE)

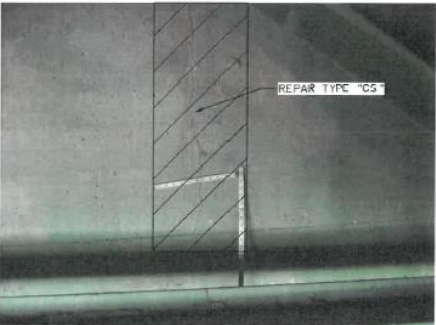
HAIRLINE CRACKING IN ABUT. 1 BACKWALL (SB STRUCTURE)

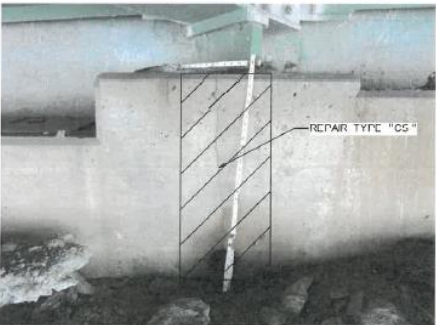
HAIRLINE MAP CRACKING IN ABUT. 1 BREASTWALL (SB STRUCTURE)

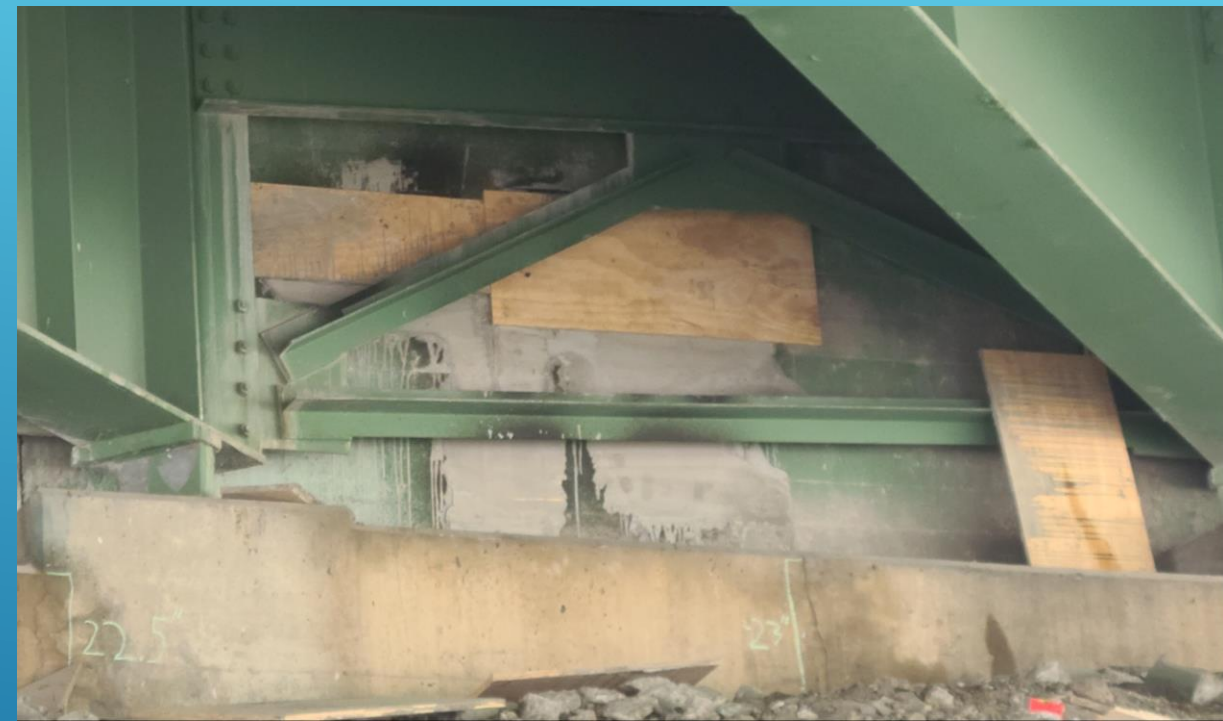
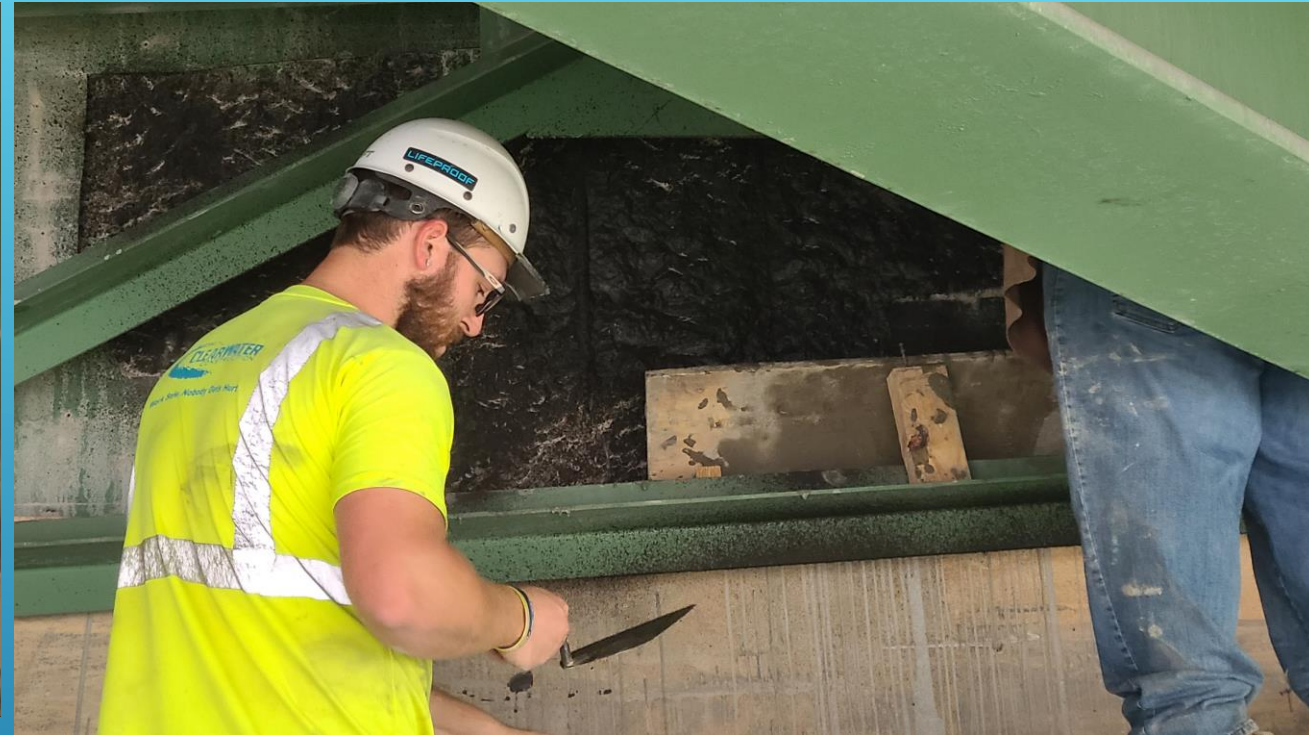
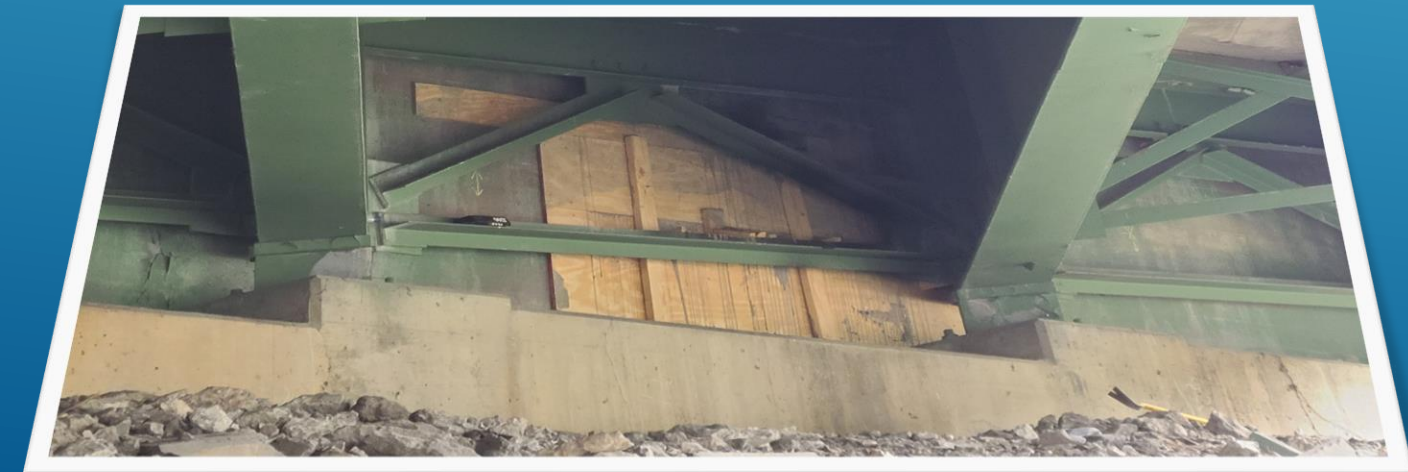
Forming up and applying Rapid Set
Cementitious Patching Mix

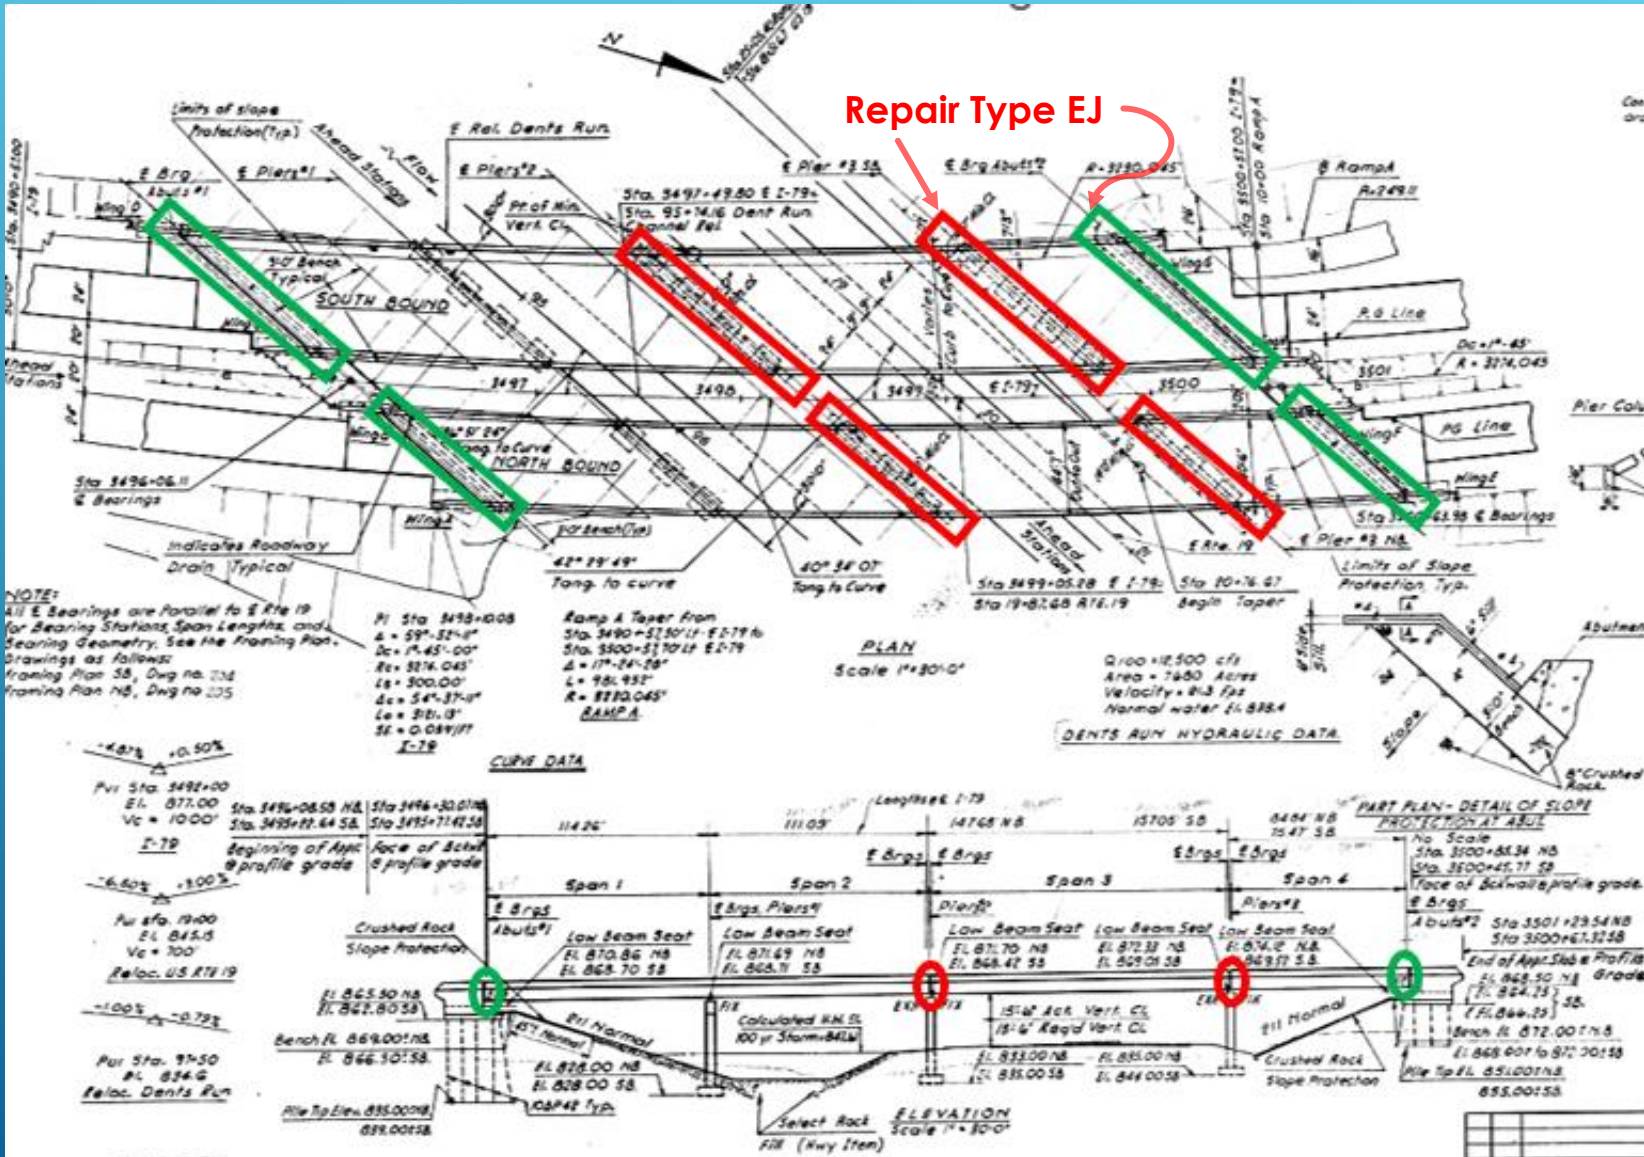
Expansion Joint Replacement

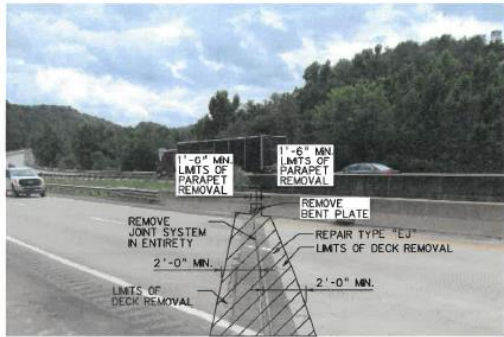
OVERALL VIEW OF EXPANSION JOINT ABUTMENT NO. 1 NORTHBOUND

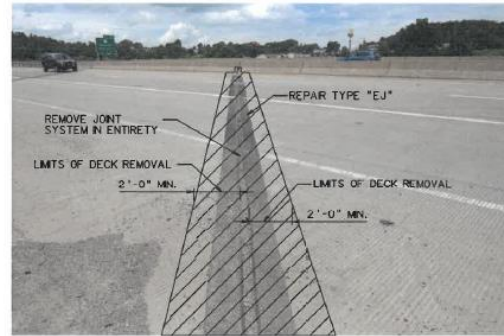
OVERALL VIEW OF EXPANSION JOINT PIER 3 SOUTHBOUND

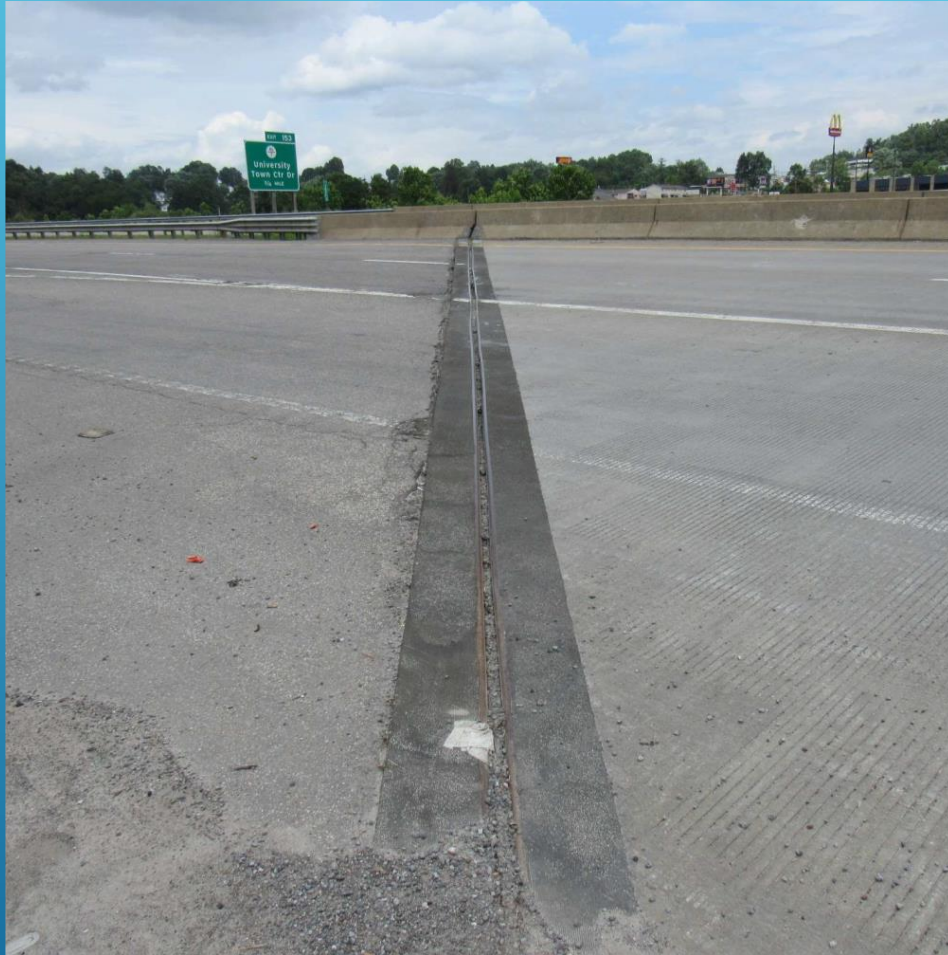
STRIP SEAL EXPANSION JOINT REPLACEMENT

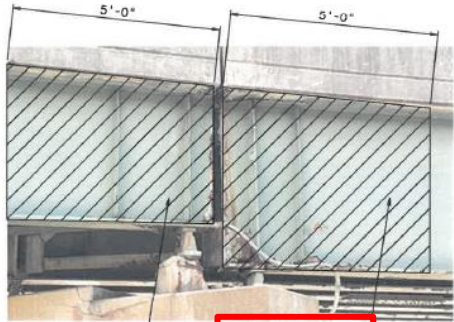
REPAIR TYPE "C&P" — REPAIR TYPE "C&P" — **Repair Type CP**
 LIMITS OF CLEANING AND PAINTING AT PIER LOCATION (TYP. @ PIER 2 & 3)

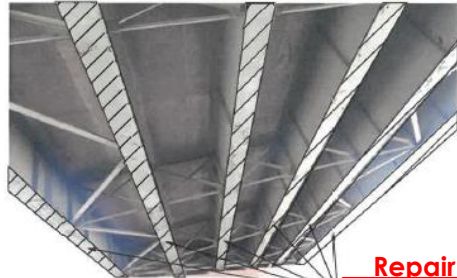
Repair Type CP
 REPAIR TYPE "C&P"
 BOTTOM FLANGE CLEANING AND PAINTING IN SPAN 3 (BETWEEN PIERS 2 & 3 OVER U.S. 19, TYP.)

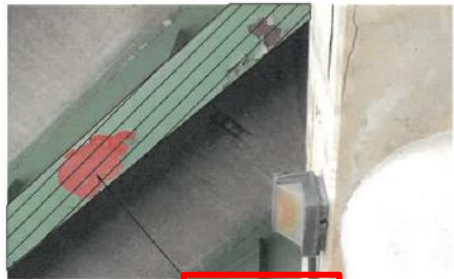
REPAIR TYPE "C&P" — **Repair Type CP**
 CLEANING AND PAINTING LIMITS

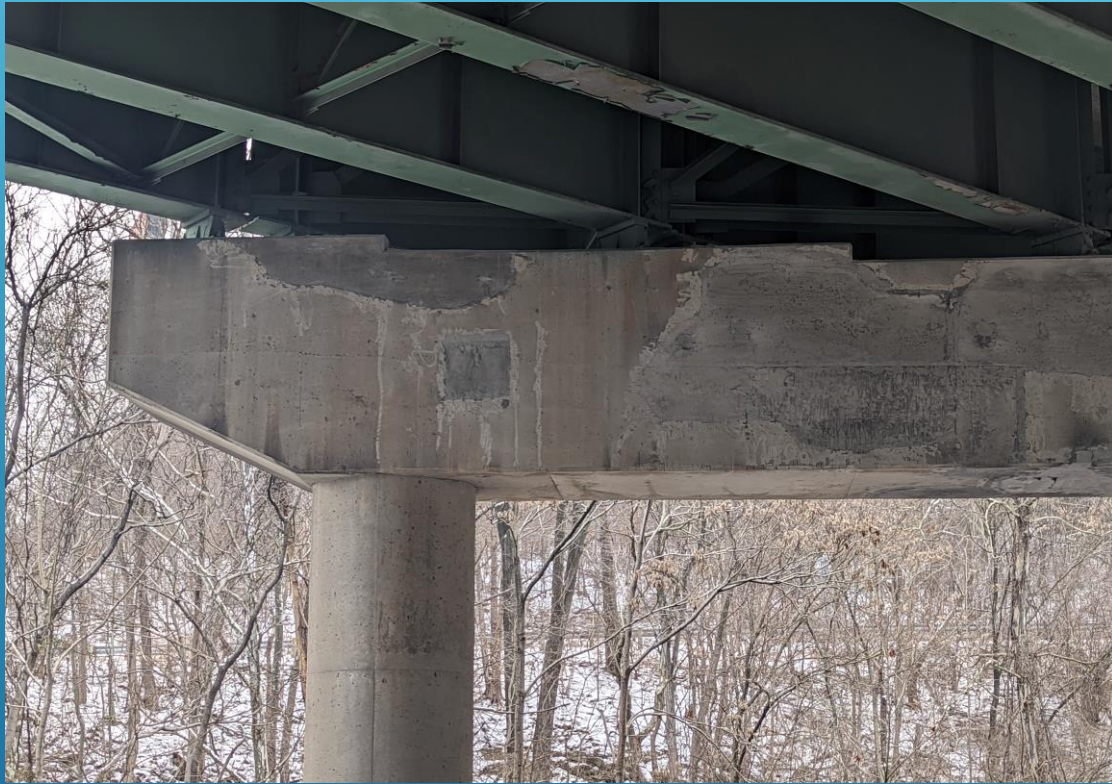
Uncoated Repair Surface

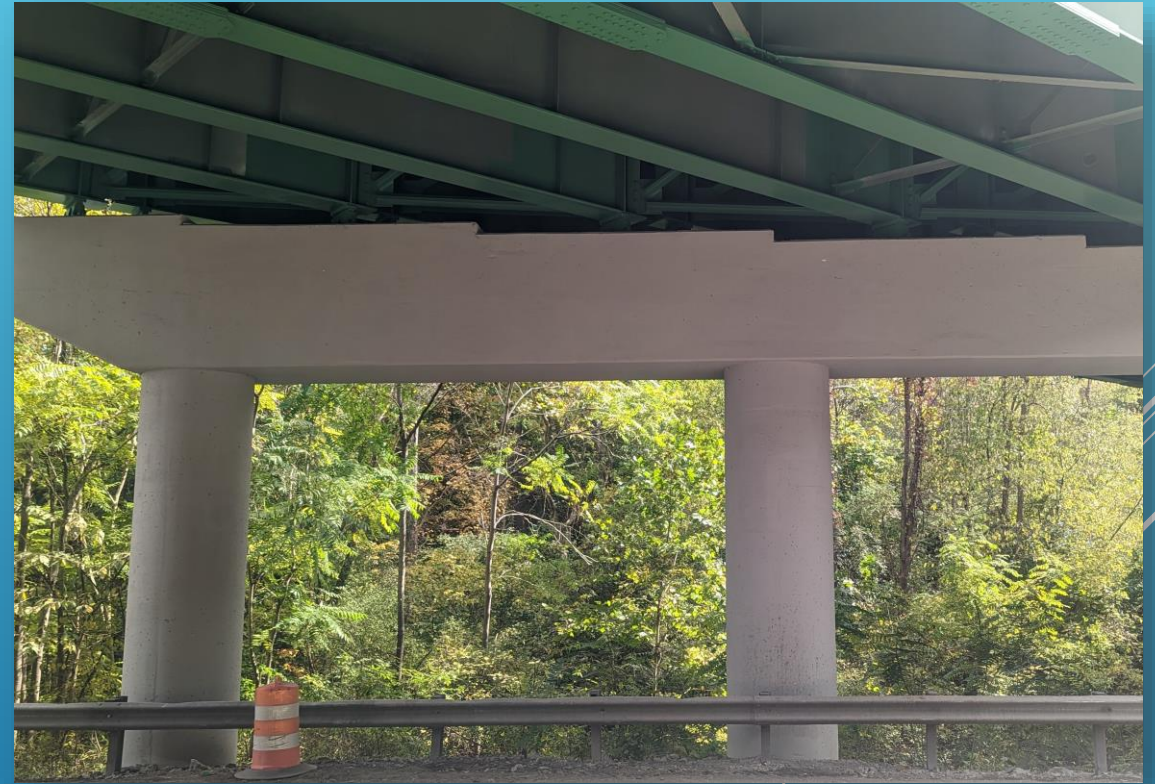
Coated Repair Surface
