Evaluation of the Potential Benefits of Implementing the AASHTO Guide Specifications for the Analysis and Identification of NSTMs, SRMs and IRMs

Robert J. Connor - Purdue University

IRM Evaluation – US 41 – White River Bridge

IRM Evaluations – I74 Wabash River Bridge

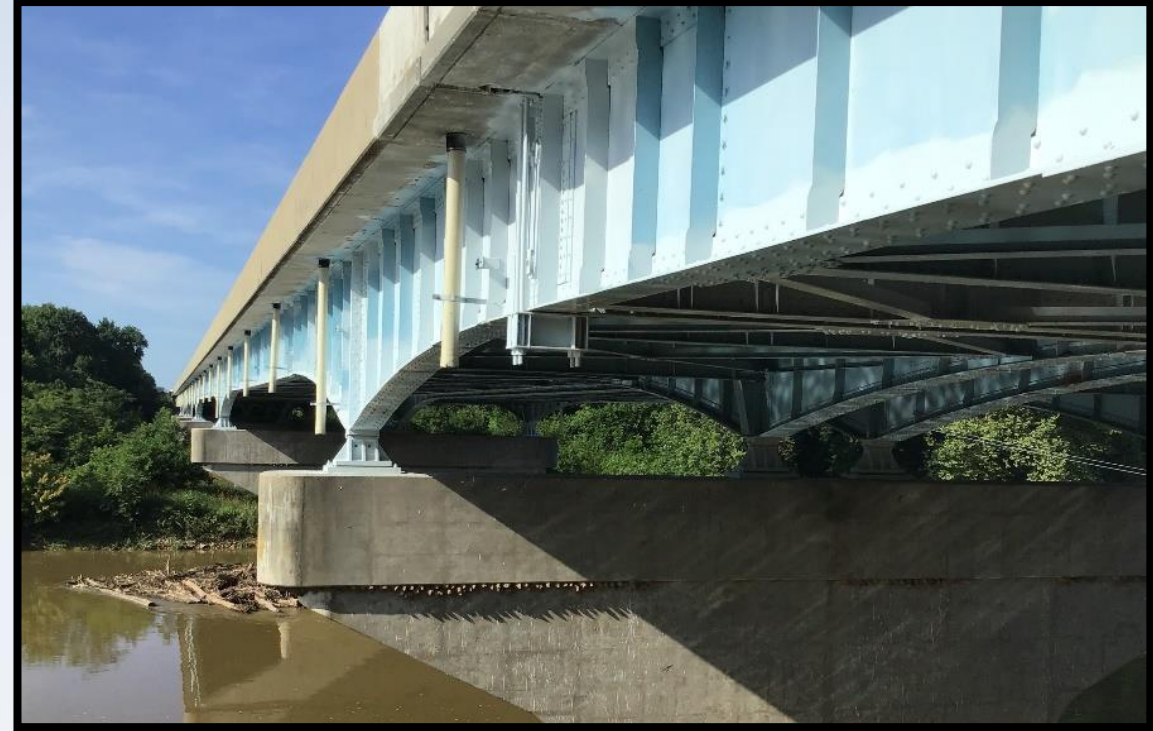
- Gibson County, IN
- 16-span, Steel Two-Girder Twin Bridges
- Built in 1958
- ADT (2021): 11,322, %Trucks = 26%
- Has pin and hanger details
- SPR-3472, Purdue University, July 2011, *Evaluation of the Effects of Super-Heavy Loading on the US-41 Bridge*

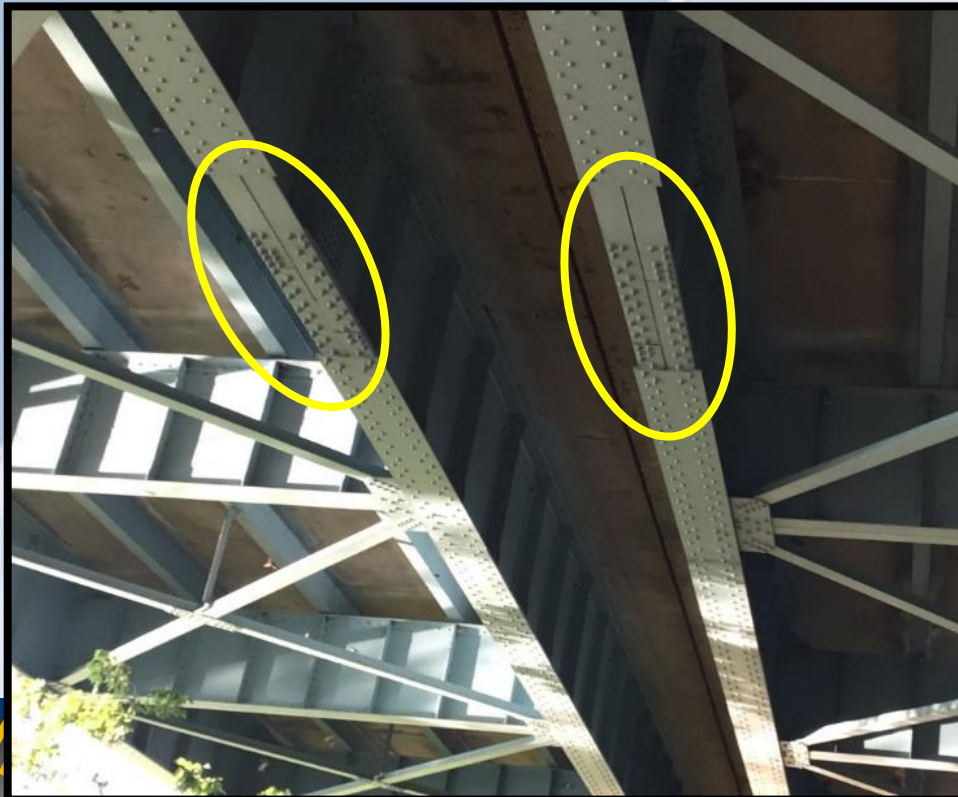
Lack of cover plates
20 locations per girder
(~3% of girder length)

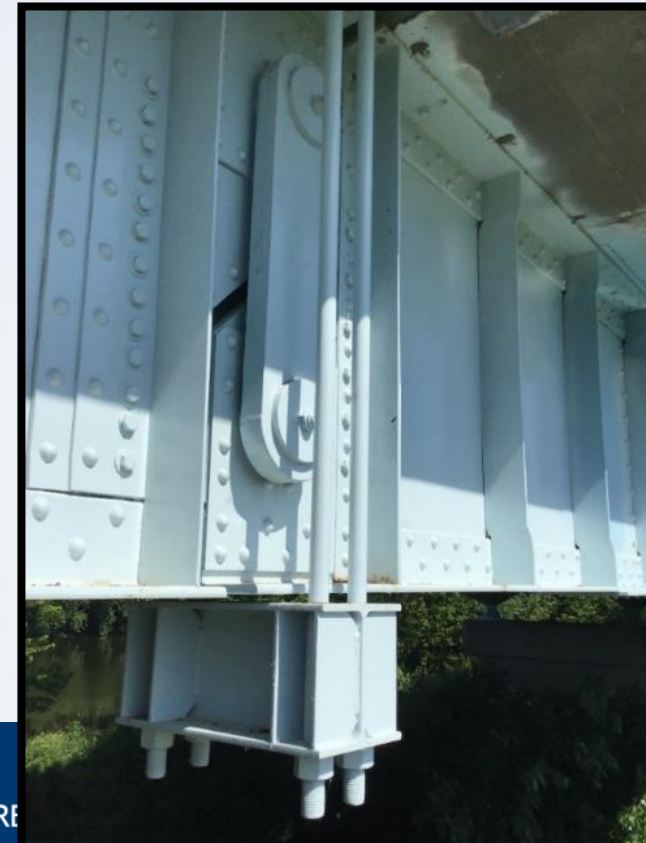
Pin and hanger - 4
locations per girder
(~0.5% of girder length)

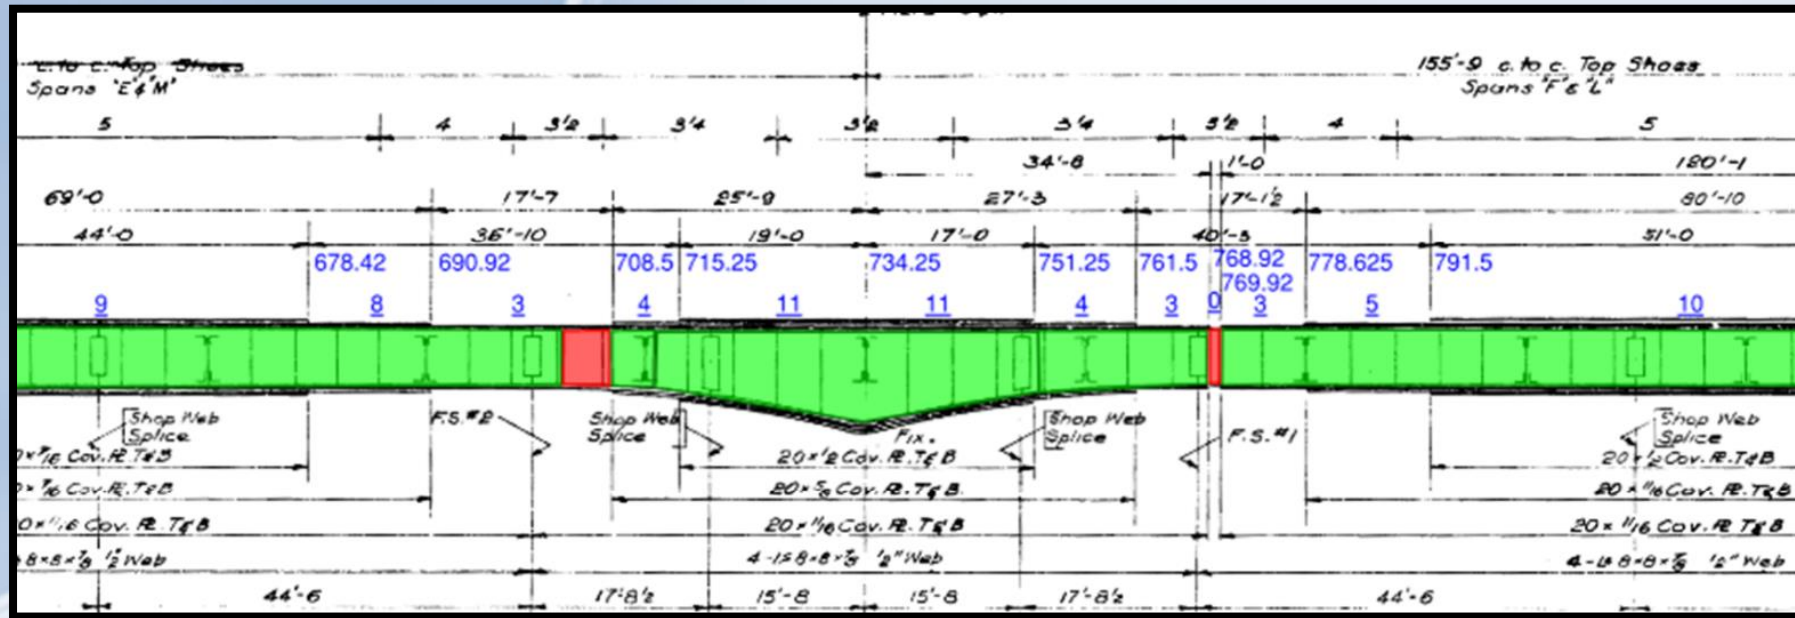
- Using in-situ effective stress ranges and cycles...

- Nearly 94% of the main girders of the bridge are eligible to be reclassified as IRMs
- Resulted in a *Special Inspection* frequency of 10 years

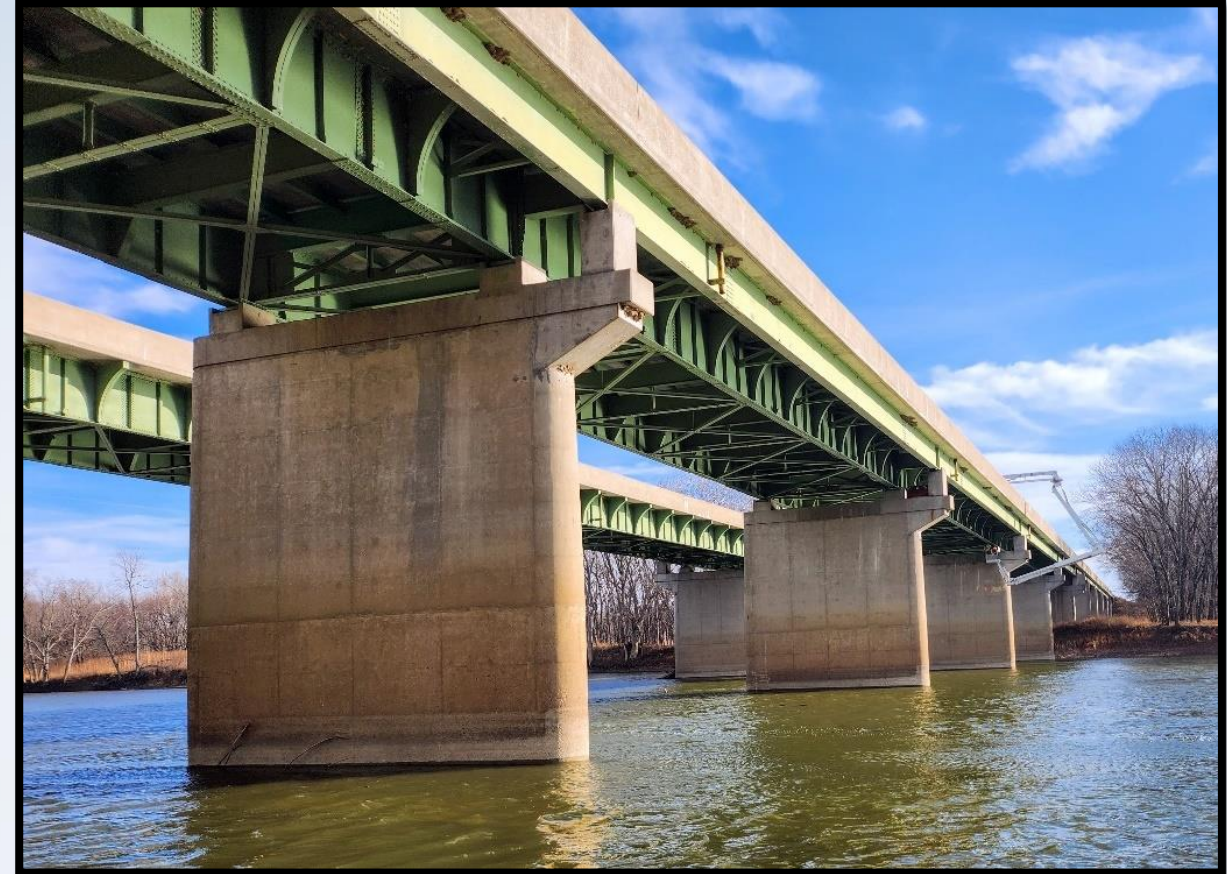
- Vermillion County, IN
- Twin, 5 main spans with 12 approach spans
- Steel two built-up girders with added girder
- Built in 1958
- ADT: 17,156, % Trucks = 59%

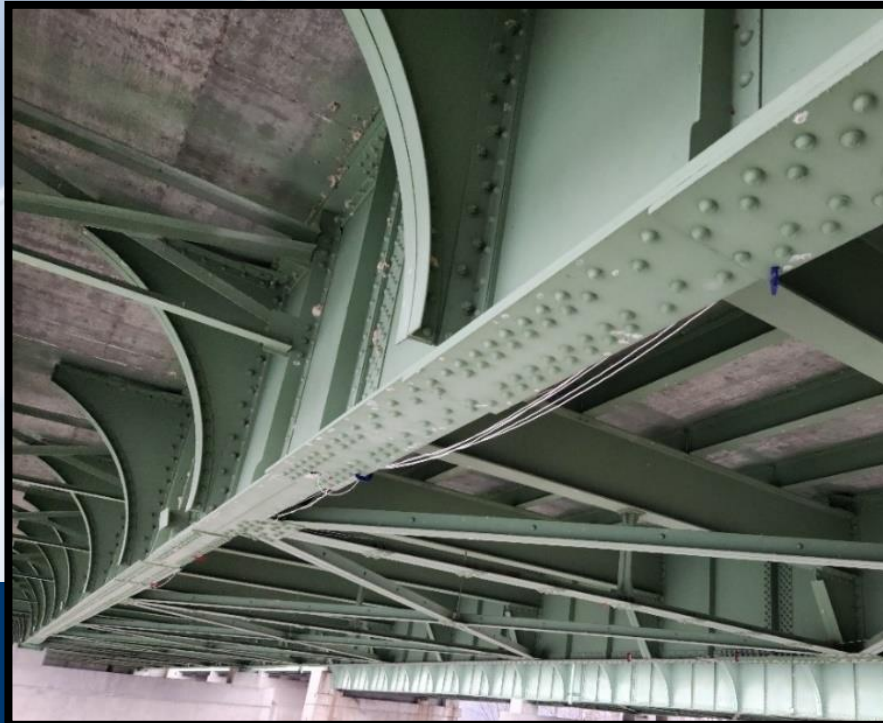
- Using AASHTO fatigue truck design loads, a high percentage of the structure did not qualify as IRMs due to insufficient remaining fatigue life
- Based on experiences with US 41 Bridge, it was decided to install limited instrumentation and collect data

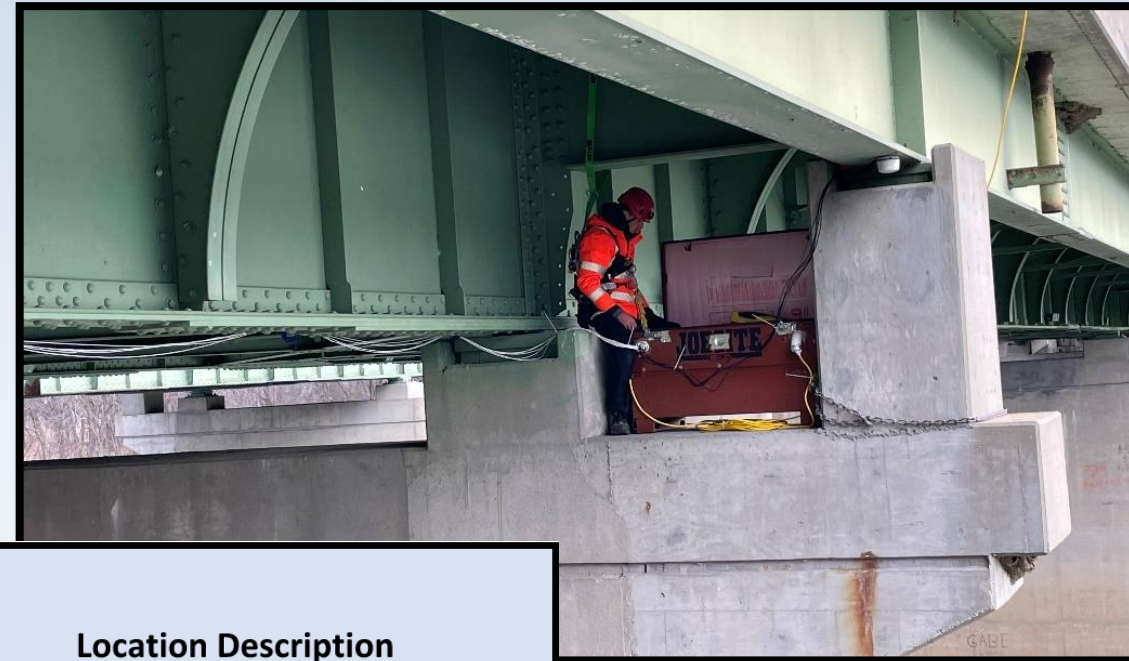
- Lower effective stresses (~60% of Stress due to AASHTO Fatigue Truck)
- Lower total cycles per day (~25% of ADTT values)

XSec	Strain Gauge	Distance from Pier 7 (ft)	Eff Stress Fatigue Truck (ksi)	Eff Stress Field Test (ksi)	Eff Stress Ratio	Cycles/day	Location Description
XSec-1	SG1	56.95	4.92	2.75	0.559	182.8	Specific Cross Section Check
XSec-1	SG2	56.95	4.92	2.33	0.474	1128.9	Specific Cross Section Check
Xsec-2	SG6	163.67	4.23	2.56	0.604	161.6	Near Max Positive Moment Region
Xsec-2	SG7	163.67	4.23	2.34	0.553	58.7	Near Max Positive Moment Region
XSec-00	SG8	194.92	5.43	2.63	0.484	162.8	Near Inflection Area
XSec-00	SG10	194.92	5.43	2.30	0.424	940.0	Near Inflection Area

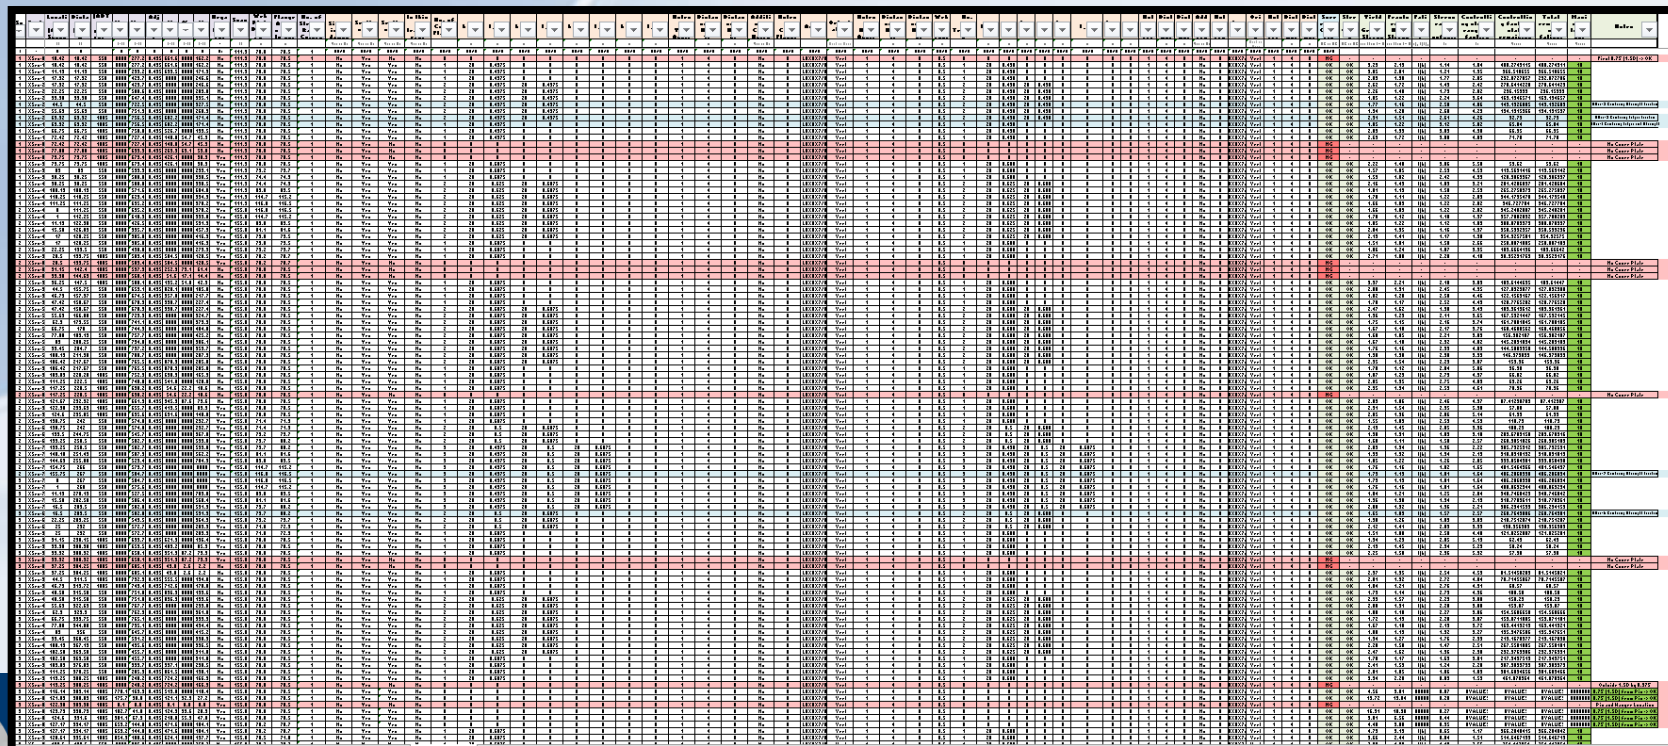
- Data and organizational overload
 - Macros developed to evaluate every point along
- Long term bridge monitoring adds valuable data for to evaluations
