CAIS: Culvert Autonomous Inspection Robotic System

Dr. Hung (Jim) La

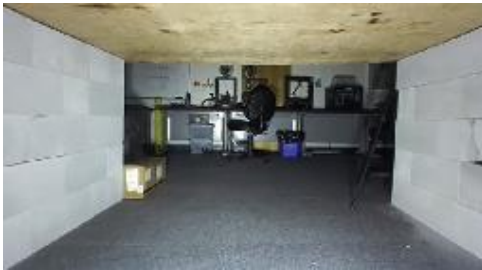
CAIS v1: Defect Detection

Image

Detection Output

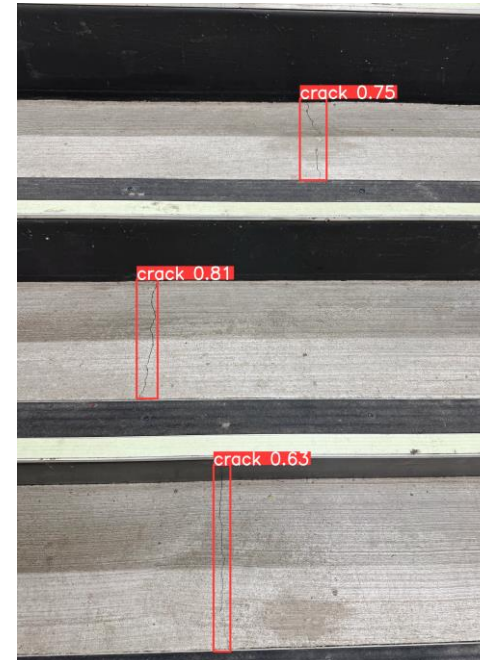
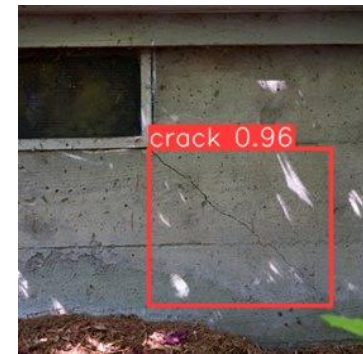
Training and Validation:

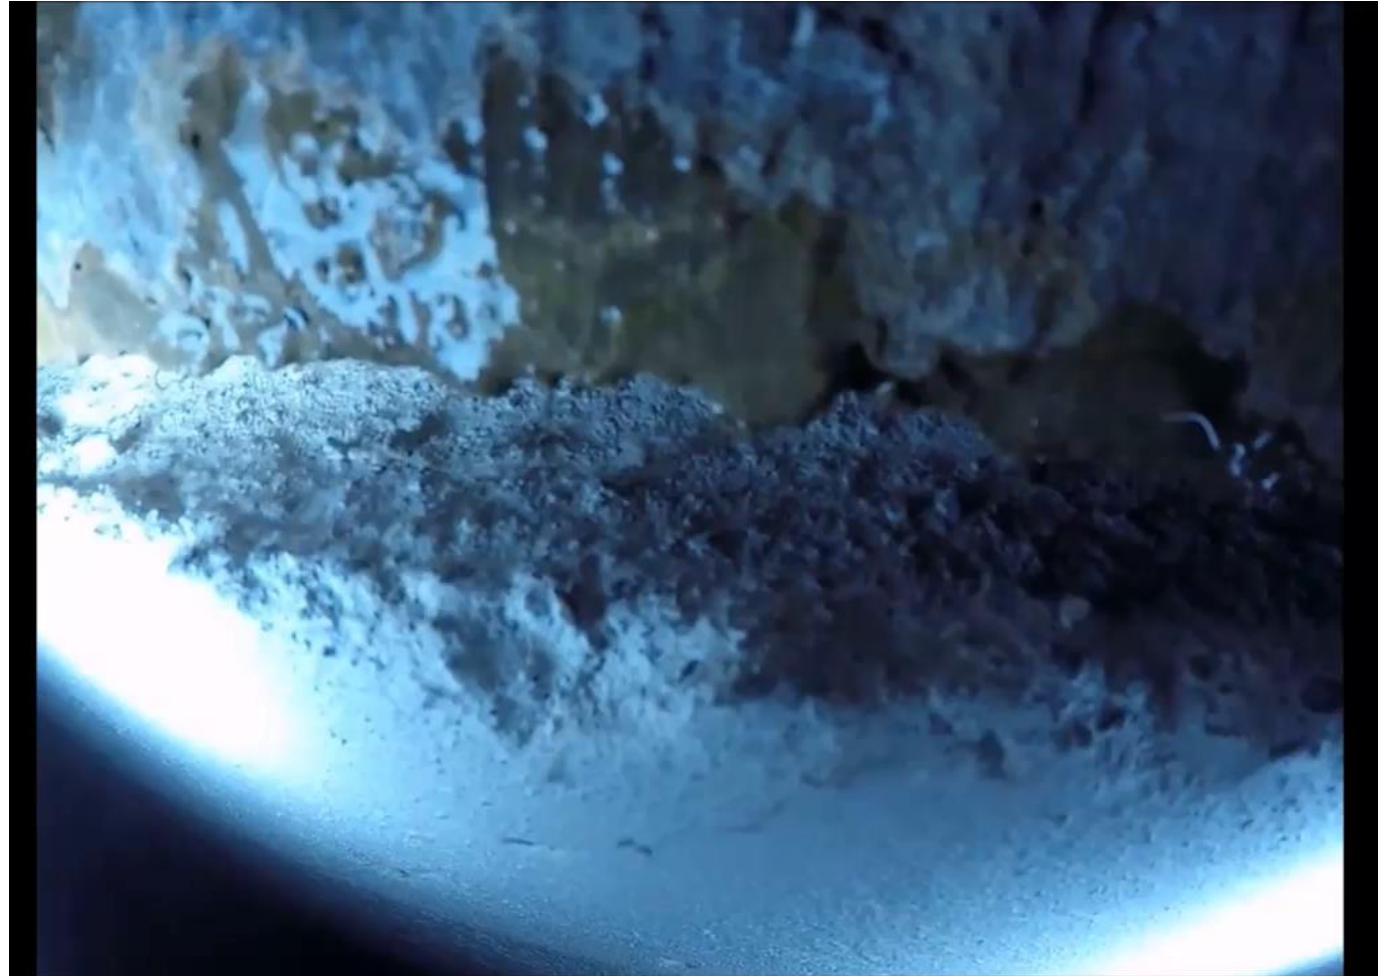
CAIS v1: Outdoor Location: College Pkwy, Carson

Crack and Spalling Detection

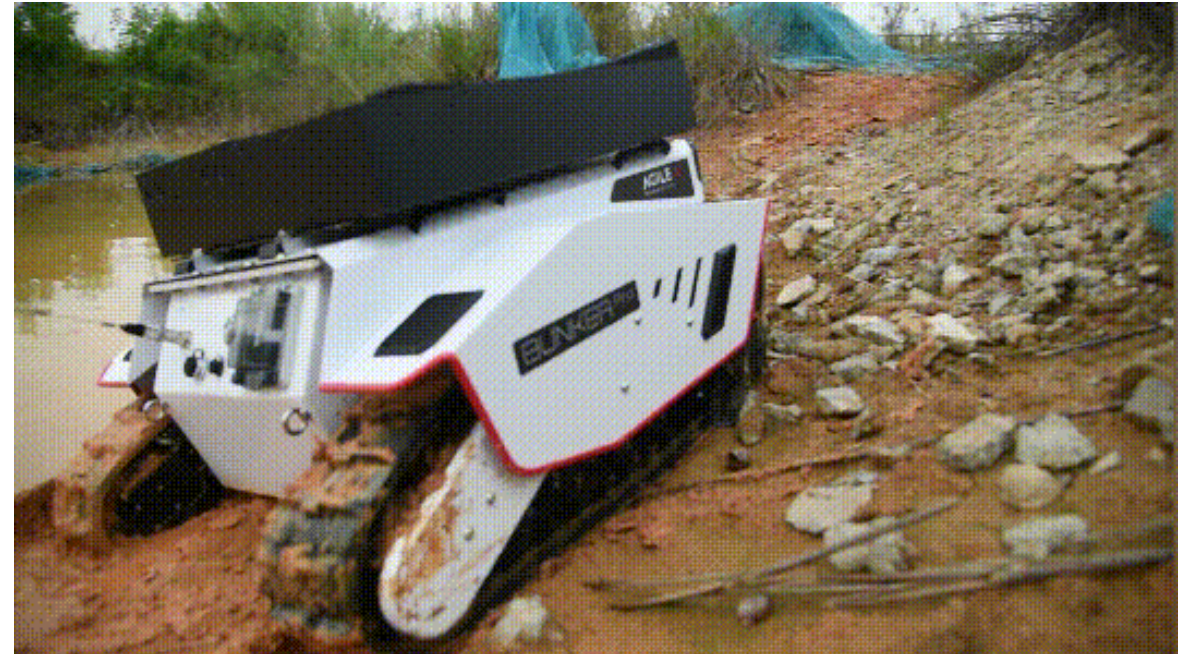
CAIS v2: Maneuverability

Bunker Pro:

- Precise maneuvers
- Obstacle crossing and climbing
- High payload of 120kg
- Accurate Positioning

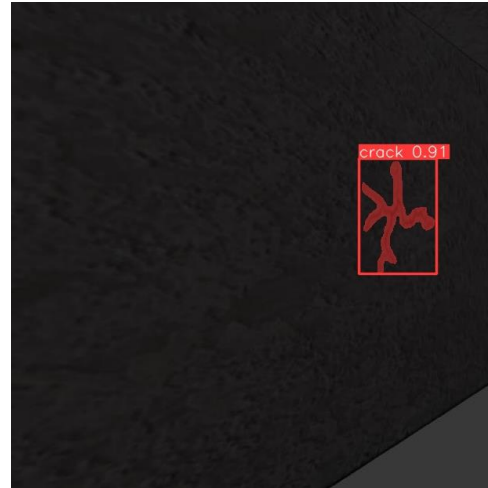
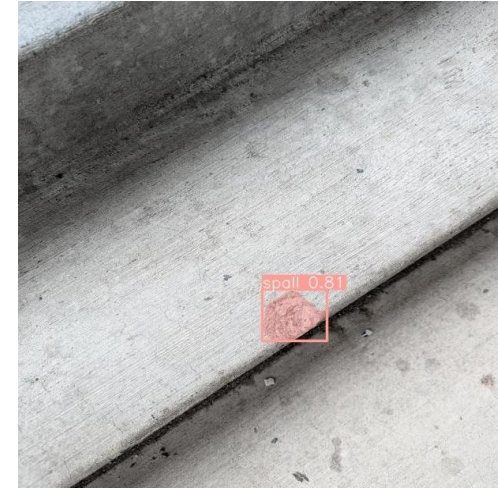
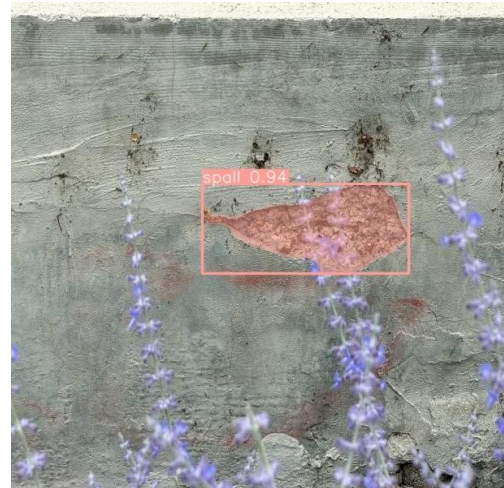
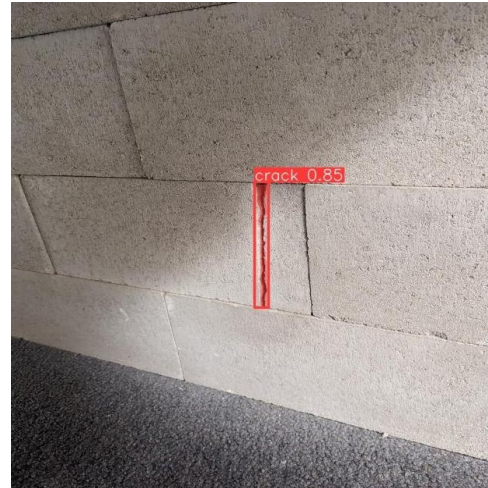
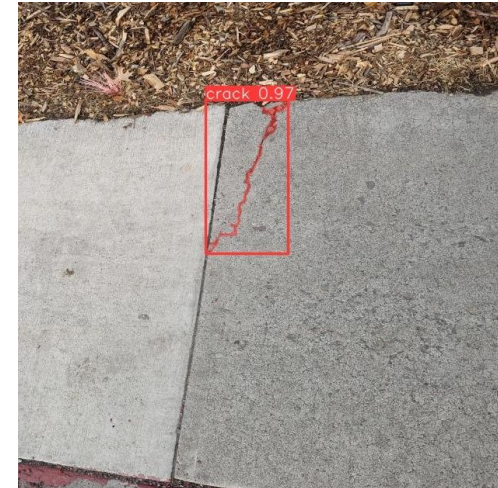
CAIS v2: Instance Segmentation

Advantages

- Provides a pixel-wise mask
- Precise object boundaries
