Steel Exploration at Blue Mesa

Nondestructive Testing and Repair
of T-1 in Colorado

Blue Mesa Bridges - General Information

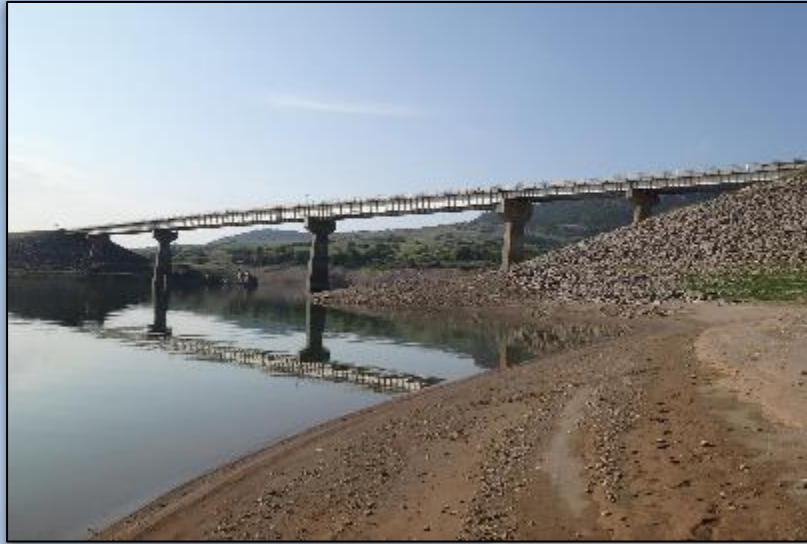
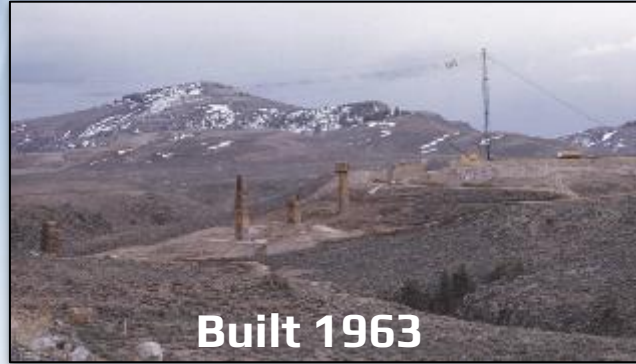
K-07-A

- US 50 over the Lake Fork at mile marker 132.69
- 6 Span, Continuous Composite Welded Girder bridge. 993ft, 300ft max span
- Spans 3, 4, and 5 are Non-redundant Steel Tension Members (NSTM).
- 2 total lanes, 1 lane each direction
- Built 1963, FAIR Condition

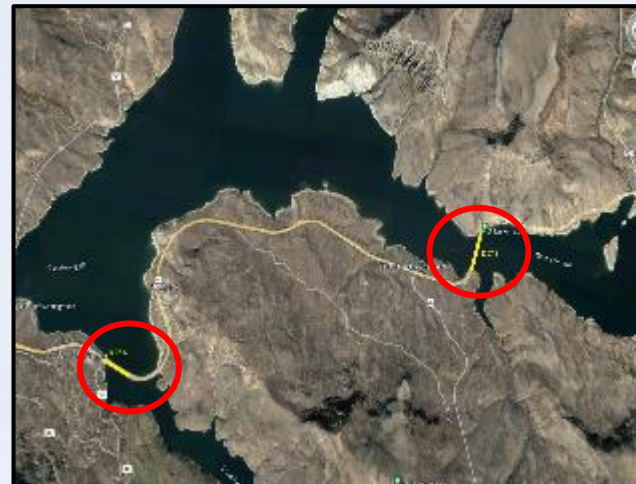
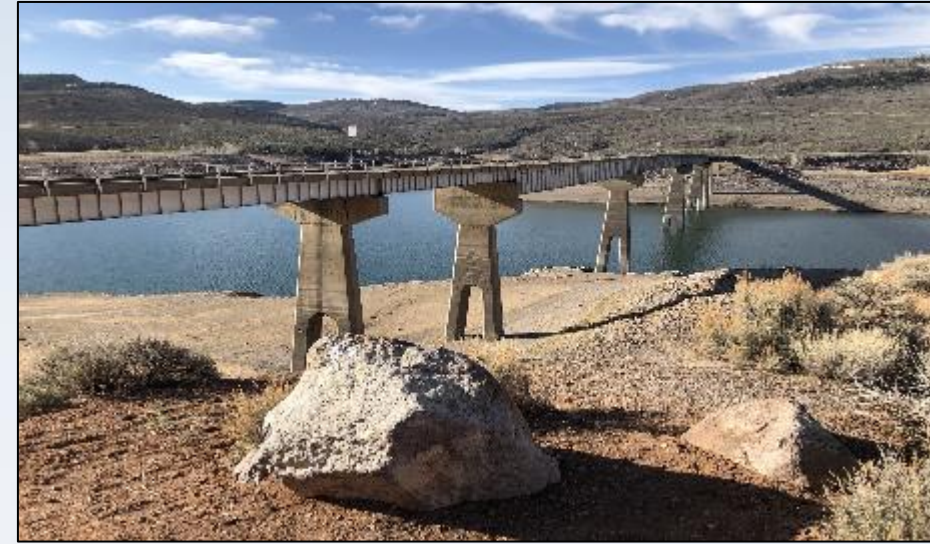
K-07-B

- US 50 over the Blue Mesa Reservoir at mile marker 136.16
- 10 Span, Continuous Composite Welded Girder bridge. 1,532ft, max span 360ft
- Spans 5, 6, and 7 are Non-redundant Steel Tension Members (NSTM).
- 2 total lanes, 1 lane each direction
- Built 1963, FAIR Condition

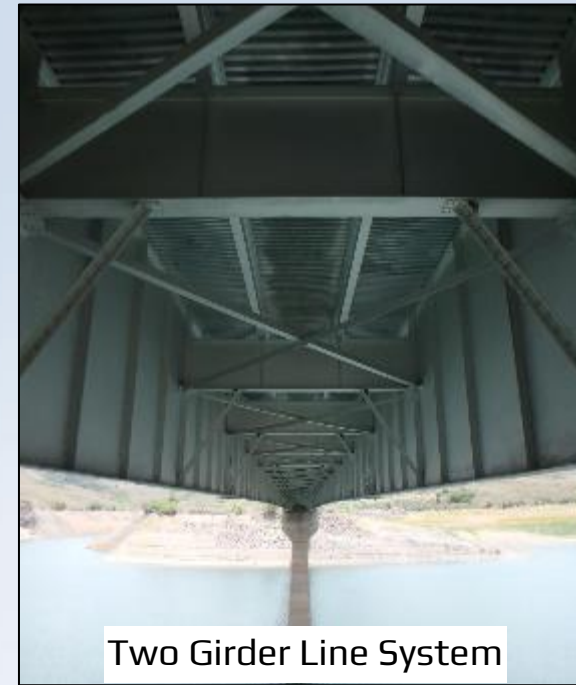
The bridges main spans are composed of 100 ksi T1 Steel built-Up (welded) members and are NSTM (Non-Redundant Steel Tension Member) bridges

Two Girder Line System

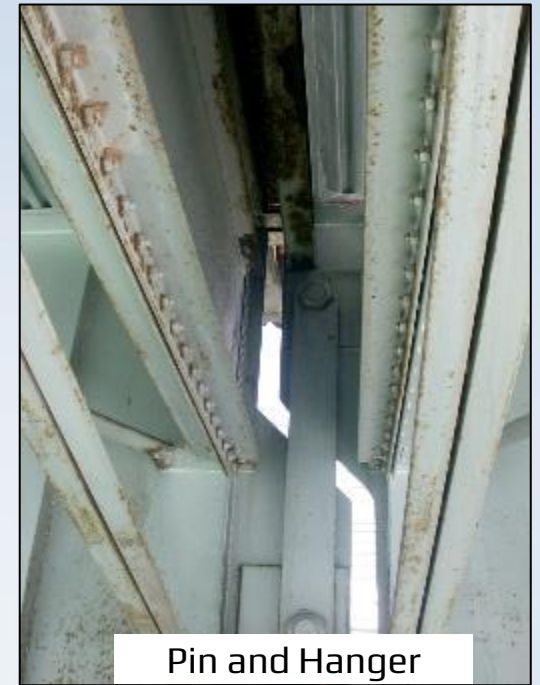
Pin and Hanger

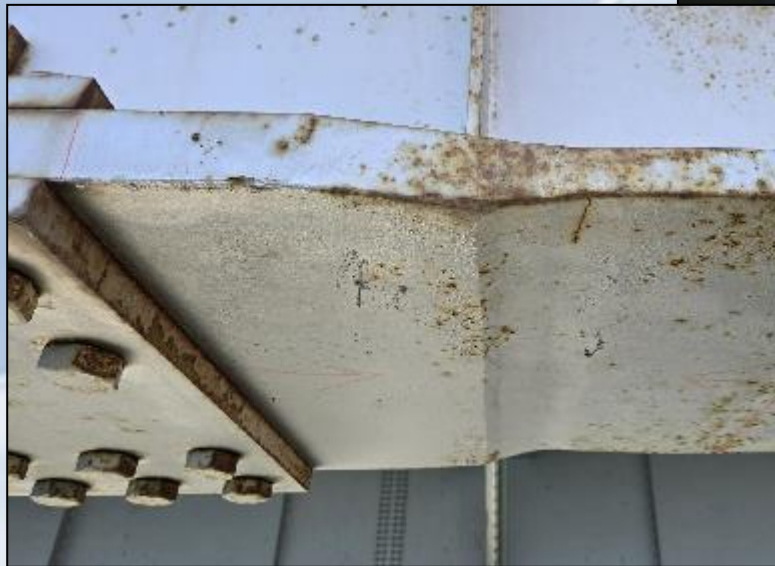
1st Determined Crack Span 6, GB, BF 11

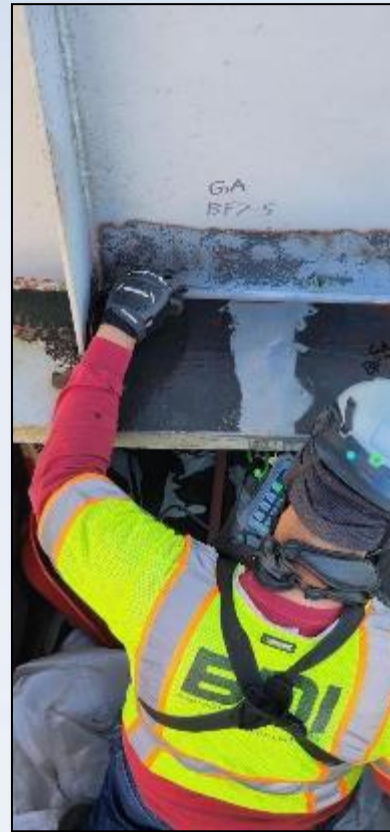
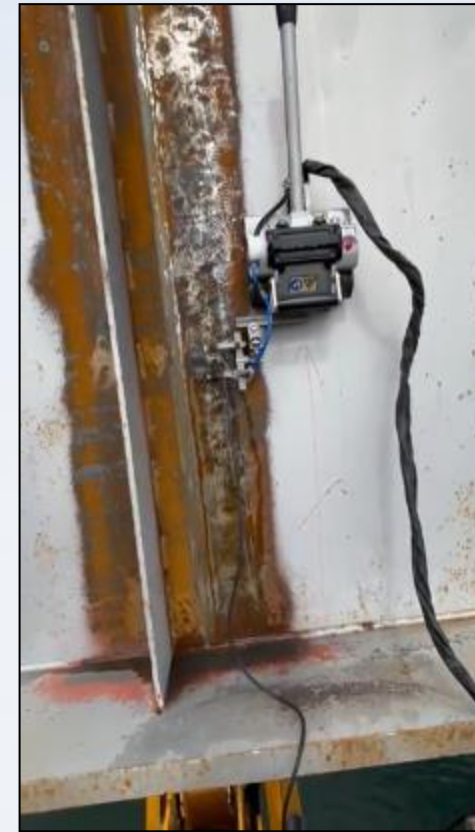
Paint Removal and UT of Butt Welds

Ultrasonic Testing (UT)

- AASHTO D1.5 Indication Classification
- UT and Phased Array UT (PAUT)
- Robotic PAUT scanning for efficiency of web scanning
- QA/QC of 10% locations (min.)

AWS Classification	Number
A	192
B Reject	17
B	11
C Reject	8
C	11
D	50
None	21

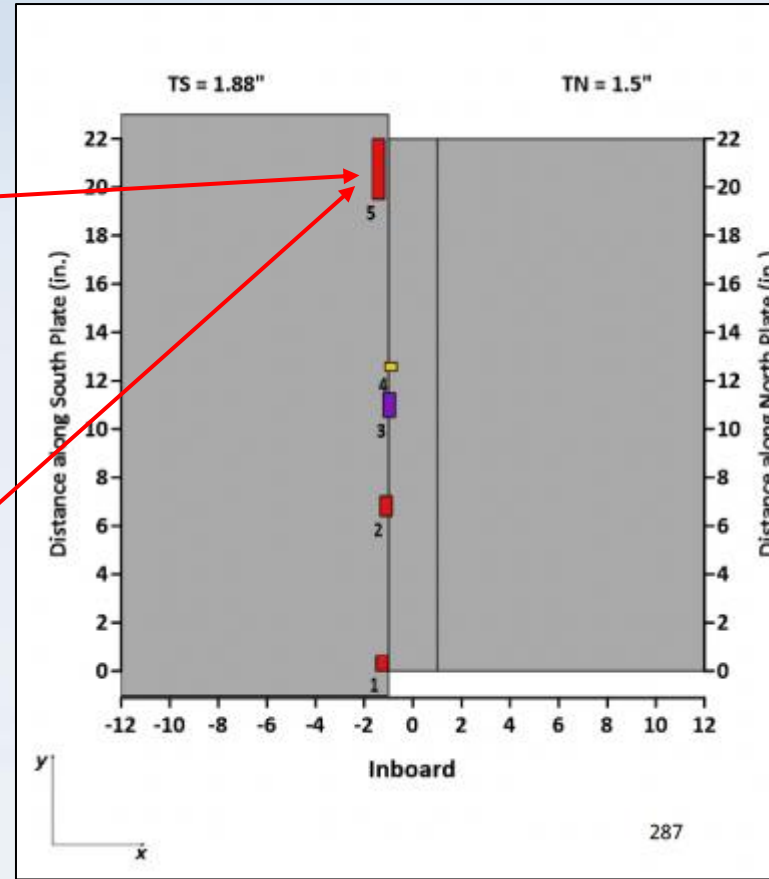
UT/PAUT Analysis and Reporting

Condition Summary					
Indication	Indication Rating	Length (in.)	Depth (in.)	X (in.)	Y (in.)
1	Annex J	0.63	0.83	-1.26	0
2	Annex J	0.83	1.35	-1.1	6.4
3	Annex J	1	1.3	-0.97	10.5
4	Annex J	0.36	0.7	-0.9	12.4
5	Annex J	2.5	0.81	-1.41	19.5

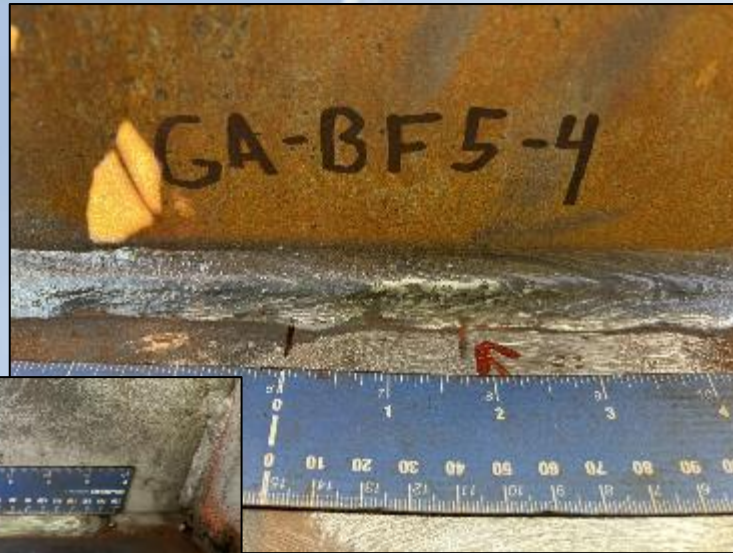
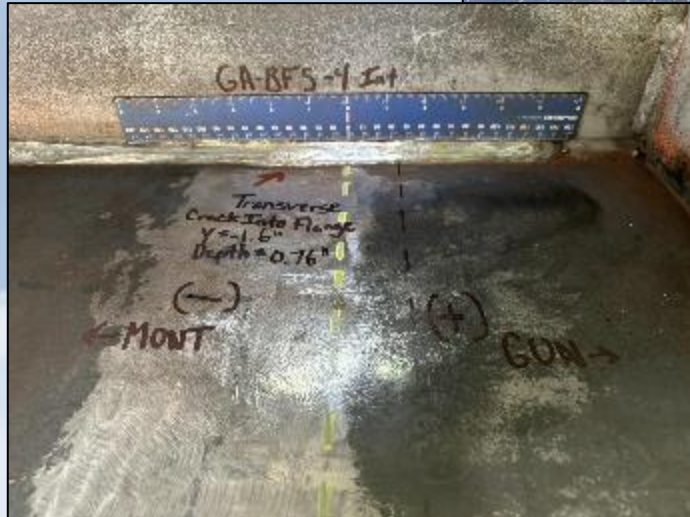
Secondary Web-Flange Fillet weld testing

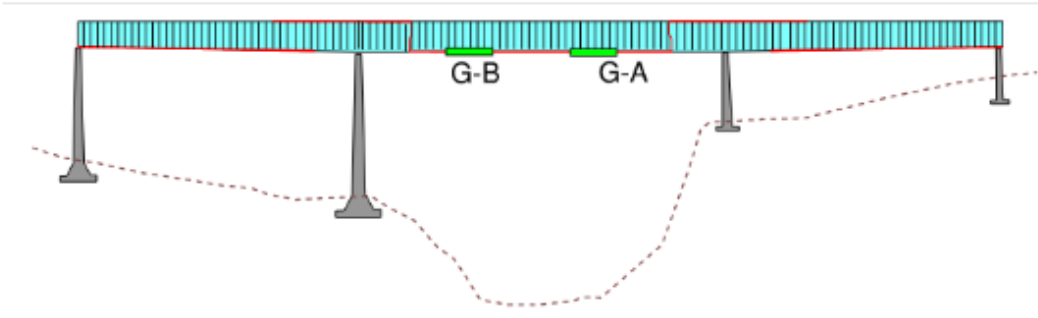
Options	Sketches	Risks or unknowns	Schedule ^{1,2}	Relative cost ¹
Local Plating

<ul style="list-style-type: none"> Increases complexity if additional defects are later found. Relative costs increase with the number of defects found. 	1 – 3 Months	\$
Suspended Span Bottom Flange Only

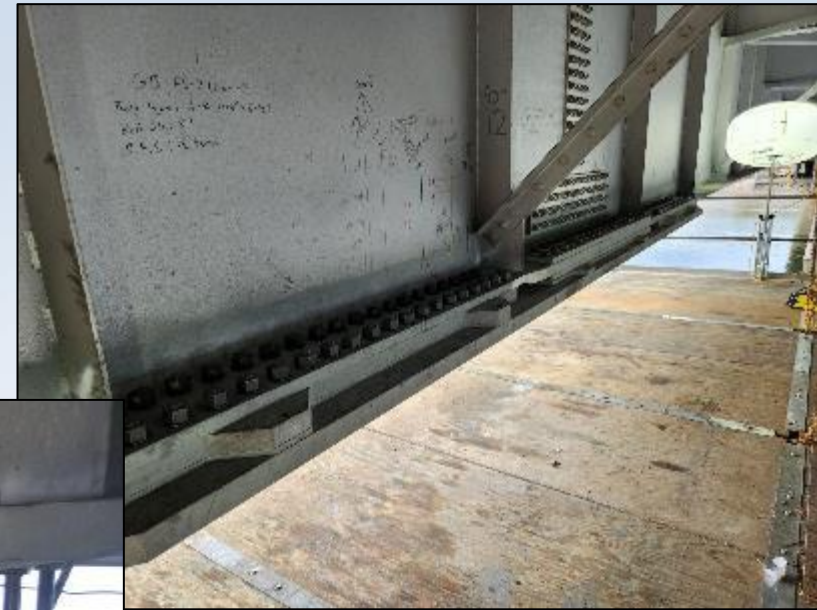
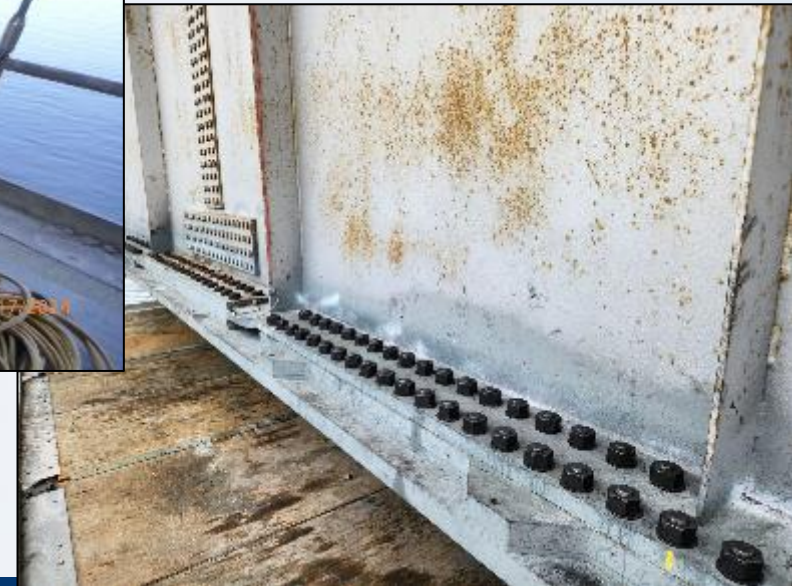
Bridge B Critical Repairs

- Open for July 4th
- Address flange to flange surface indications
- Use material that is immediately available
- Detail considering the loading limitations

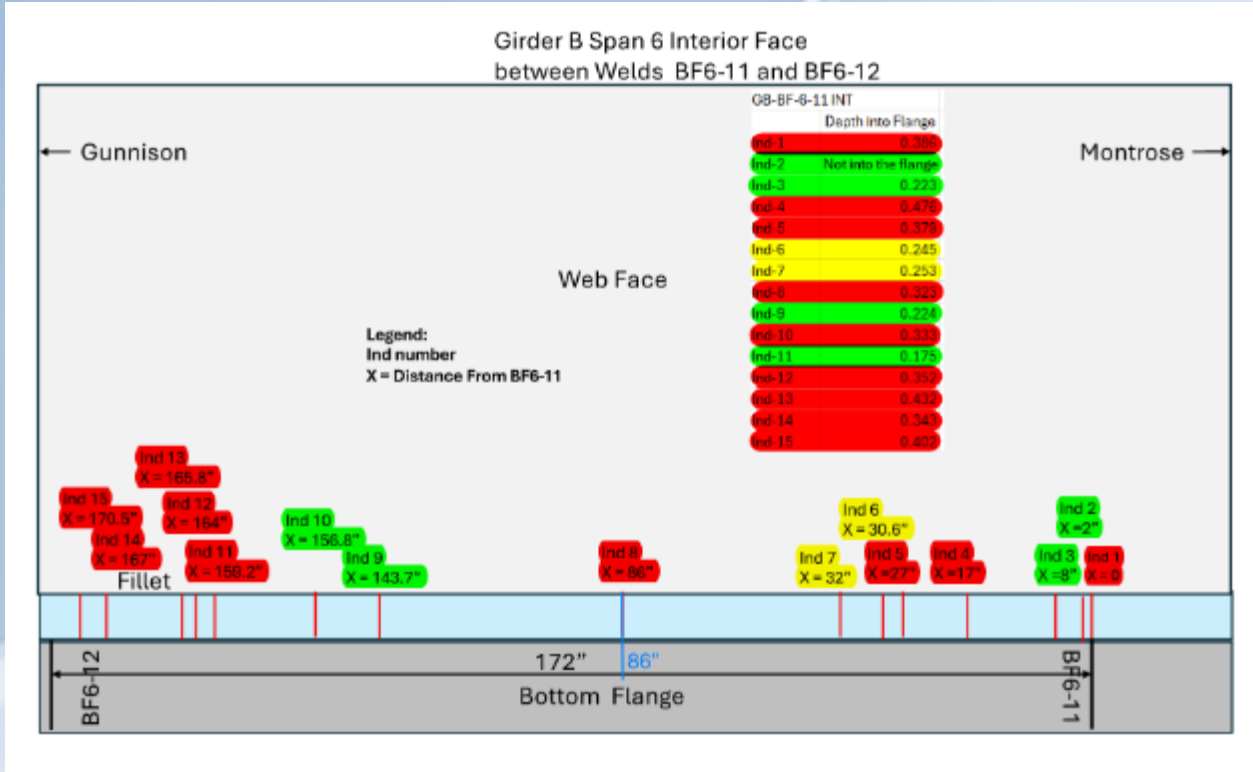
Fillet Weld Cracking

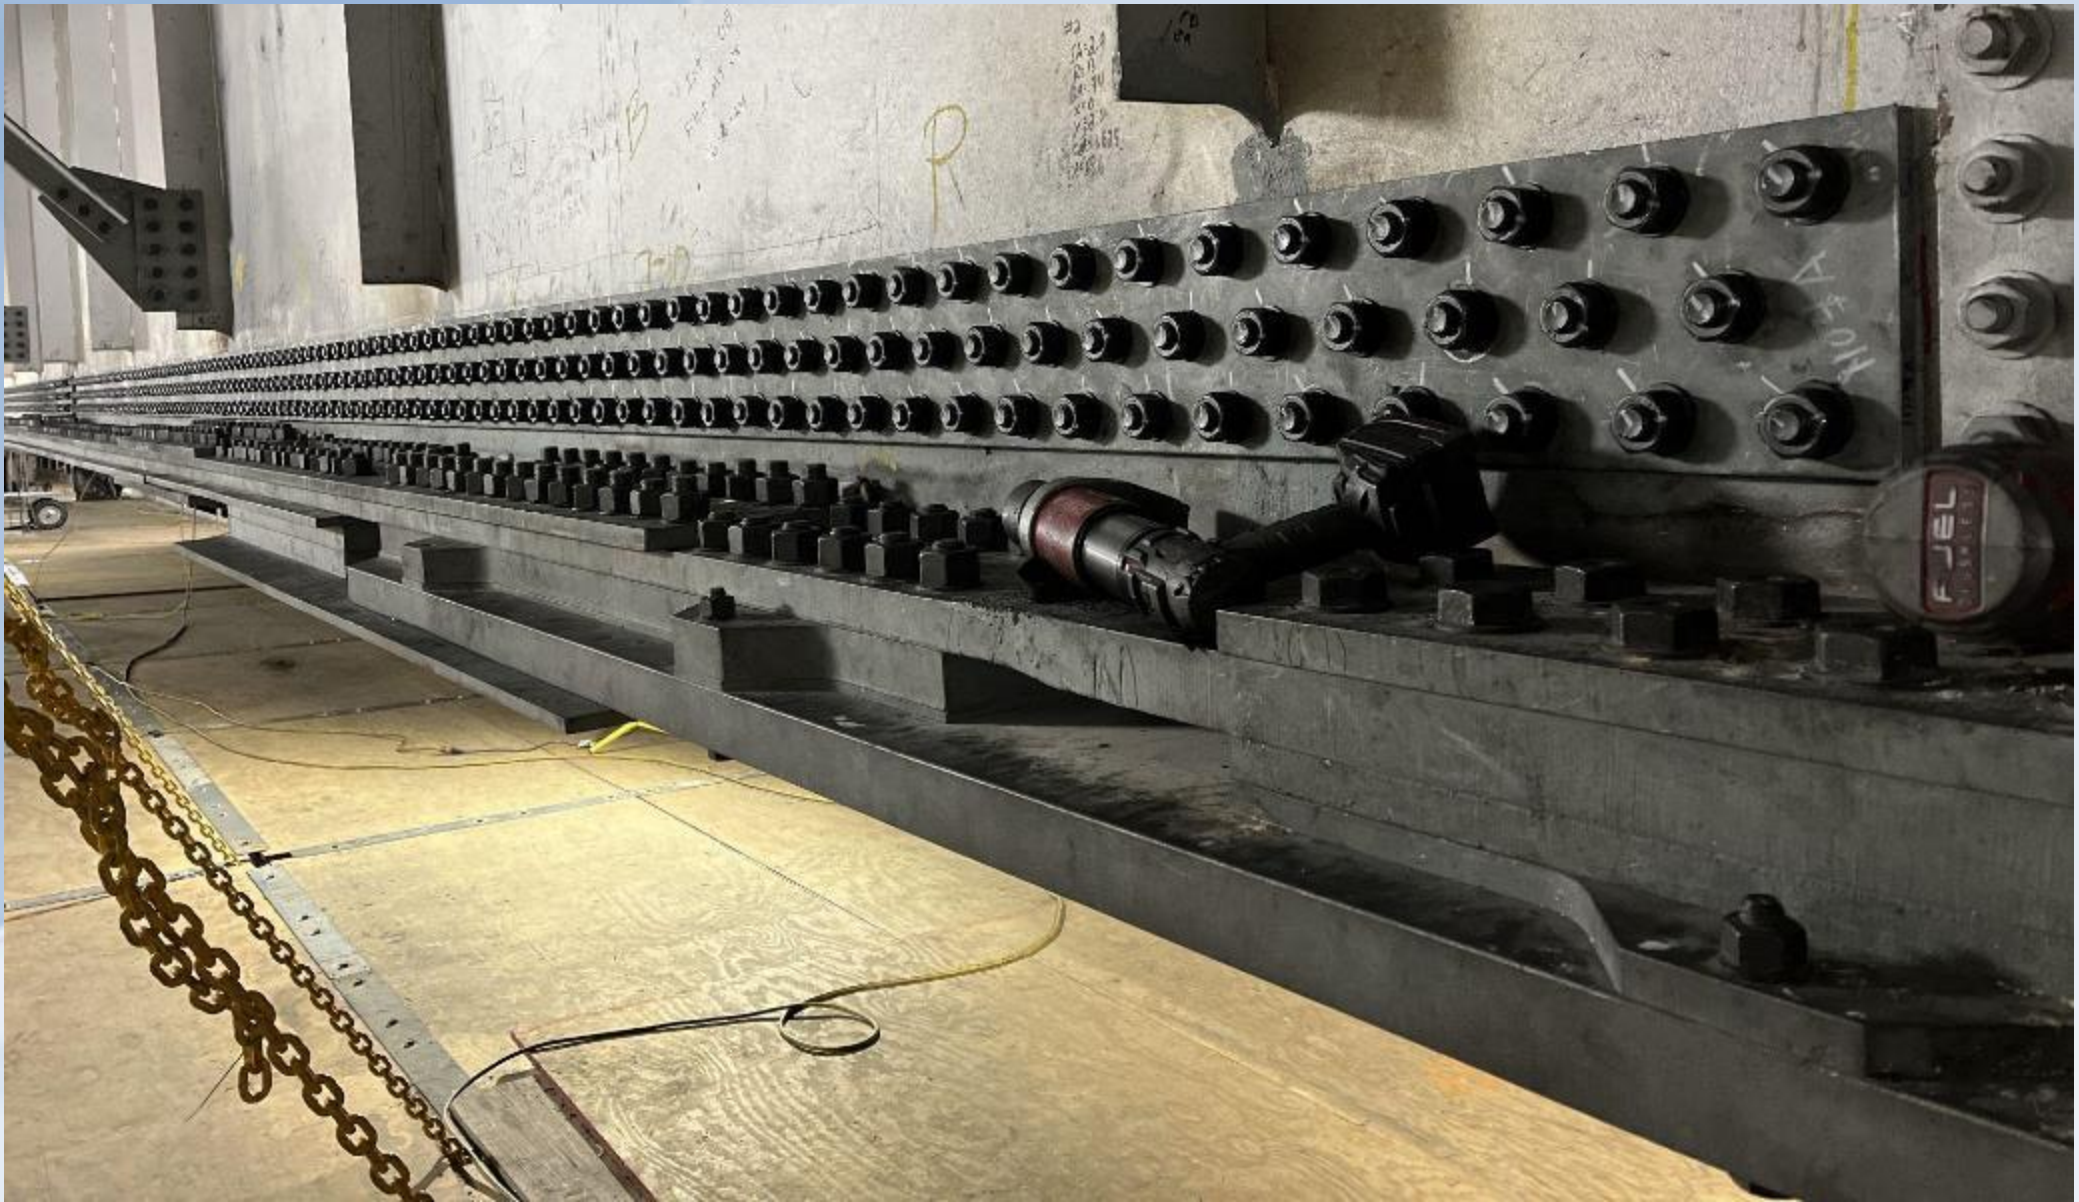
Innovative Crack Arrest Strategy

- Orientation of principal stresses is critical
- These stresses are variable through web
- Typical Dog bones detail would have overlapped
- Collaboratively with Purdue developed detail that drives potential cracks to adjacent bolt holes
