Case Studies and Recommendations for Repeatability NDE Surface and Subsurface Bridge Deck Condition Assessment

Kyle Ruske, Technology Lead
NEXCO-West USA, Inc.

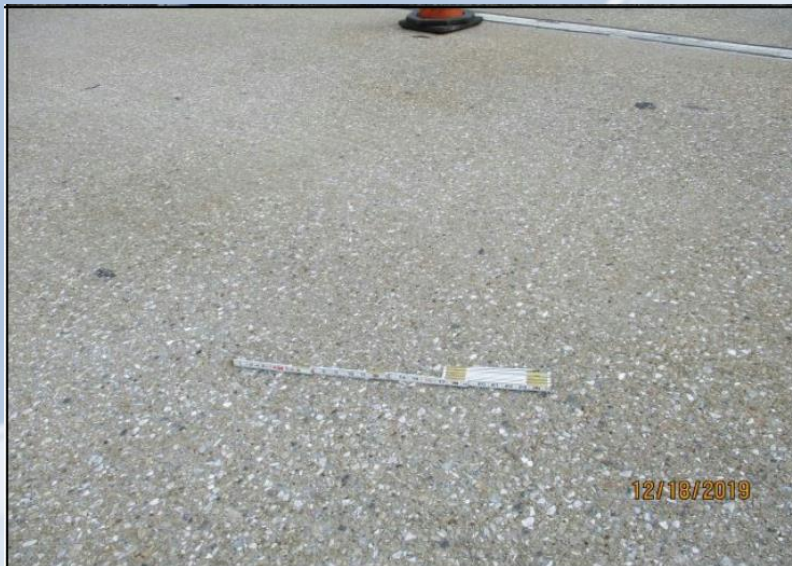
A complete “stitched” surface (or recently full scaled model)

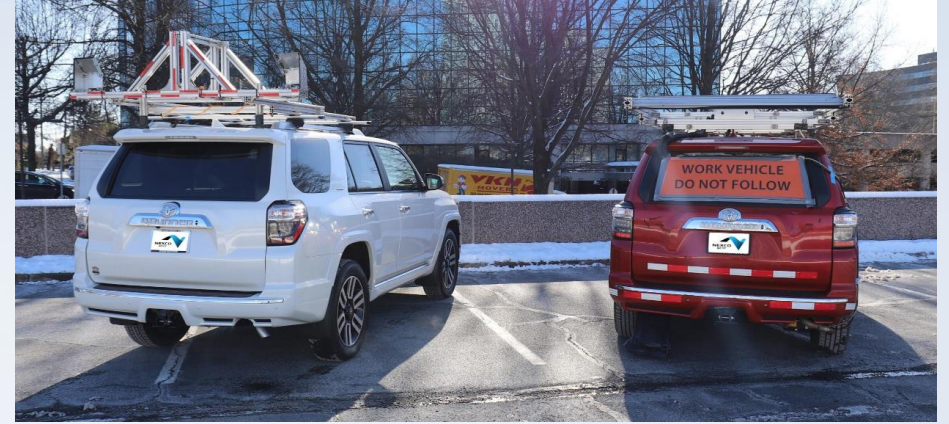
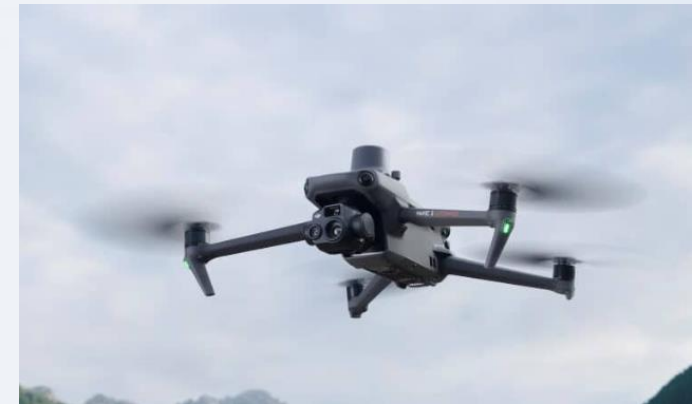
Vehicular, UAV, Aerial-Mounted Methods

- Greatly enhanced collection potential for large areas
- May or may not provide 100% definitive results, but that's *not the primary intent*.
 - It's to get a reasonable assessment of full-deck area condition state.
 - Note: the rest of the presentation will refer to these rapid acquisition types

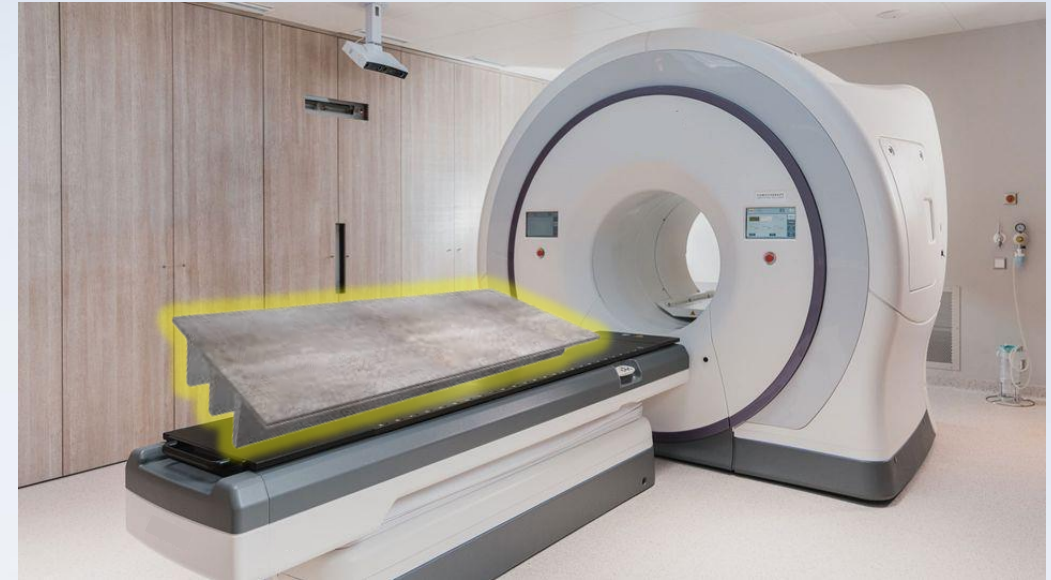
- ASTM, AASHTO, NBIS do not consider reporting 3D quantities (volume).
 - It is somewhat unrealistic to generate accurate volume quantities anyhow, you'd need to run the bridge deck through something like an MRI machine...

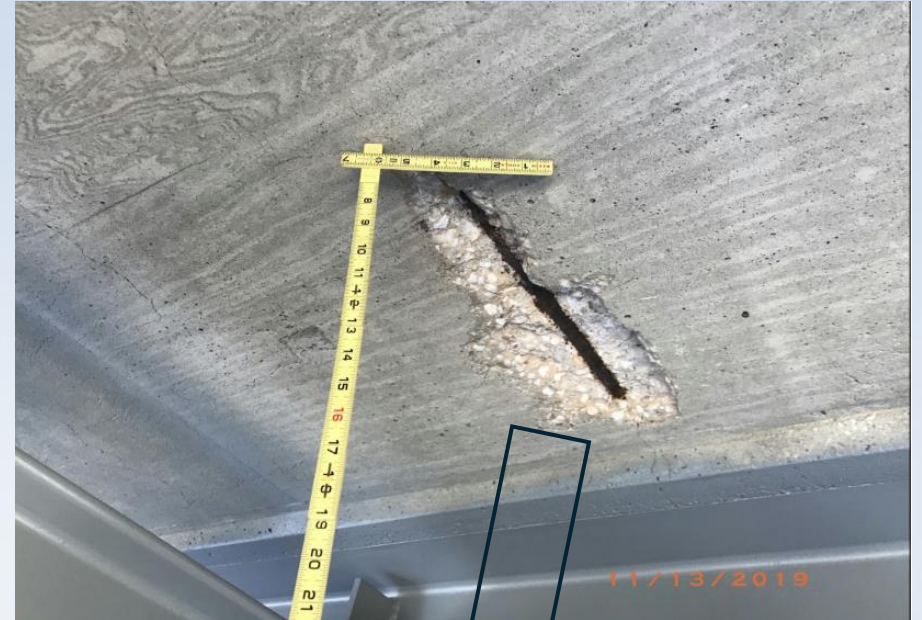
- Surface area covered by deficient findings are summed into CS categories 1-4.
- This becomes a guesstimate for needed repair quantities.

Span: ALL							
Element Number	Element Description	Unit of Measure	Total Quantity	Condition State 1	Condition State 2	Condition State 3	Condition State 4
12	Reinforced Concrete Deck (SF)	SF	7938	7554	350	34	0

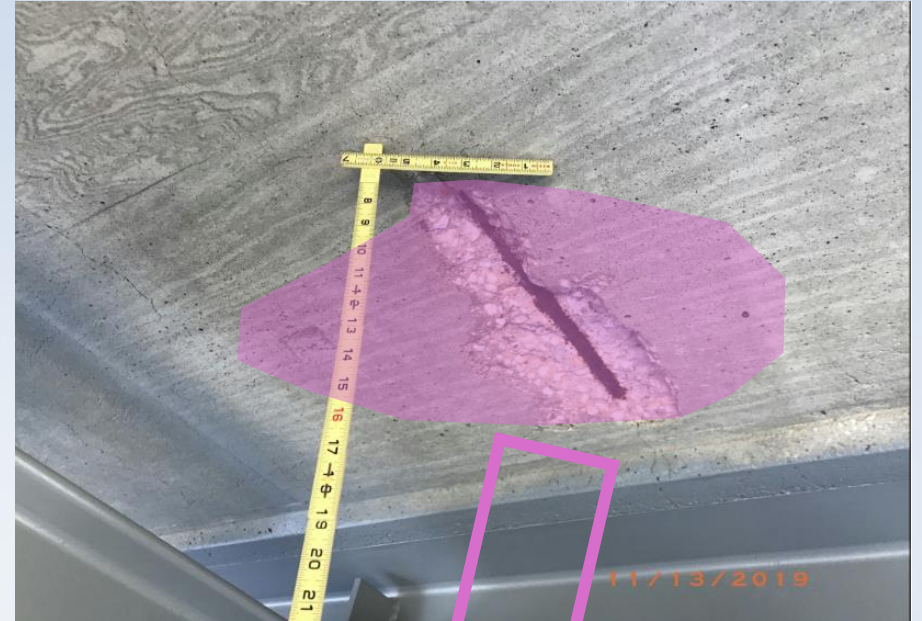
- Let's suppose we scan this deck underside with an IRT camera, and find that a wider area is affected. This offers us a more realistic repair quantity. It may not be the exact repair size needed, but potentially closer than the visual inspection.

Span: ALL							
Element Number	Element Description	Unit of Measure	Total Quantity	Condition State 1	Condition State 2	Condition State 3	Condition State 4
12	Reinforced Concrete Deck (SF)	SF	7938	7554	350	45	0

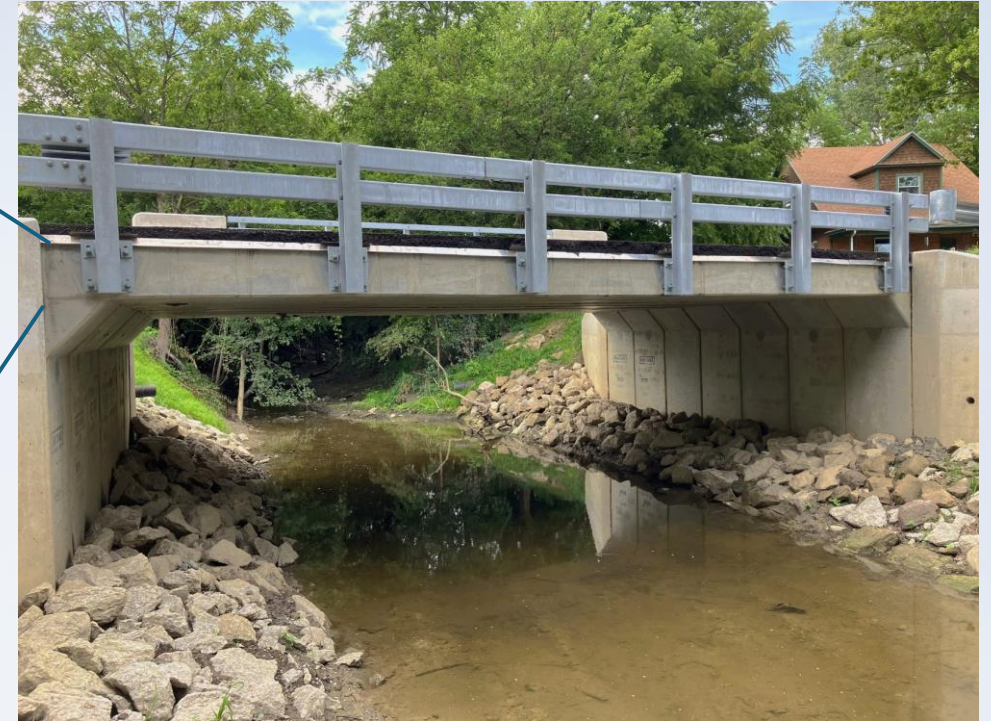
Elevation View

- This hypothetical xample shows two typical findings near rebar depth: evidence of corrosion from GPR signal attenuation and evidence of debonding from IRT hotspot.
