Innovative Strategies for Bridge Preservation:

A Case Study on Pile Jackets in Cape Cod

Charles Packer, PE

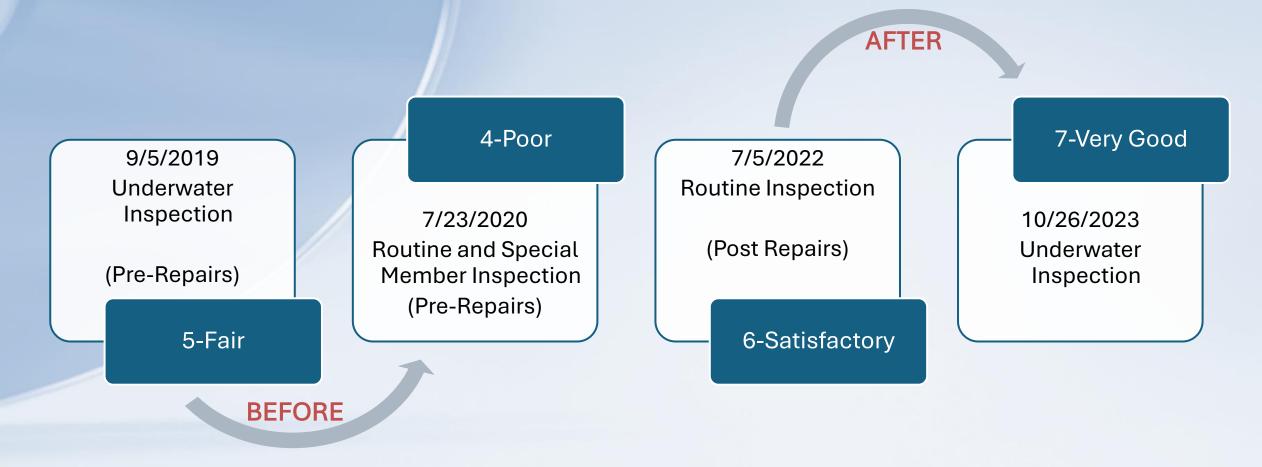
Substructure Condition Rating

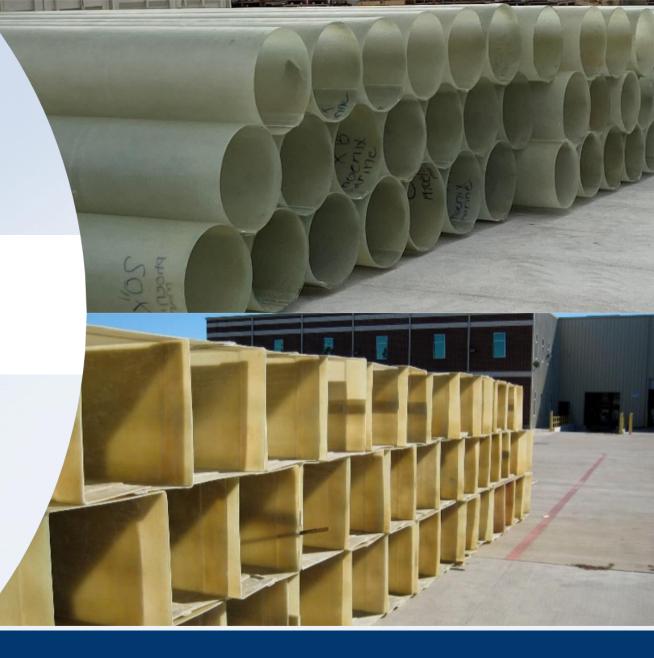
FABRICATION

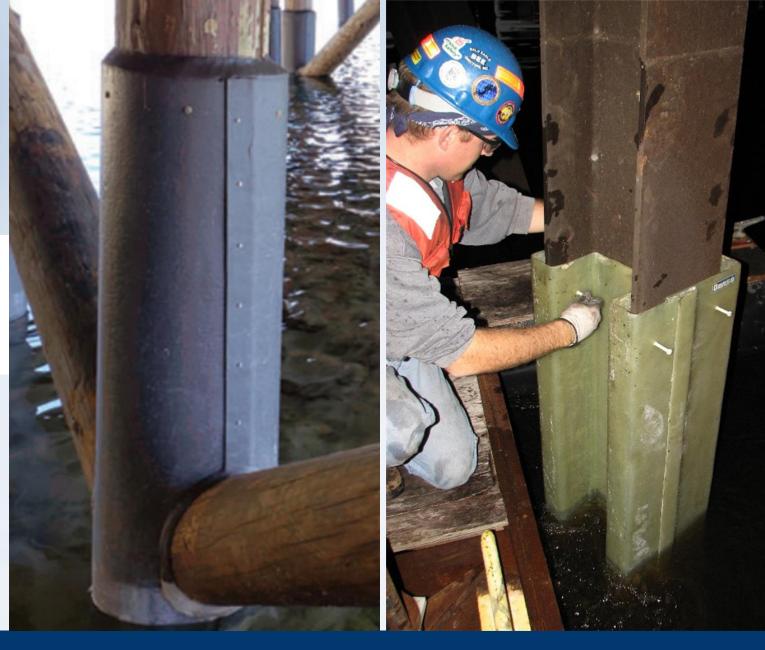
FABRICATION

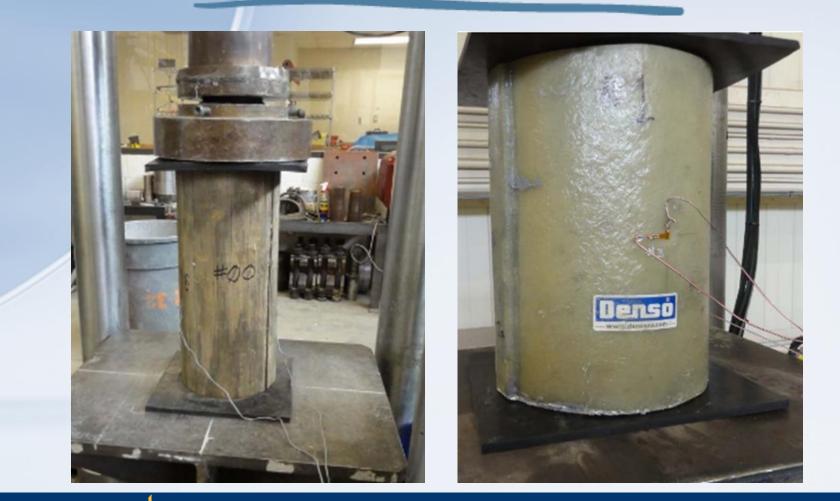
Technical Information Axial Compression

ADDED DIAMETER (INCLUDING JACKET)	GROUT TYPE	MAX STRESS (KSI)	PERCENT INCREASE
Control (8.75" Timber)	ΝΑ	NA	2.10	NA
Specimen 1	5.50 in.	Seashield 510 U/W Grout (9ksi- 28 day)	2.71	29%
Specimen 2	5.56 in.	Seashield 510 U/W Grout (9ksi- 28 day)	2.5	19%
Specimen 3	3.75 in.	Seashield 550 Grout (9.9ksi- 11.2 - 28 day)	3.5	66%
Specimen 4	3.88 in.	Seashield 550 Grout (9.9ksi- 11.2 - 28 day)	3.73	77%

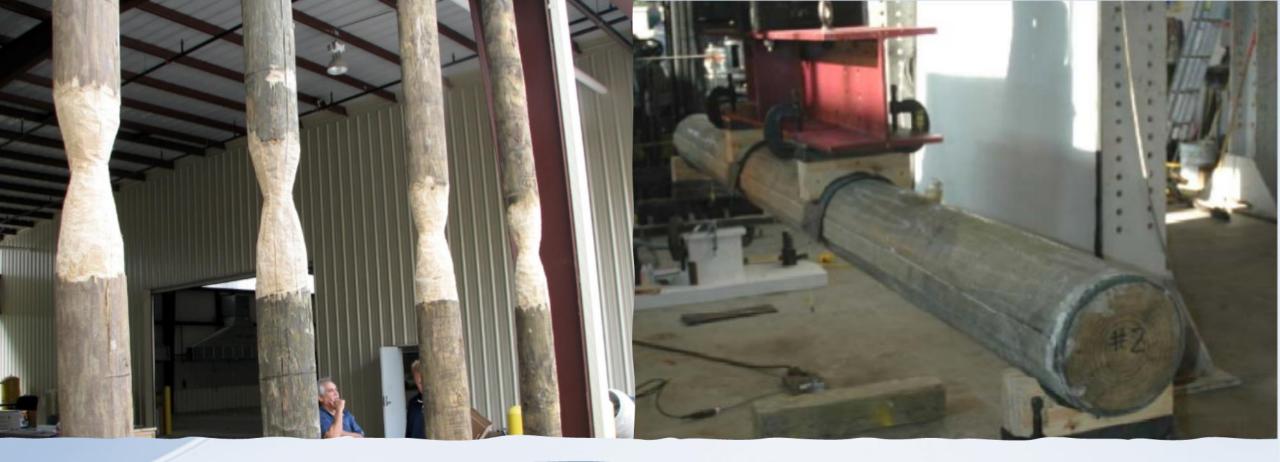
Technical Information Bending

Added Diameter (Including Jacket)	Grout Type	Max Load (Kips)
Control (~8" Diameter)	NA	NA	9.05
Specimen 1	4 in.	Epoxy Grout	20.5
Specimen 2	4 in.	Cementitious Grout	23.5

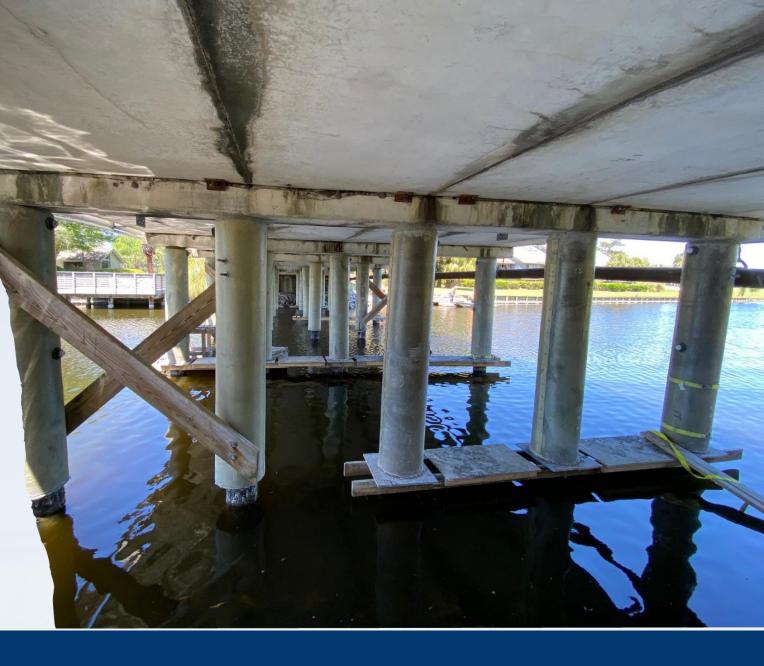
Standardized Forming Detail

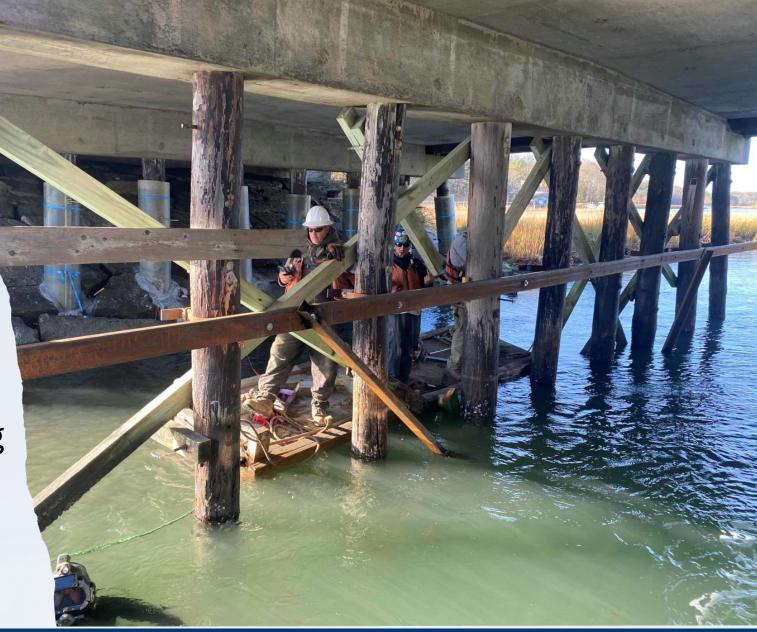
Standardized Temporary Bracing

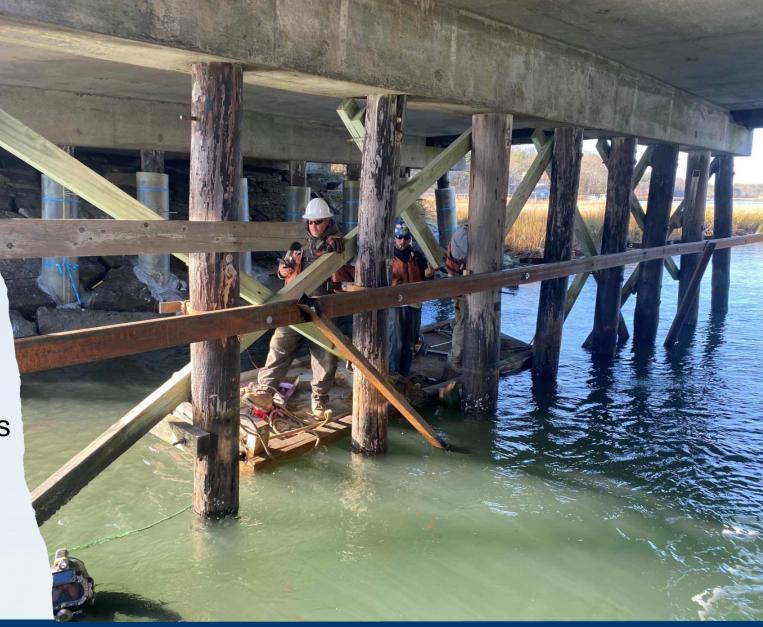
Ability to Increase Unbraced Lengths
