# Enhancing Safety and Efficiency in Bridge Maintenance: Implementing Steel Bridge Deck Formwork Retrofits at the Colorado Department of Transportation

Tristan R Siegel, MCE, PE

Colorado Department of Transportation (CDOT)

Staff Bridge Branch

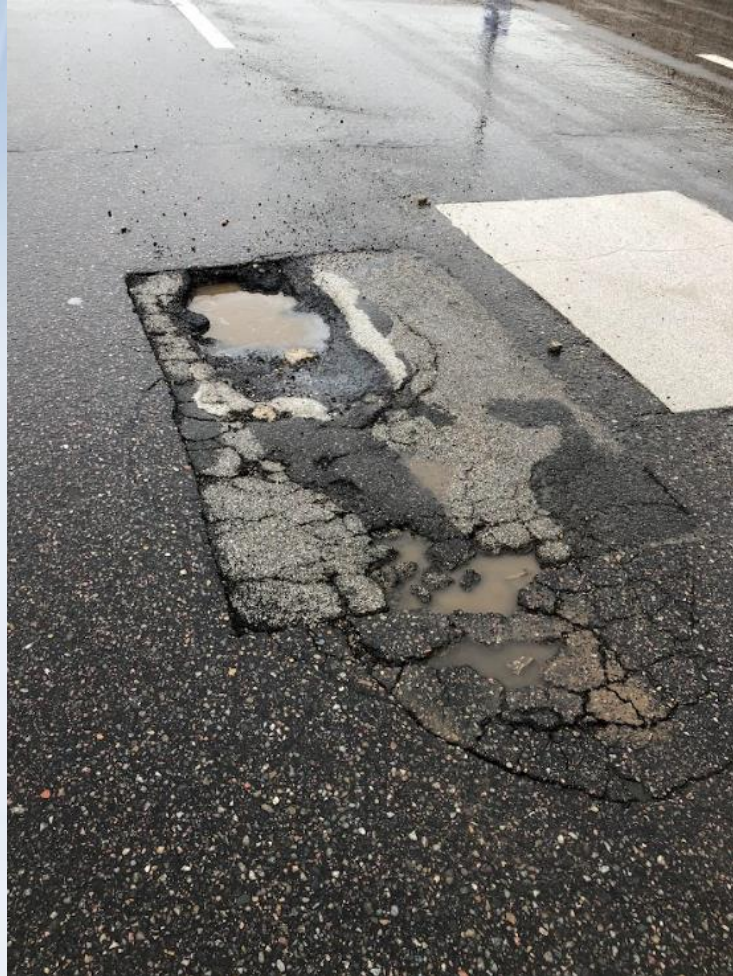
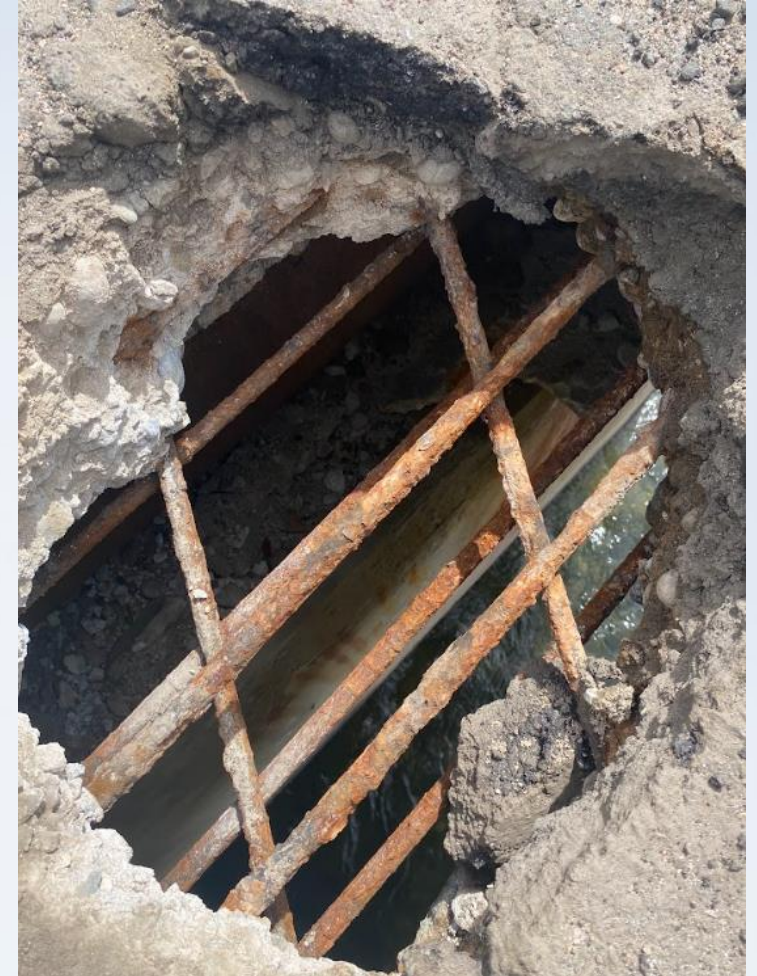
- Typical case
- Freeze-thaw of snowmelt
- Chloride Penetration
- Unknown amount of damage until you open it up

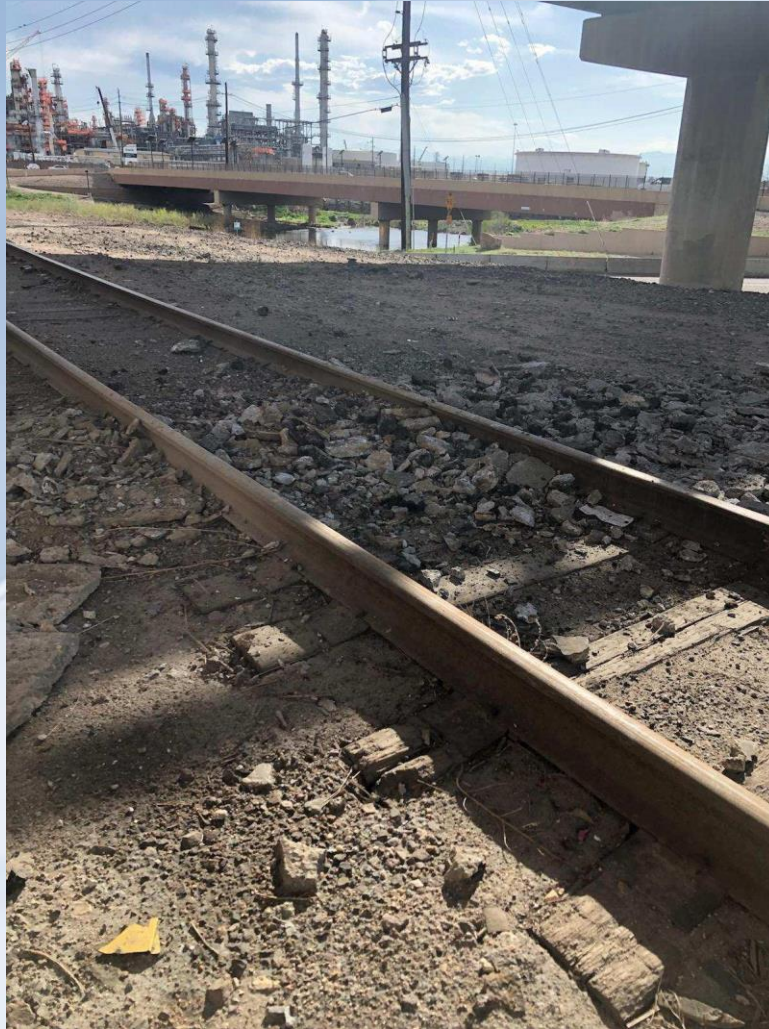
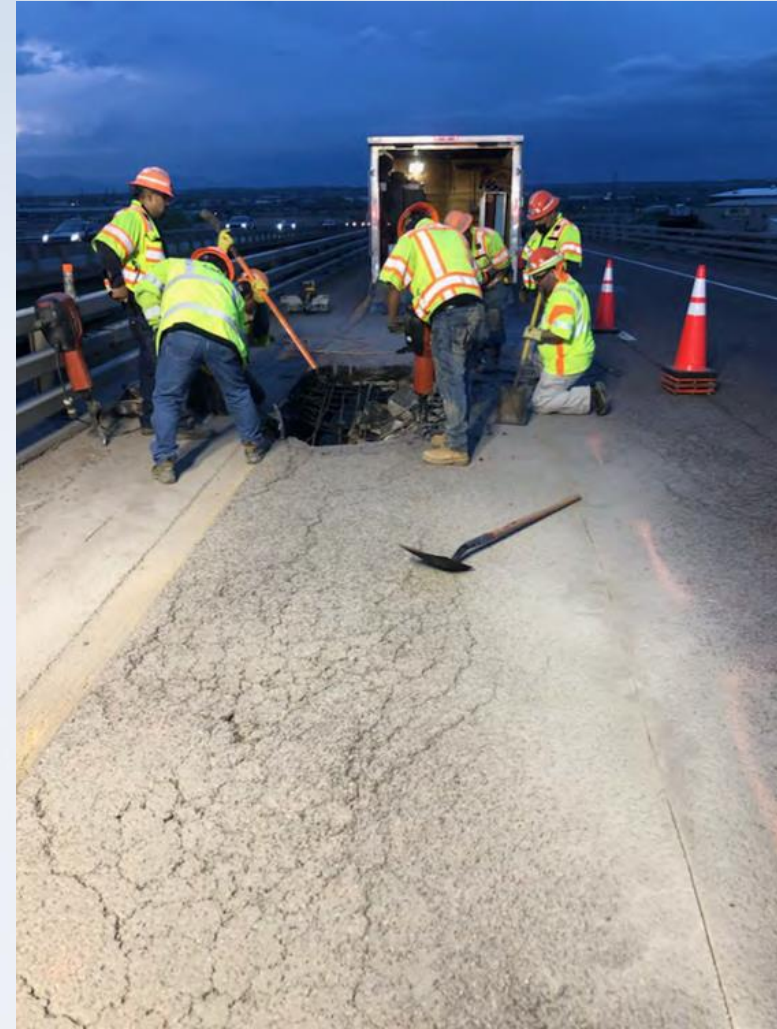
I-270 over  
UPRR, BNSF

May 2021

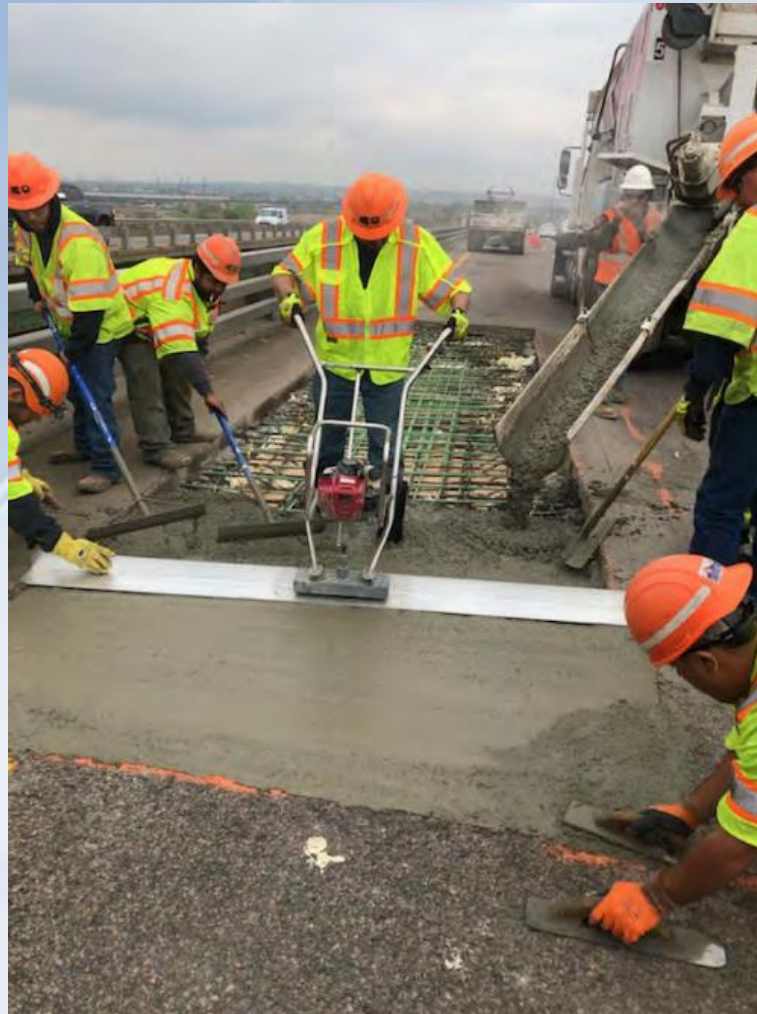
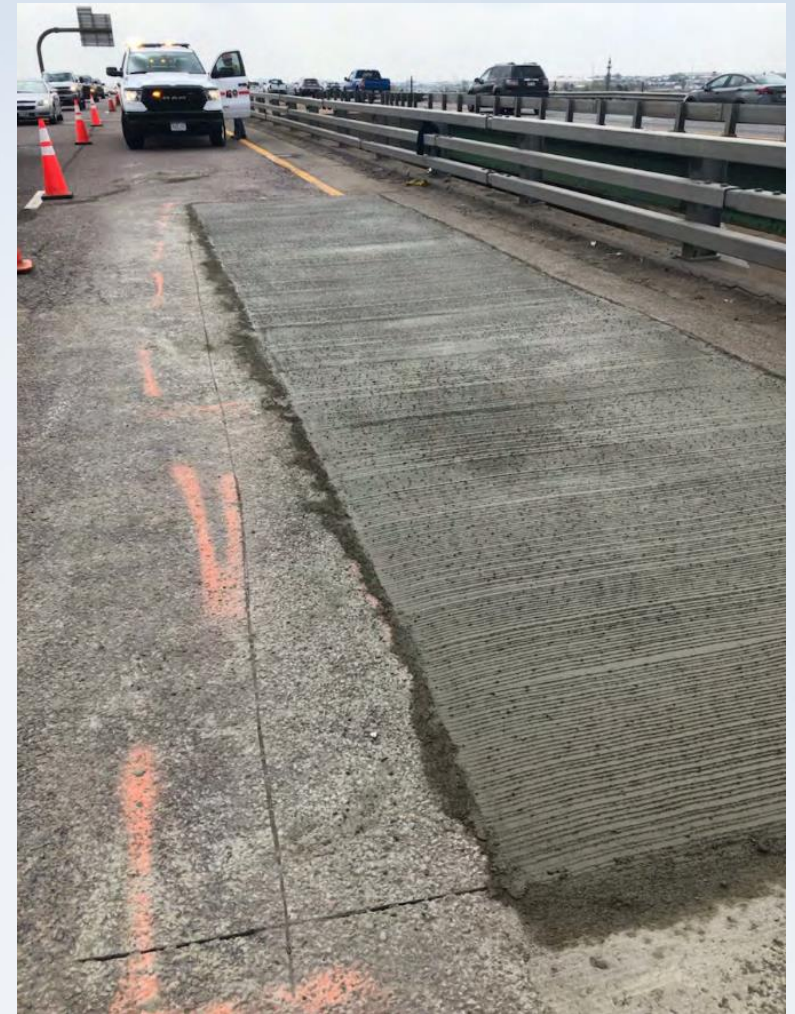
- Total Closure time:  
~48hours
- Keep this timing in  
mind for later

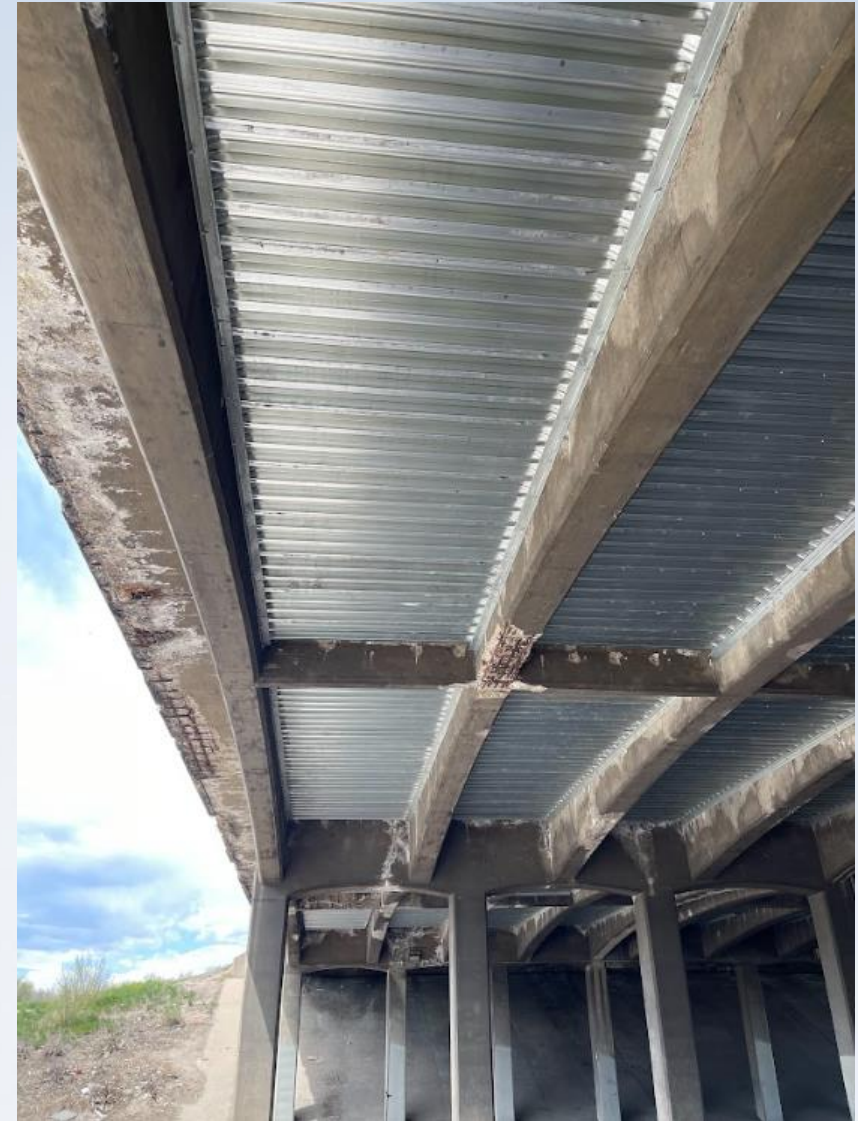
- Short-term, economical solution
- Provides solution for immediate deck concerns
- Provides formwork for quick repair in the event of new deck potholes
- Aesthetically pleasing

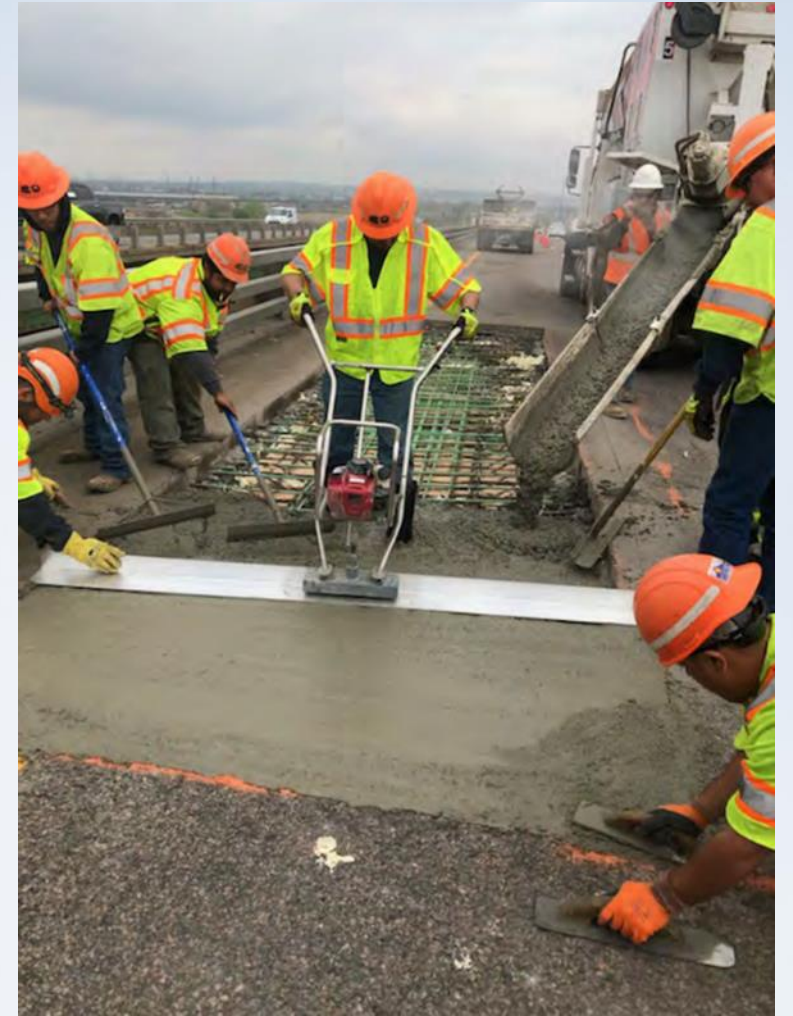
- Dead load of wet concrete + Pedestrian Live Load (Maintenance and construction workers) AASHTO 9.7.4.1
- Formwork and concrete are non-composite
- Vehicular Live Load not considered

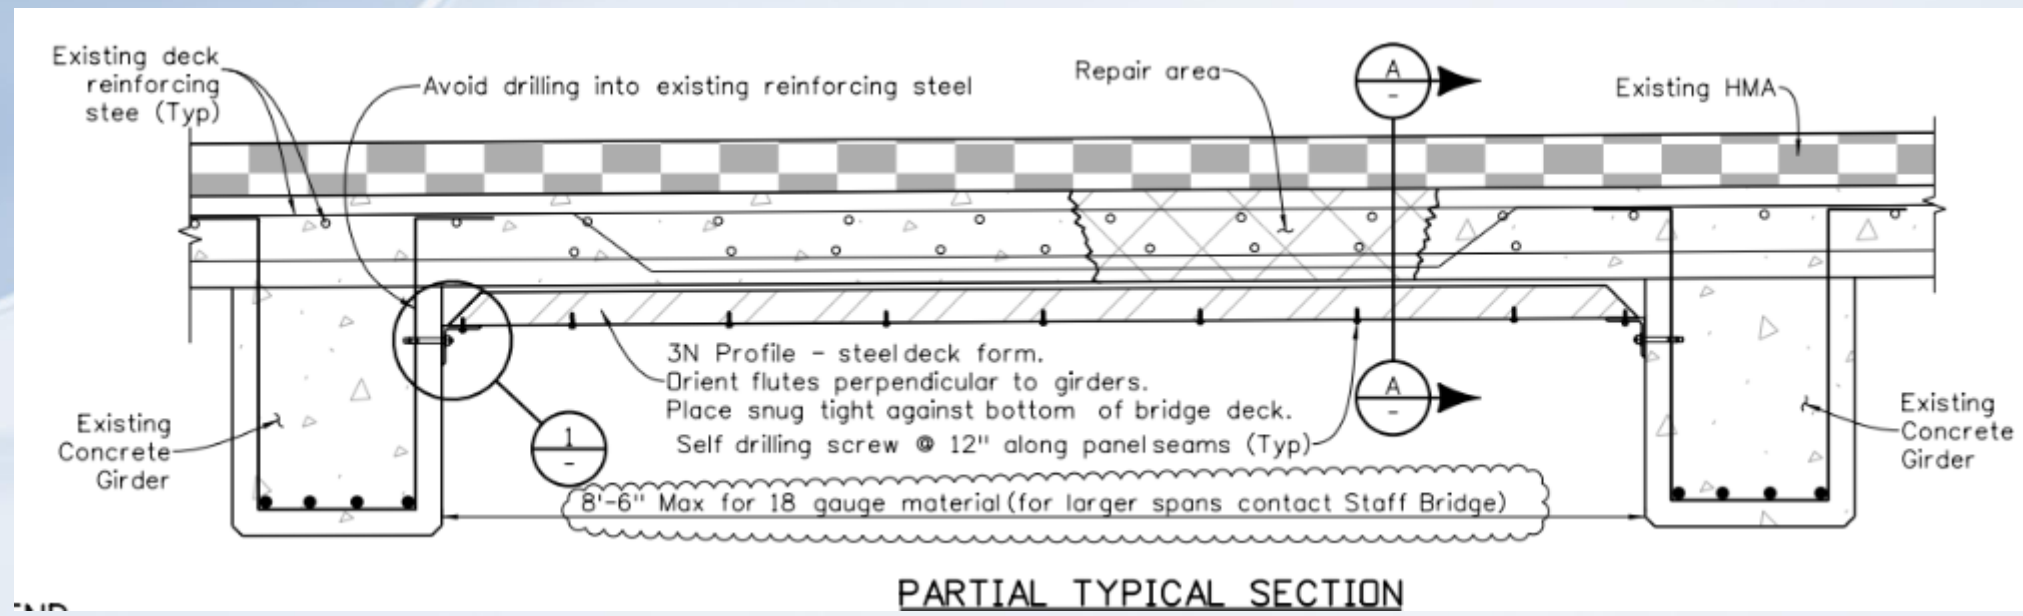
- Concrete Superstructures
- 16ga (min.) Designed to span up to 9' width bays
- Flutes aligned transversely
- Support Angles along entire length, anchored

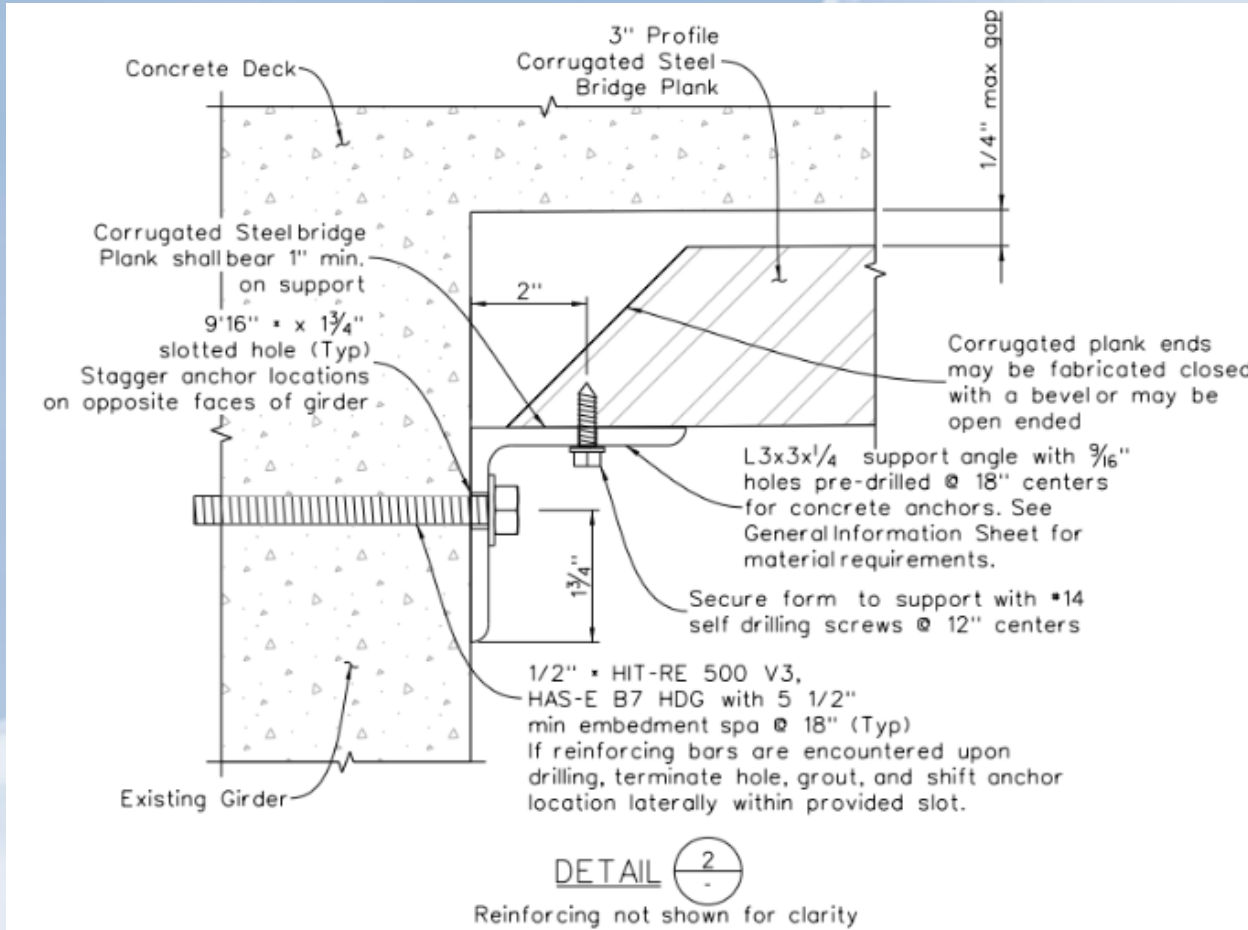
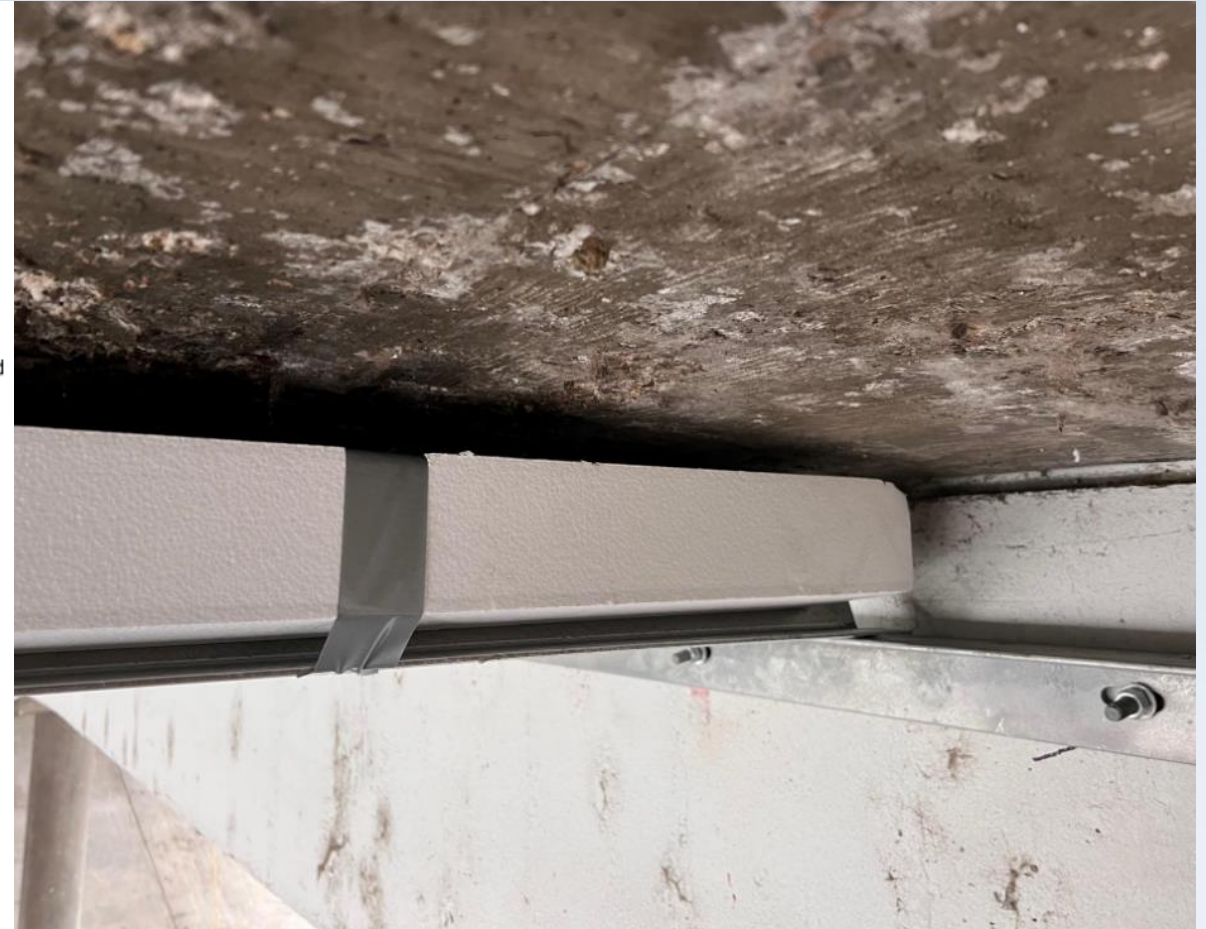
- Concrete Anchor Detail and photo example

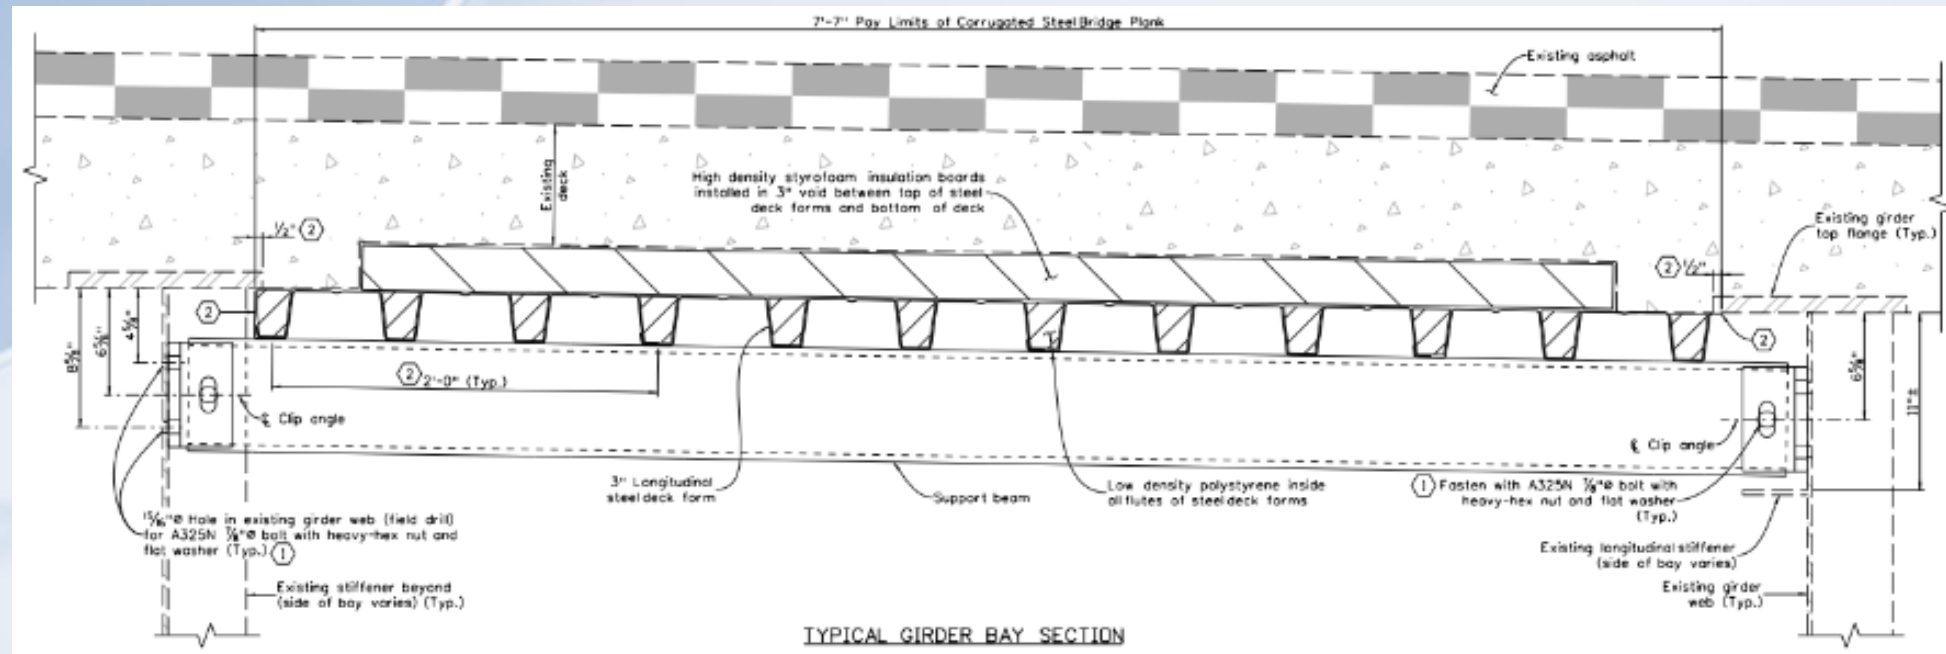
- Steel Superstructure
- Designed with the flutes aligned longitudinally
  - Steel Channels installed attached to the webs w/ clip angles = Less holes in the webs

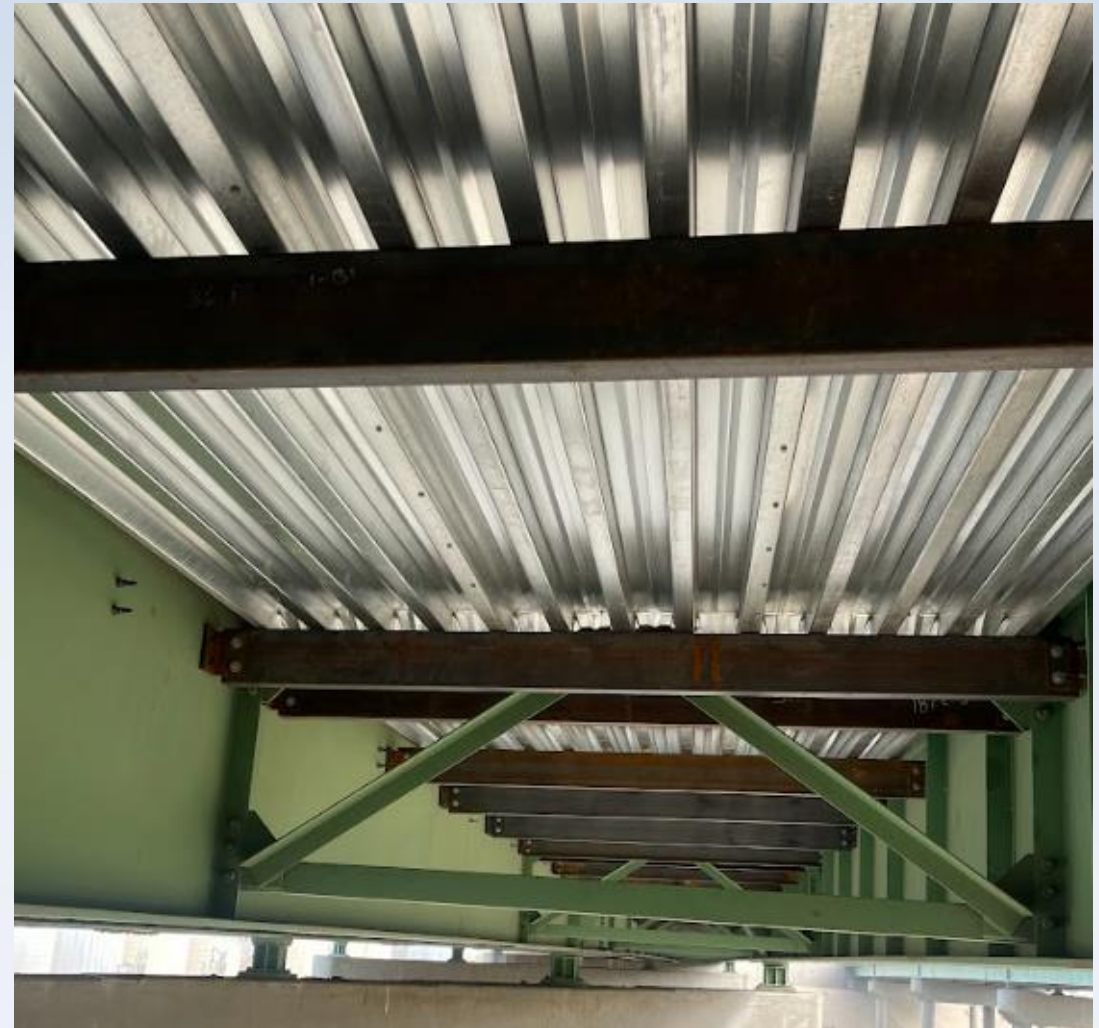
- Steel Superstructure
- Installed example
- “Why aren’t the channels galvanized like you specified?”

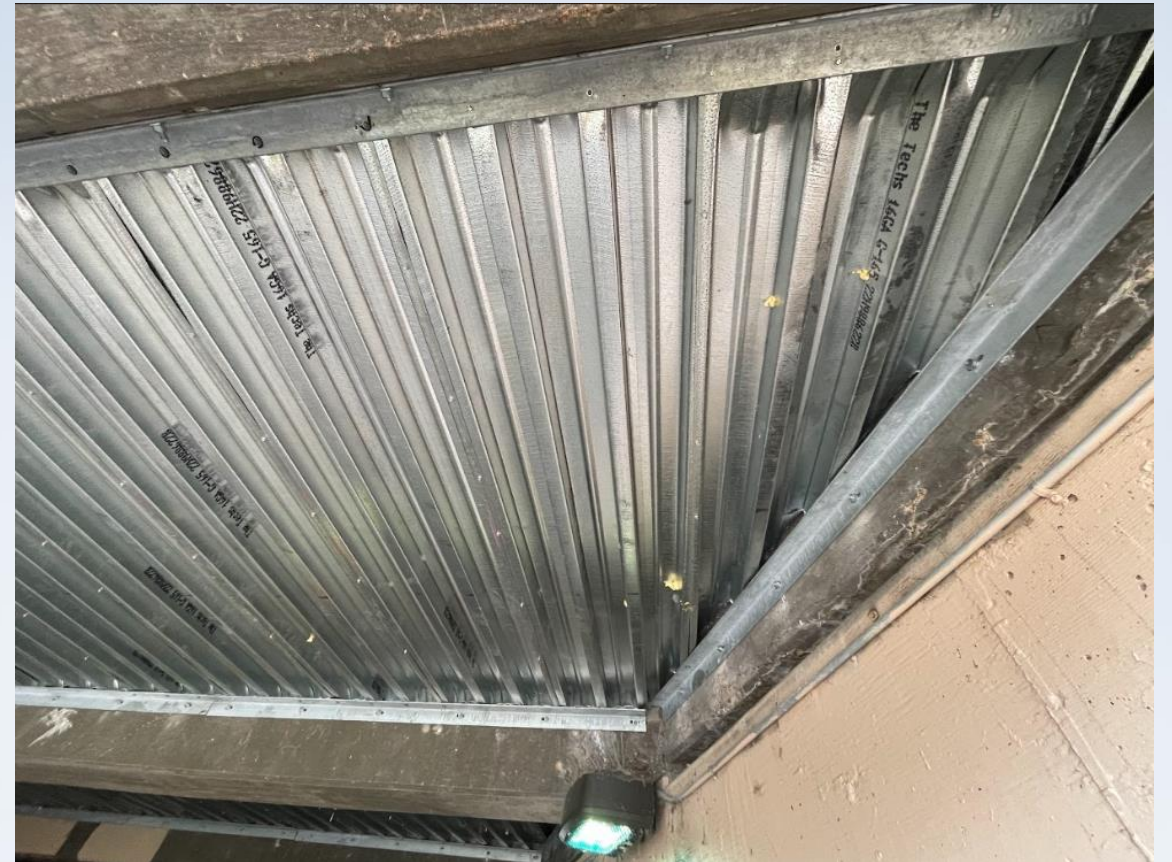
- Common Issues
  - Access
  - Tight Corners on skewed bridges were an issue
  - Fit-Up
  - Lifting into place

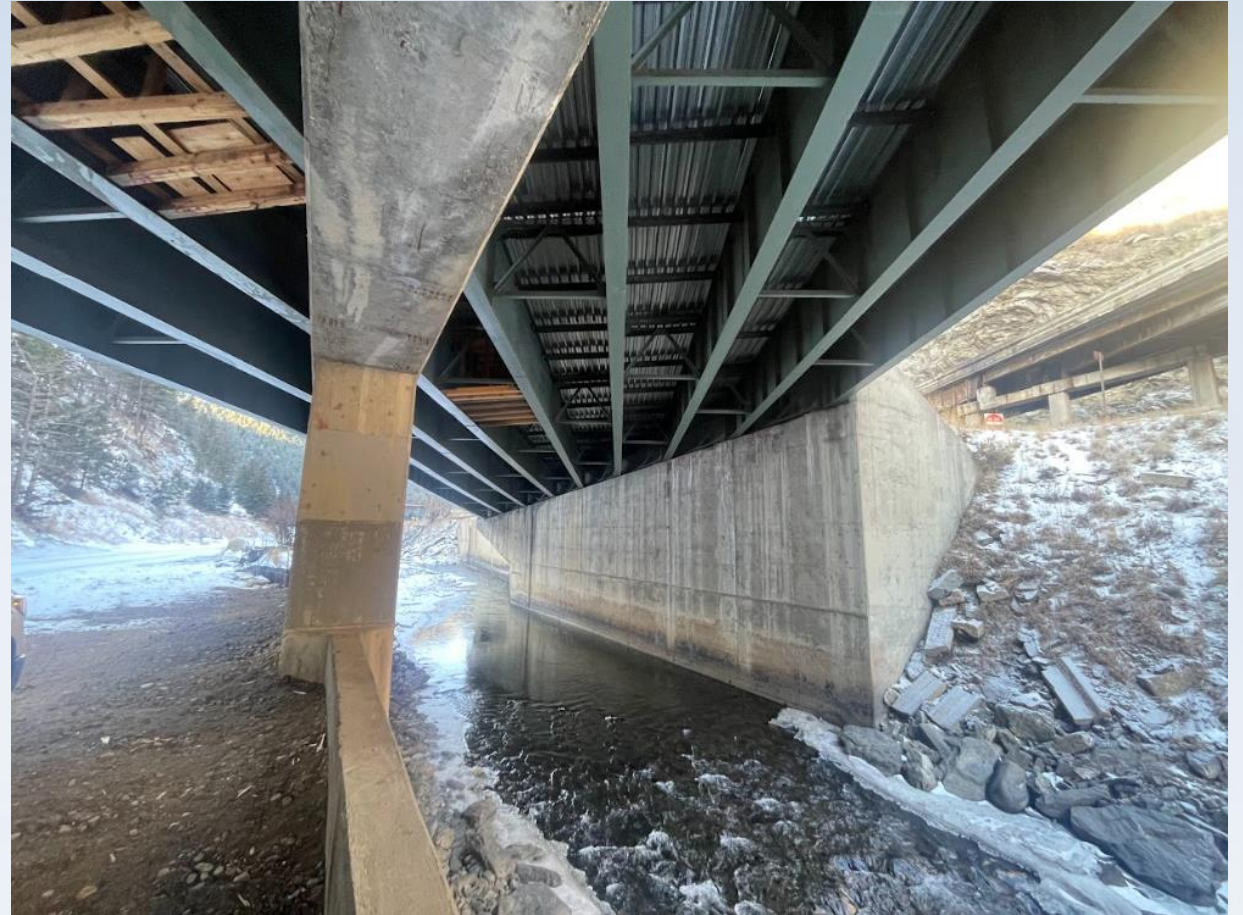
- Access at Clear Creek
  - Special manlift was needed here
  - No Access to abutment side that wouldn't require a lane closure
  - Special reach manlift extended over the creek

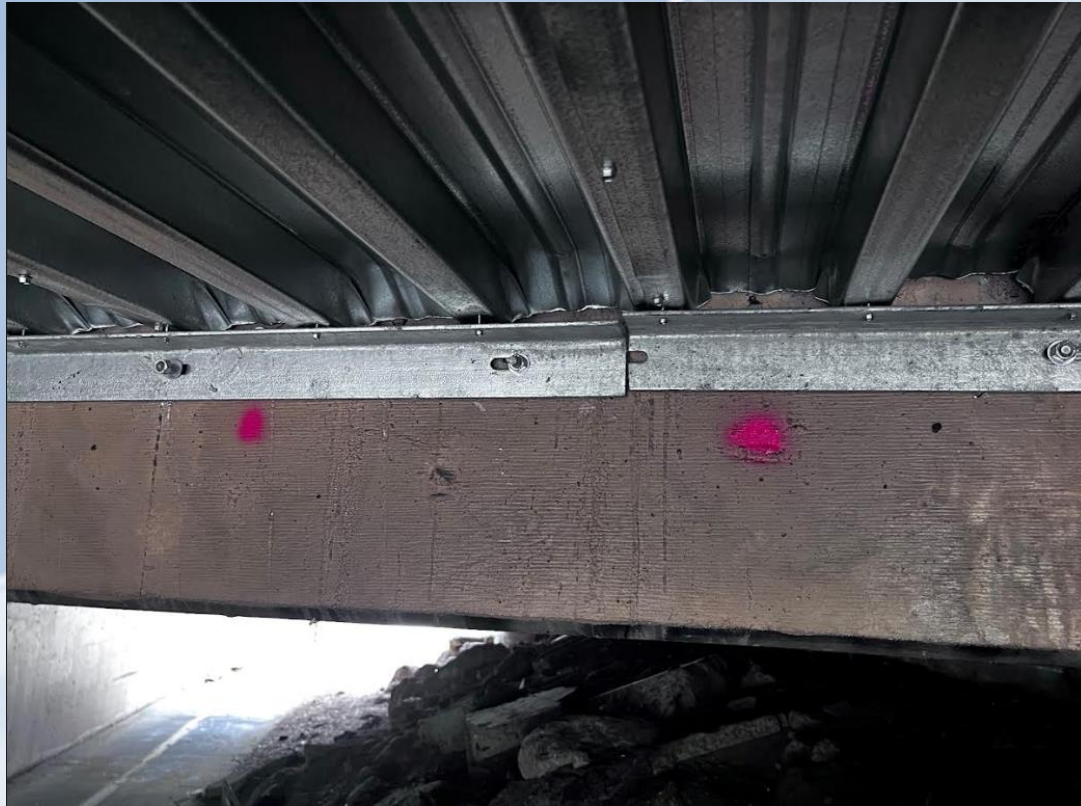
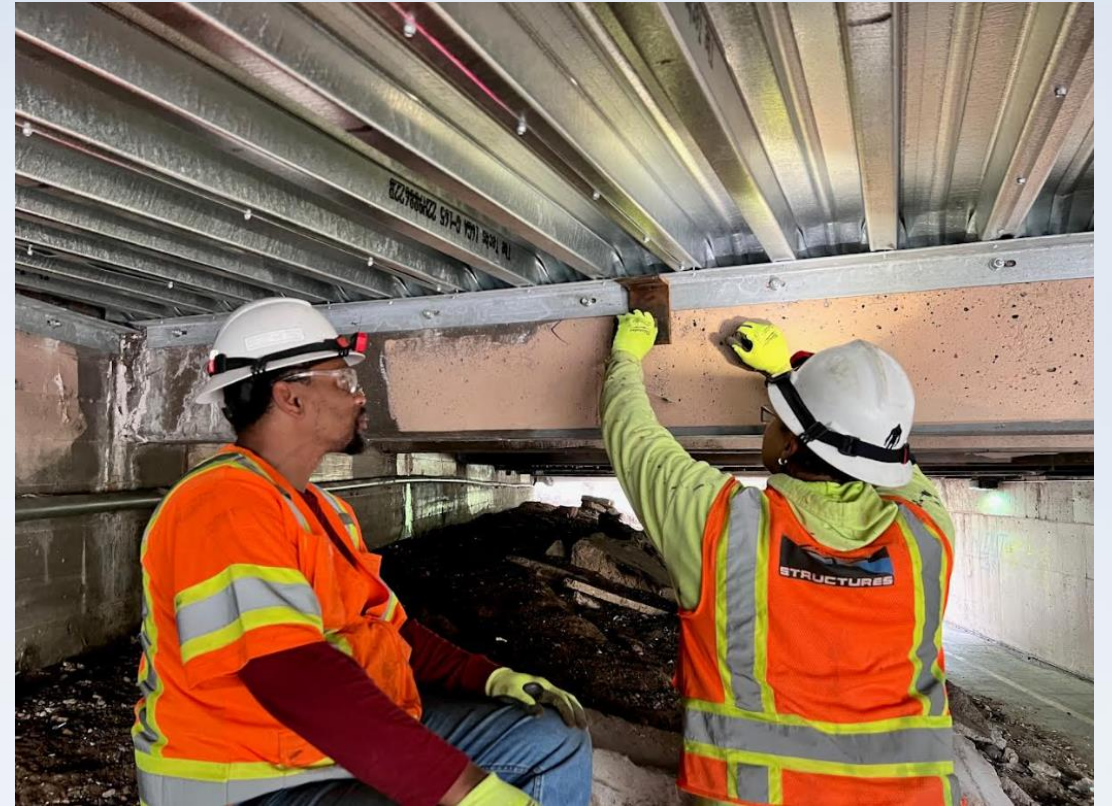
- Fit-Up of angles and anchor bolt spacing

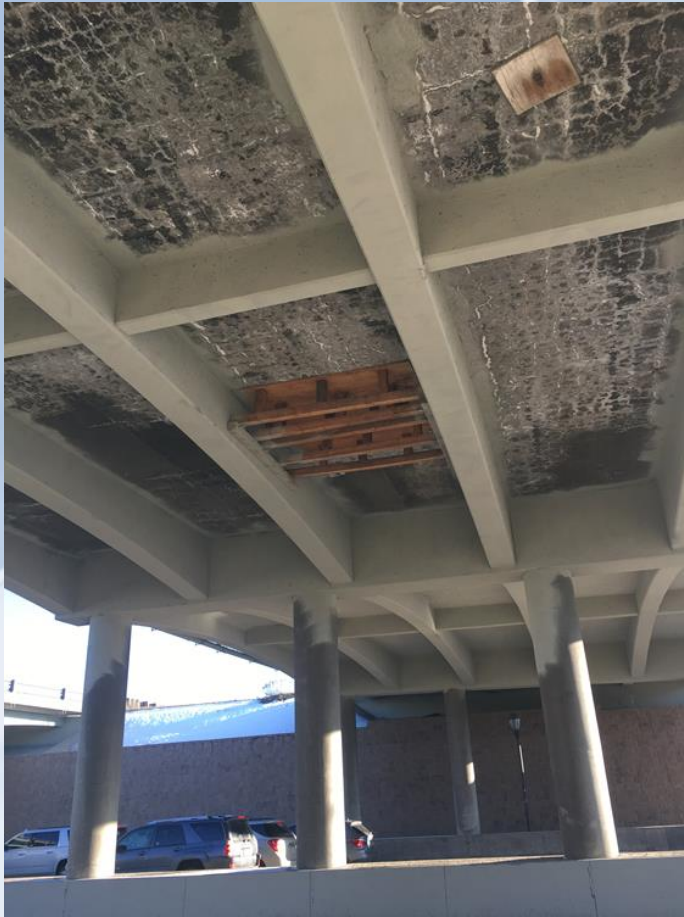
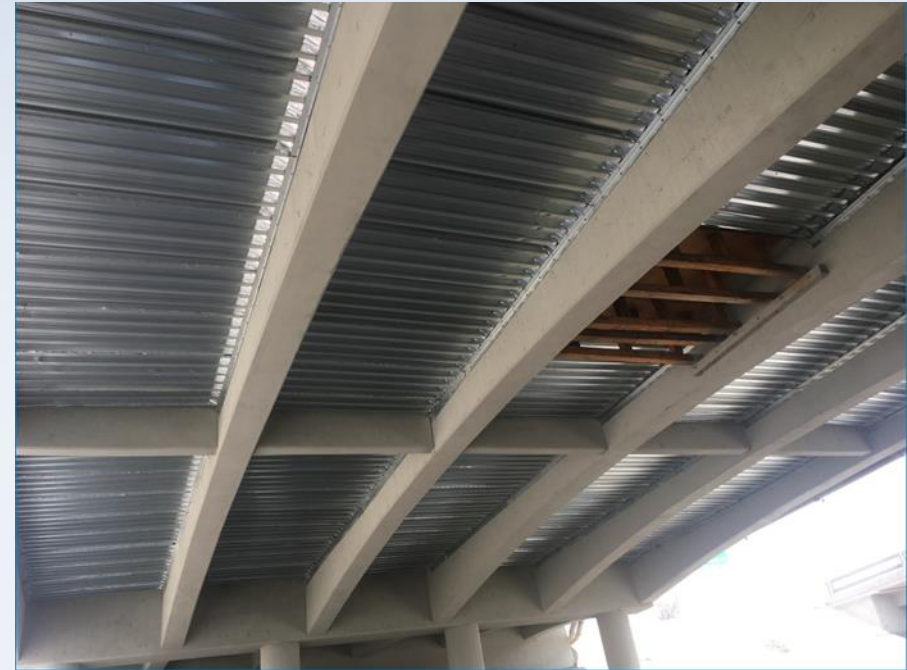
“Why did you leave the wood up??”

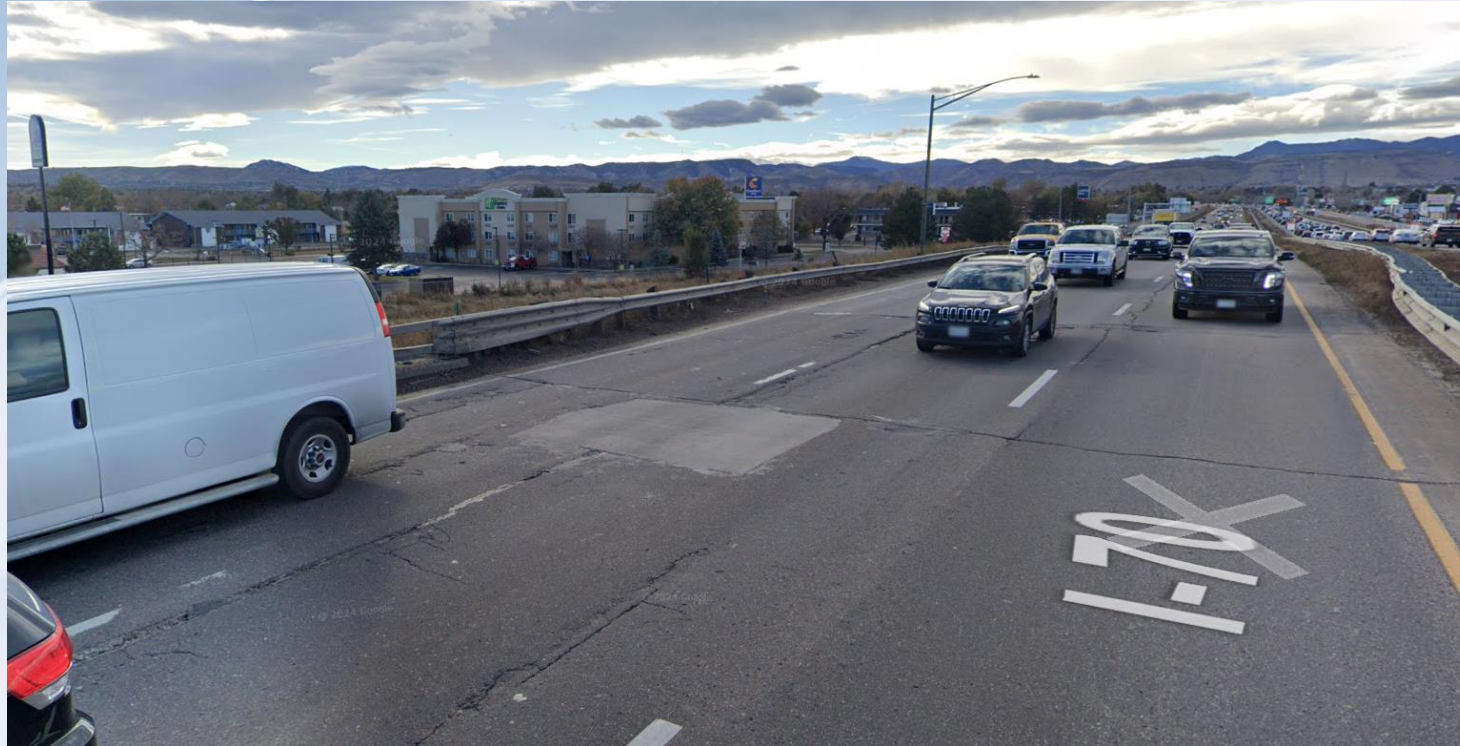
- 12 hours, 35 mins duration
- Still holding up!
