Keystone Wye Project

Owner – State of South Dakota - SDDOT

Consultant – Stantec

Keystone Wye Bridges

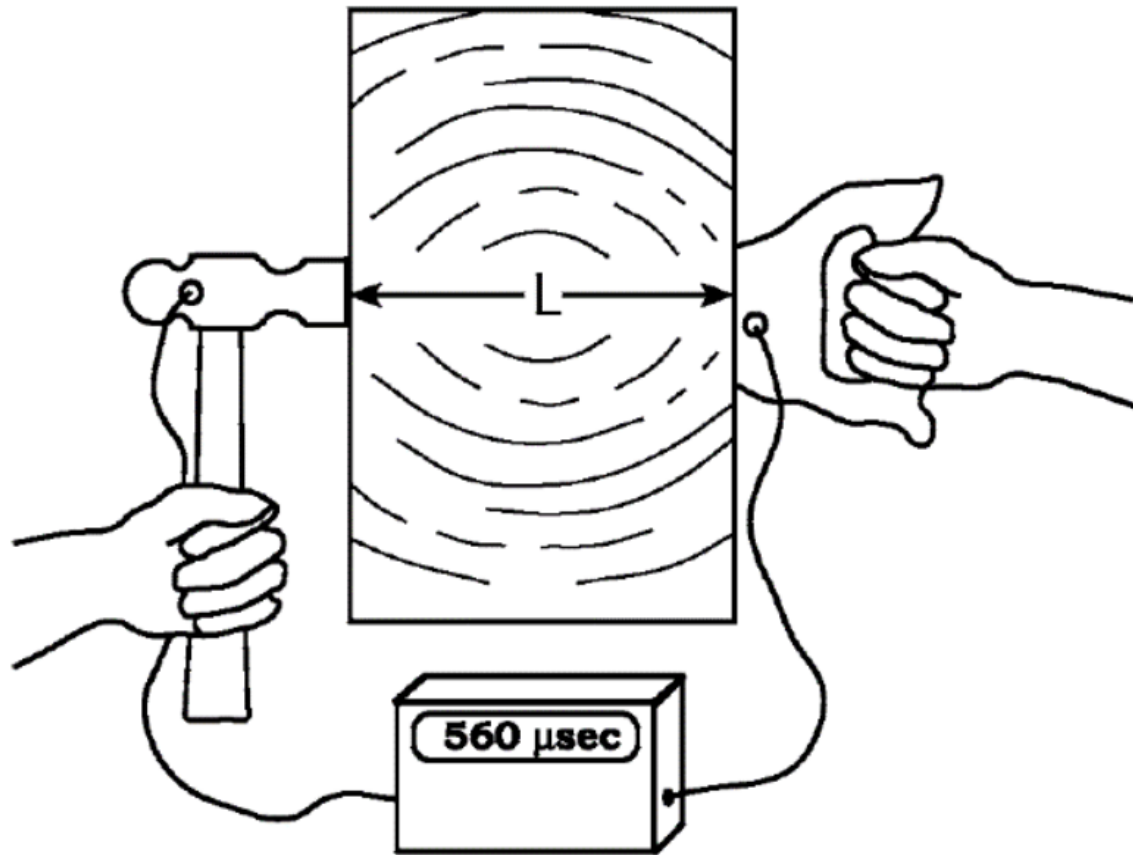
Stress Wave Timing

- Used Stress-Wave Timing Testing (SWT)
 - Measures the speed in which it travels through the timber
 - Faster – higher quality timber
 - Slower – more decay in the timber
- Took some cores to correlate and confirm the SWT results

Figure 3. Schematic. Illustration of the principle of stress wave timing tests.⁽¹⁾

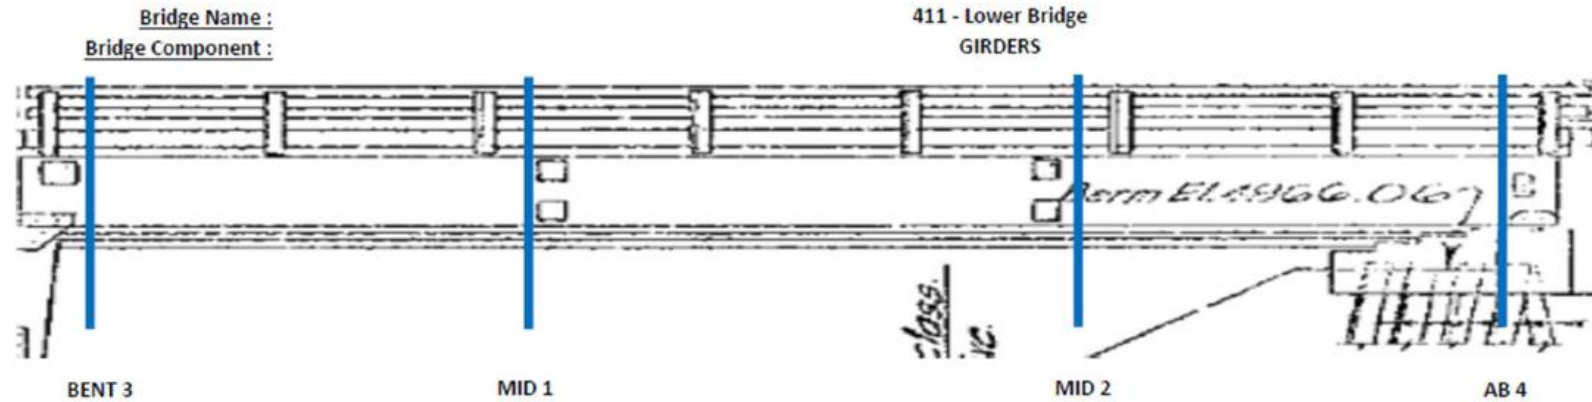
SWT Results

- Green – timber in good condition
- Yellow – timber starting to deteriorate
- Red – timber deteriorated and may impact load capacity
- Yellow/Red areas – moisture is normal driver for timber deterioration
- Results will establish a base line of the timber condition and identified areas that will need to be addressed

Location Per Plan :	Span 3	Girder 2	29 Laminations	55.49 FT Span Length
Location Per SD DOT Inspection :	Span 1	Girder 3	29 Laminations	55.49 FT Span Length

SWT Data								
Location :	Bent 3		MID 1		MID 2		AB 2	
Girder Height :	47 inches		47 inches		47 inches		47 inches	
Girder Width (Gauge Length) :	11 inches		11 inches		11 inches		11 inches	
Lamination Number	Raw SWT	Adjusted SWT	Raw SWT	Adjusted SWT	Raw SWT	Adjusted SWT	Raw SWT	Adjusted SWT
1	327	357	750	818	1241	1354	441	481
5	217	237	342	373	285	311	246	268
10	202	220	255	278	384	419	309	337
15	286	312	263	287	386	421	192	209
20	212	231	237	259	279	304	241	263
25	262	287	261	284	332	359	217	245

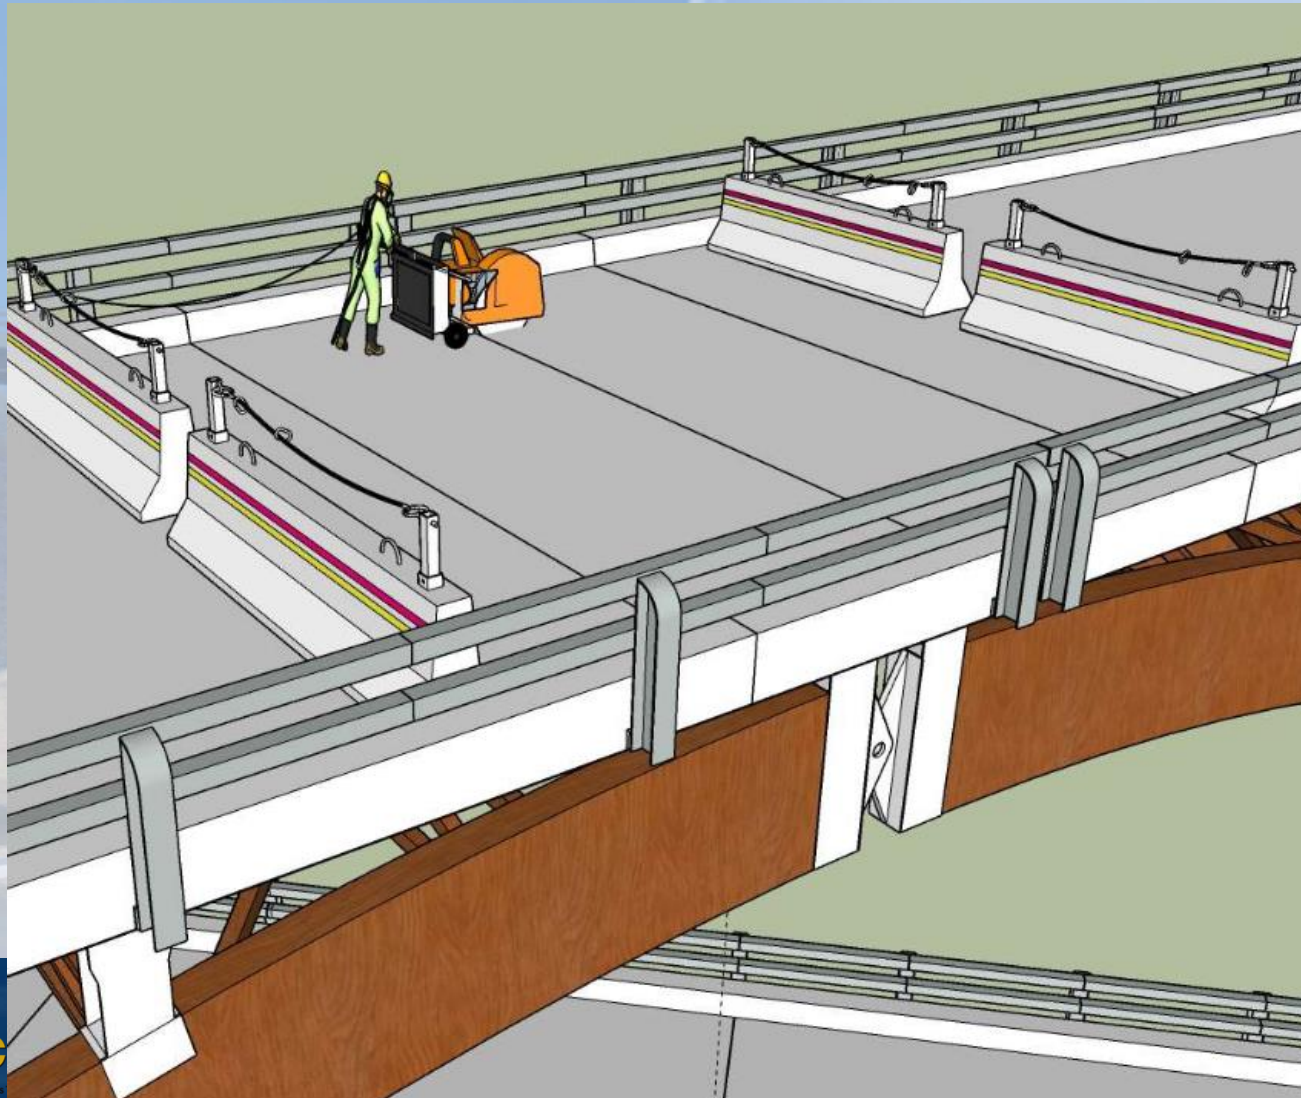
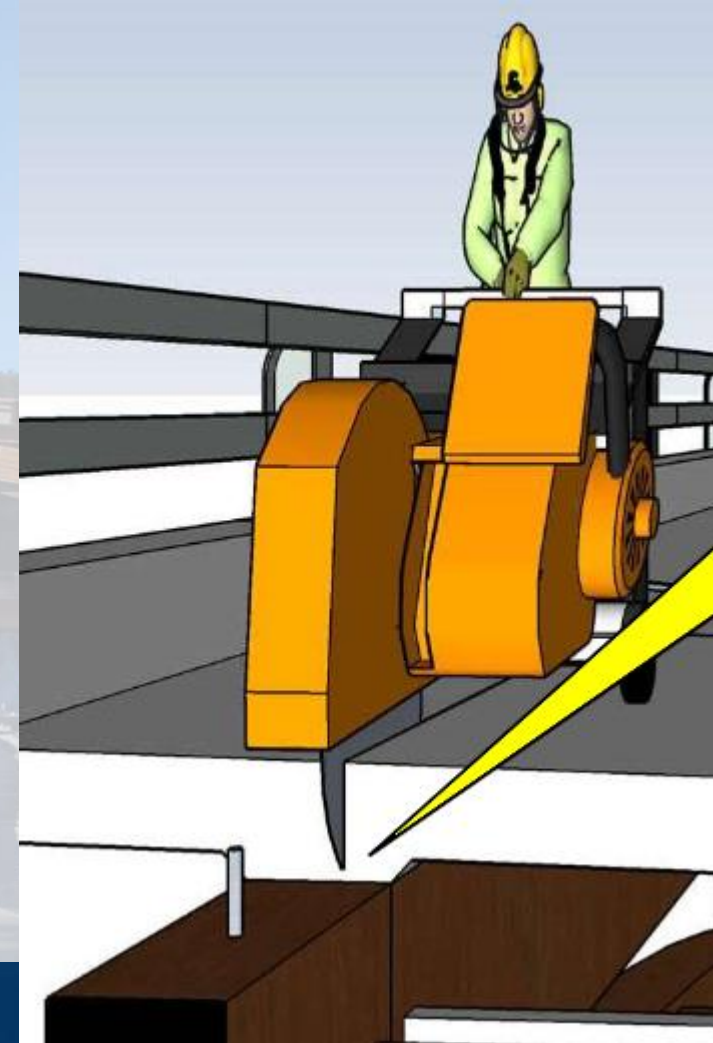
Deck Removal

Images from Corr Construction
