Maintenance Painting of a 20-year Old Metallized Through Truss

Todd S. Thompson, PE – South Dakota DOT

J. Peter Ault, PE – KTA-Tator

Aberdeen Truss

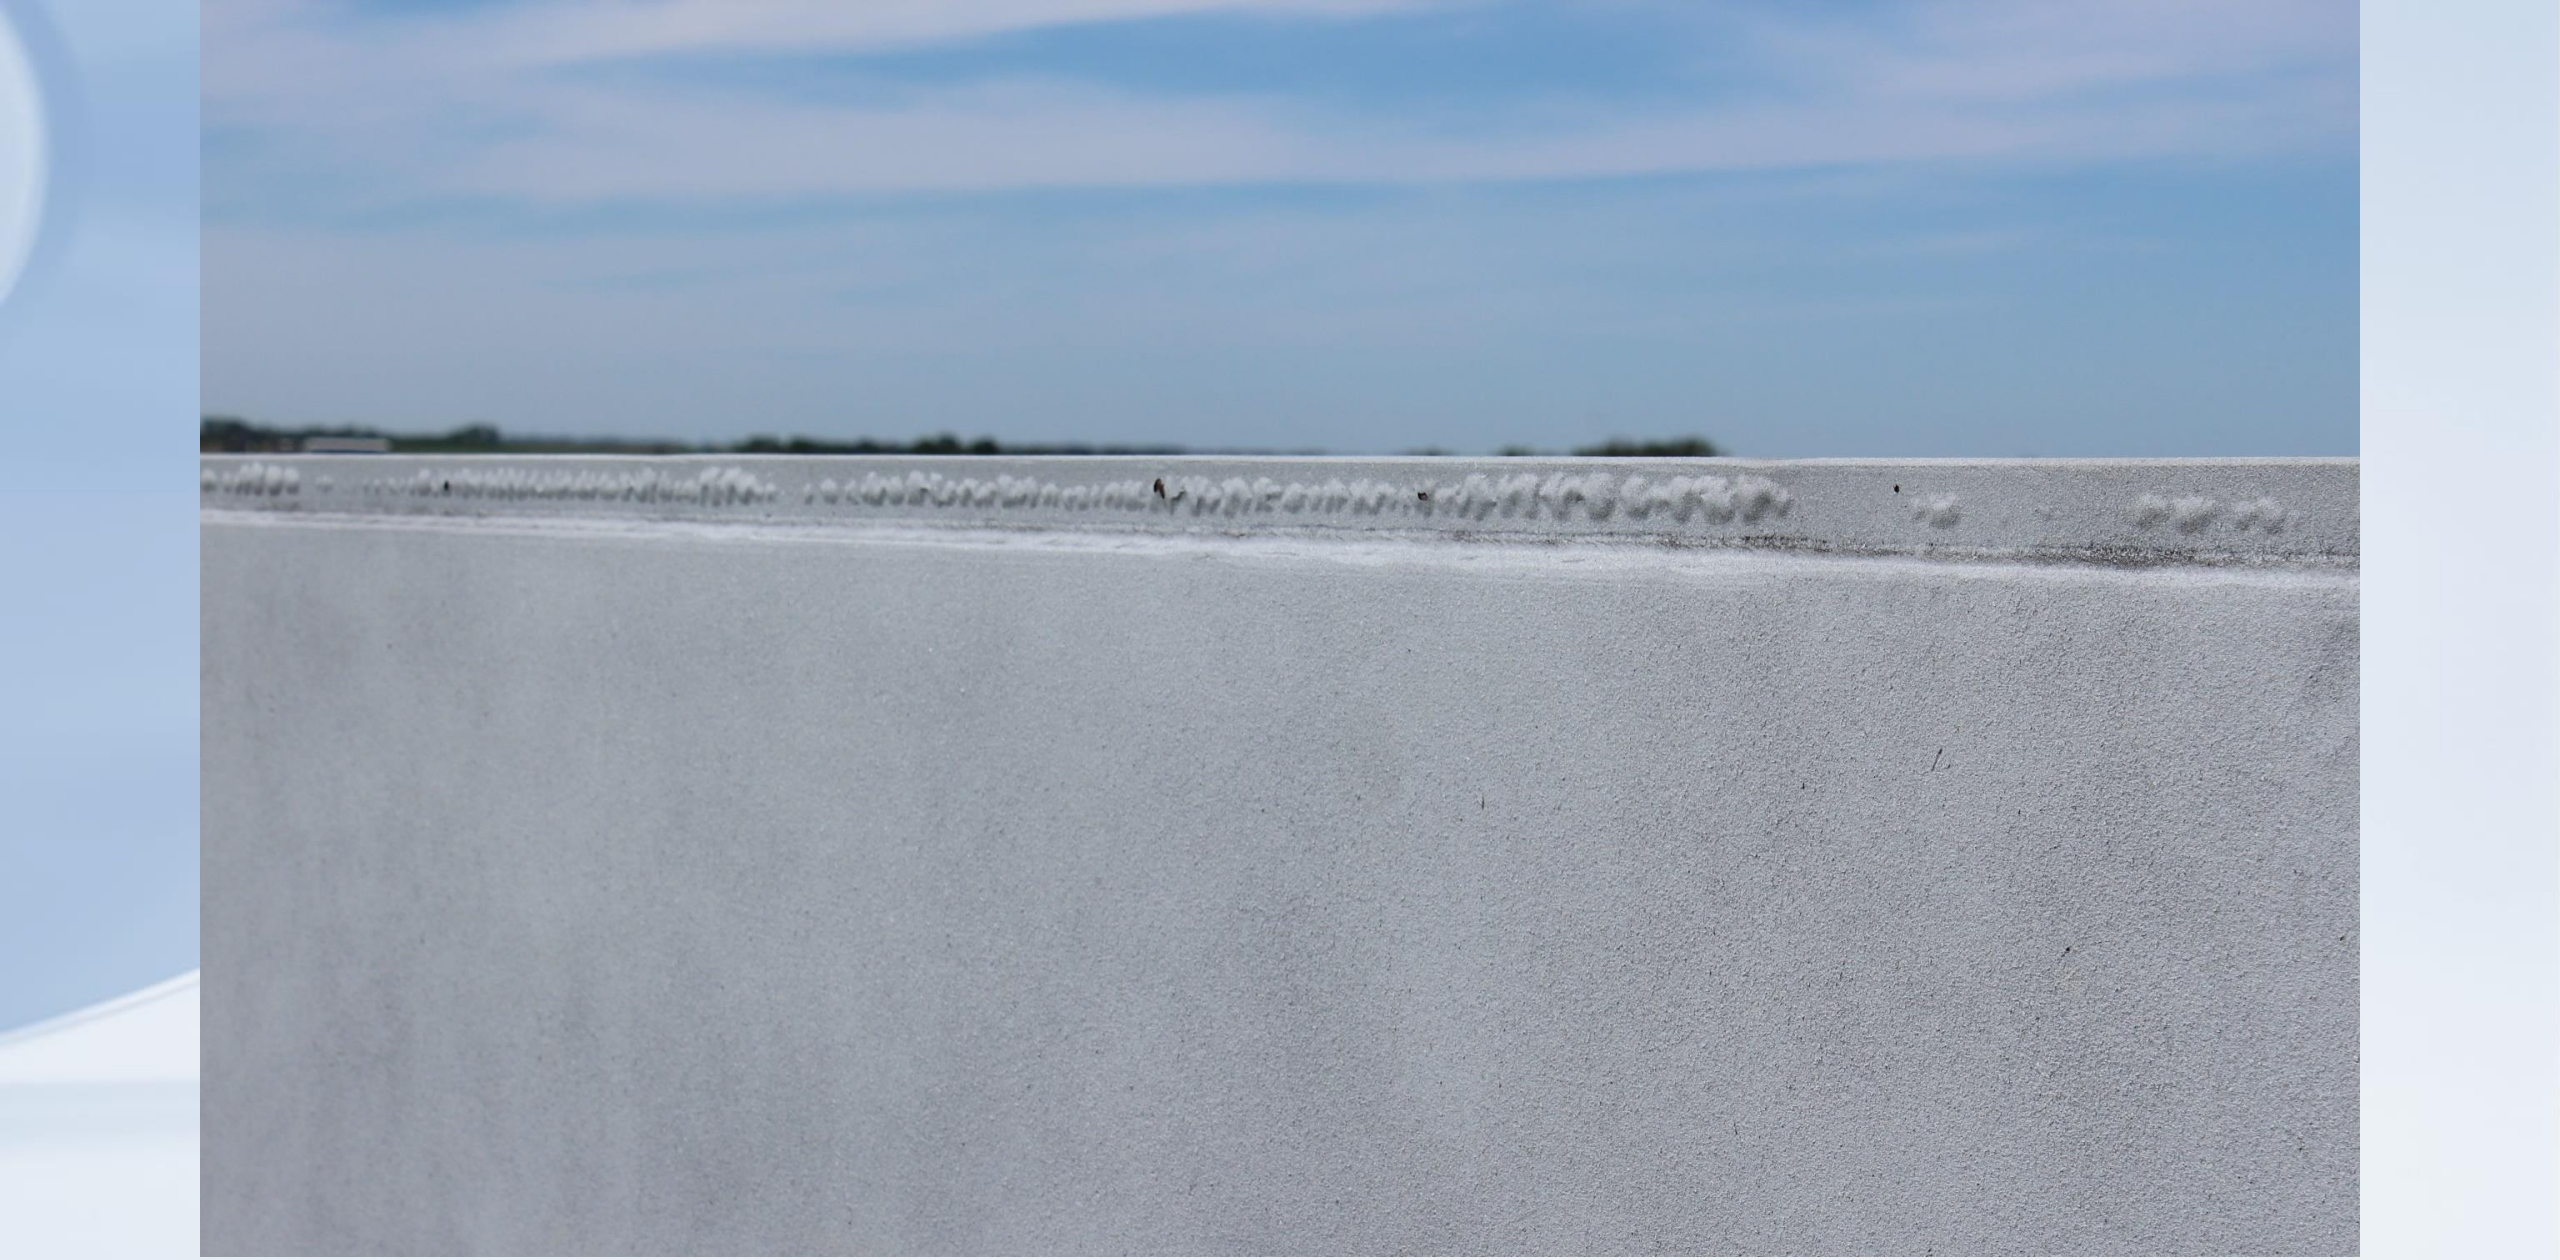
Inspections

- Inspectors started to notice issues with the metallizing in some locations
- Decided we were not sure why this was happening
- Contracted with KTA-Tator for initial investigation to the cause(s) and then another contract to help us address the problem(s)
- SDDOT Developed plan set and let Fall 2023 with construction starting the Spring of 2024

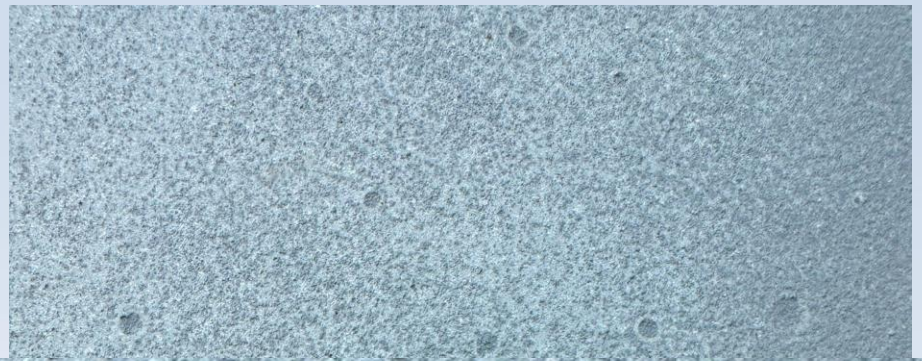
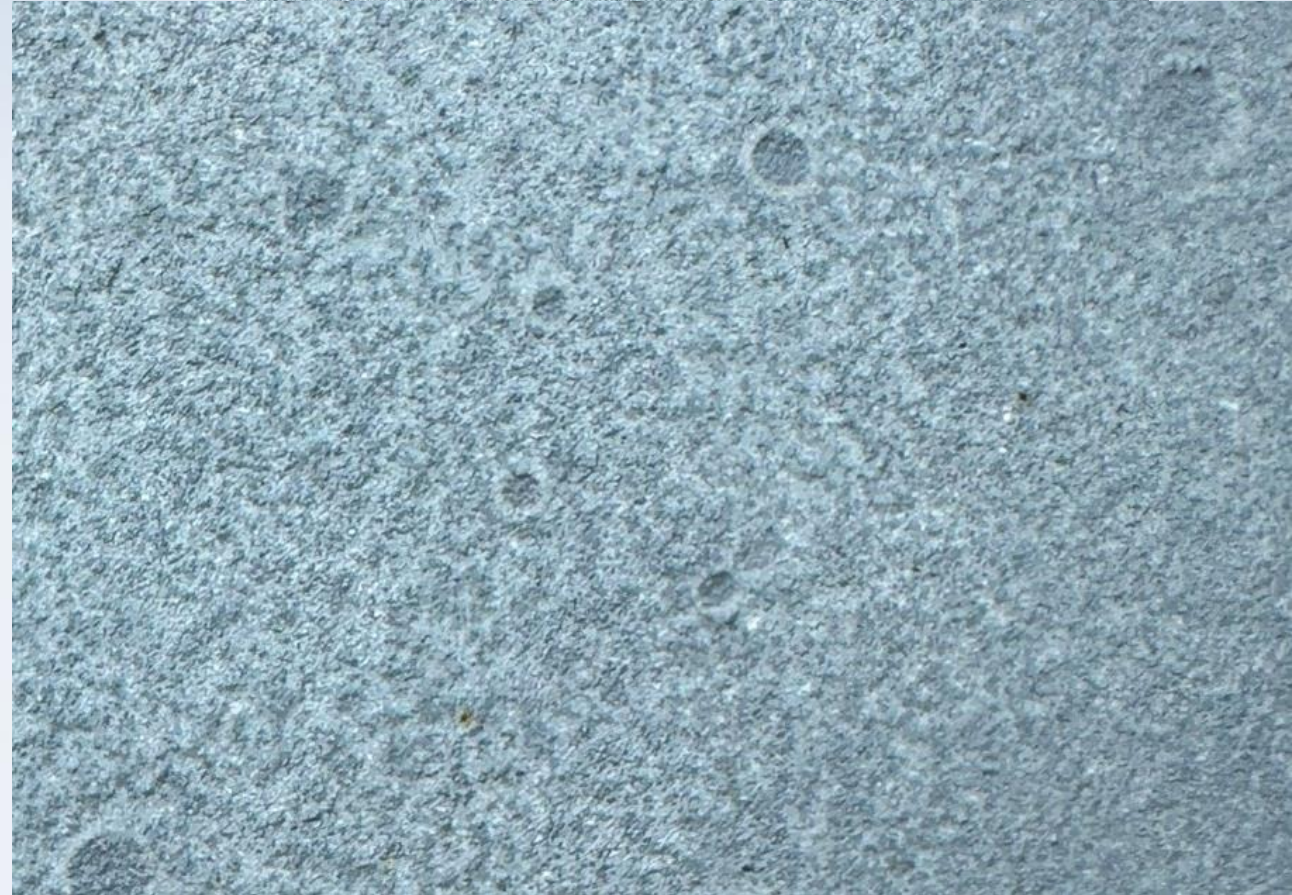
2019 Failure Investigation

- Fabricated, metalized and seal coated in a shop
 - SSPC SP5, White Metal Blast Cleaning; surface profile of 2.5 to 4.0 mils
 - 85/15 Zinc-Aluminum TSM, 10 to 12 mil thick
 - Theoretical 1.5-mil sealer coat applied to all metallized surfaces
- Field repairs reported
