NDE and Live Load Testing

Emergency Investigation of AASHTO Girders

Rebecca Nix, SE
Utah DOT

Shane Boone, PhD, PE
BDI

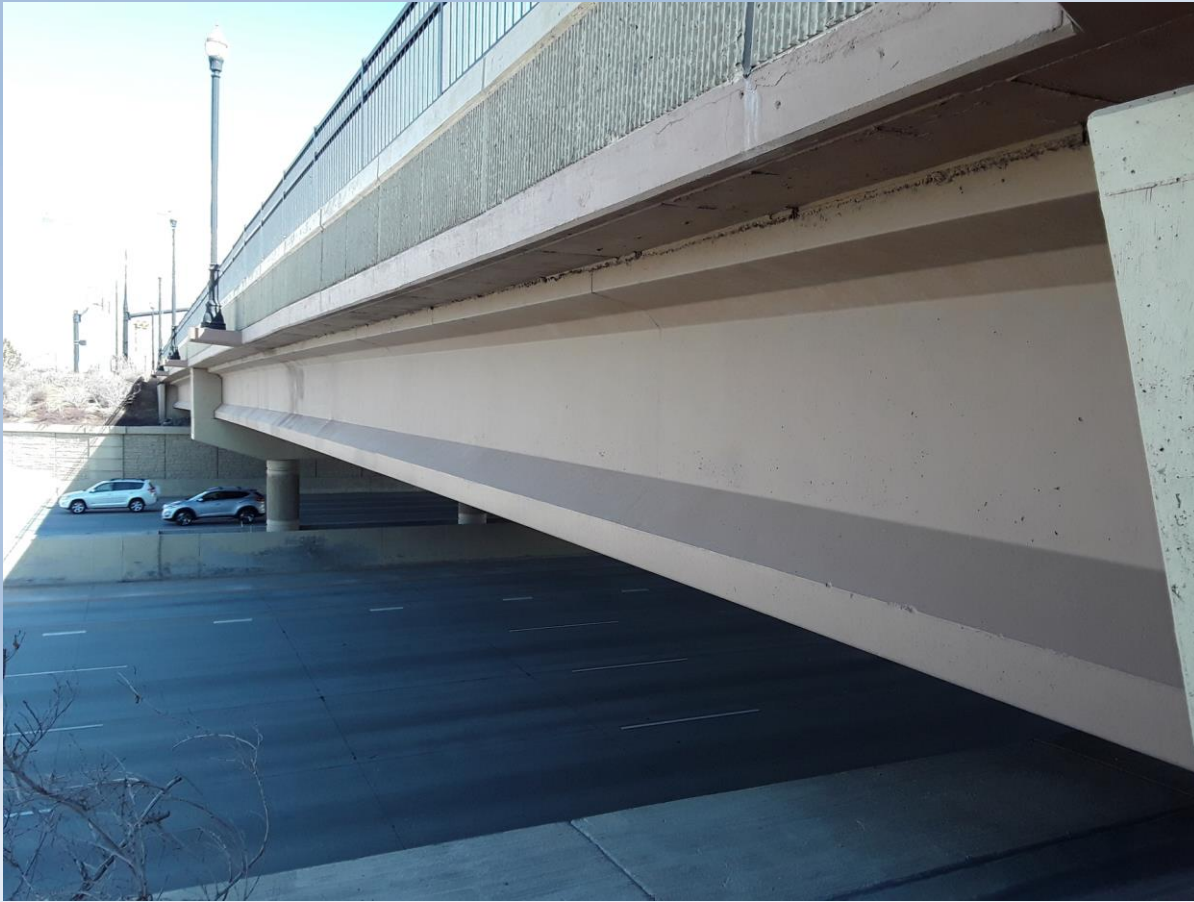
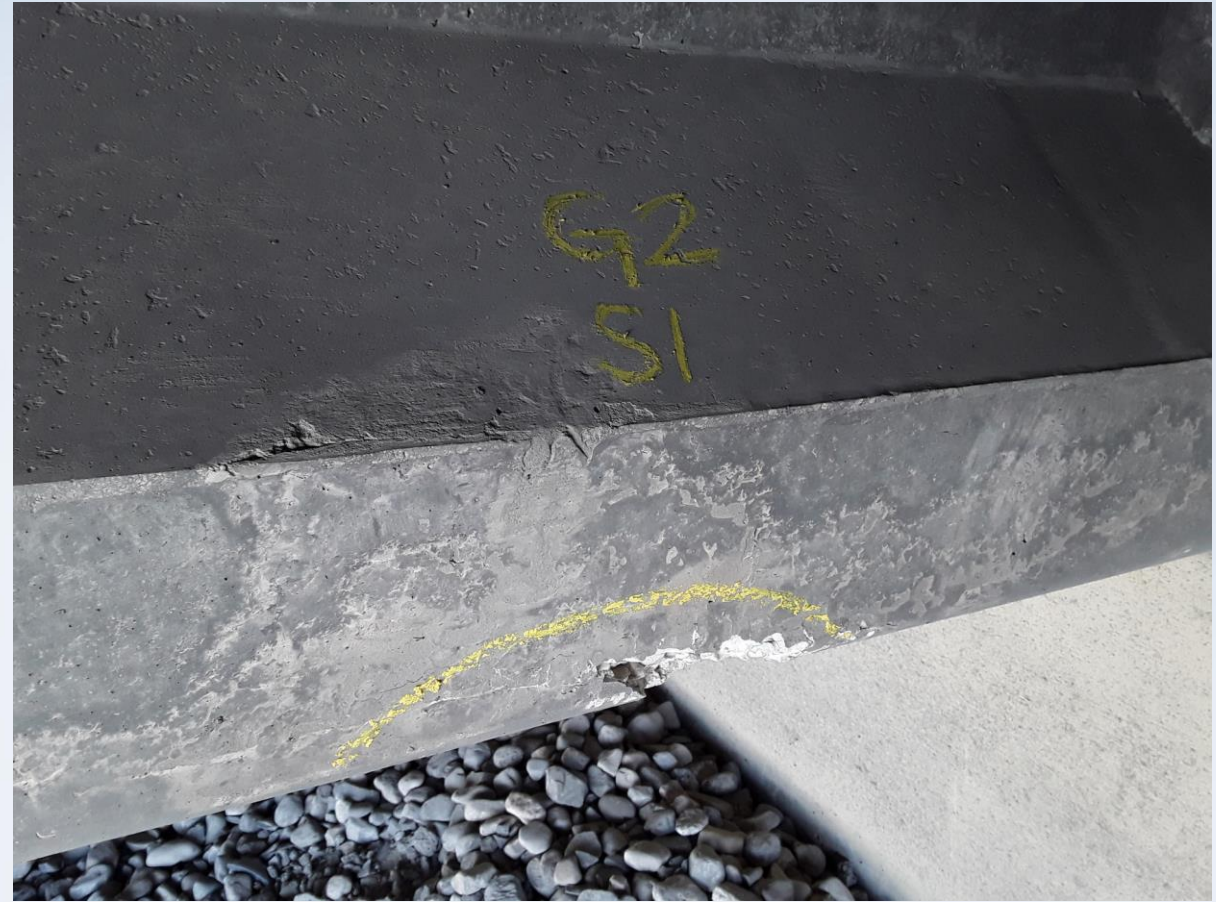
Inspection Background

- Voids in flanges were likely caused by inadequate consolidation and segregation at the time of placement
 - Inadequate vibration/over vibration
 - Stiff concrete mix
 - Delayed placement
- Honeycombing between the prestressing strands may affect the flexural and shear strength along the beam.
- Substandard concrete in thin web precast girders may:
 - Reduce shear strength capacity and thereby reduce the member's load-carrying capacity.
 - Increase cracking and reduce durability.

- Initial Recommendations:
 - Remove poorly consolidated concrete, patch, and fiber wrap
- Final Decision
 - Replace bridge as part of a capacity project
