CASE STUDY OF THE REHABILITATION AND PRESERVATION OF POST-TENSIONED (PT) COMPLEX BRIDGE 690

NATIONAL BRIDGE PRESERVATION CONFERENCE 2024
Innovation for Infrastructure Resiliency

SCOPE OF SERVICES

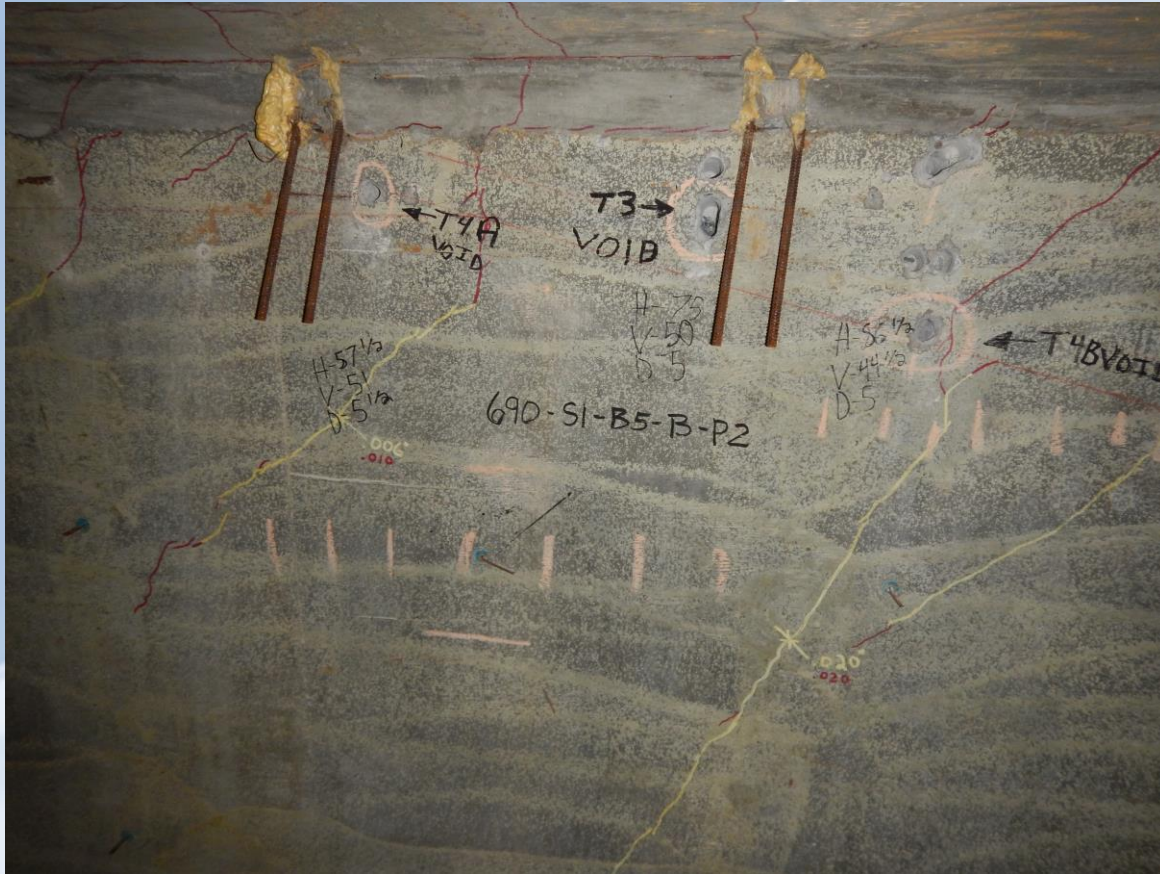
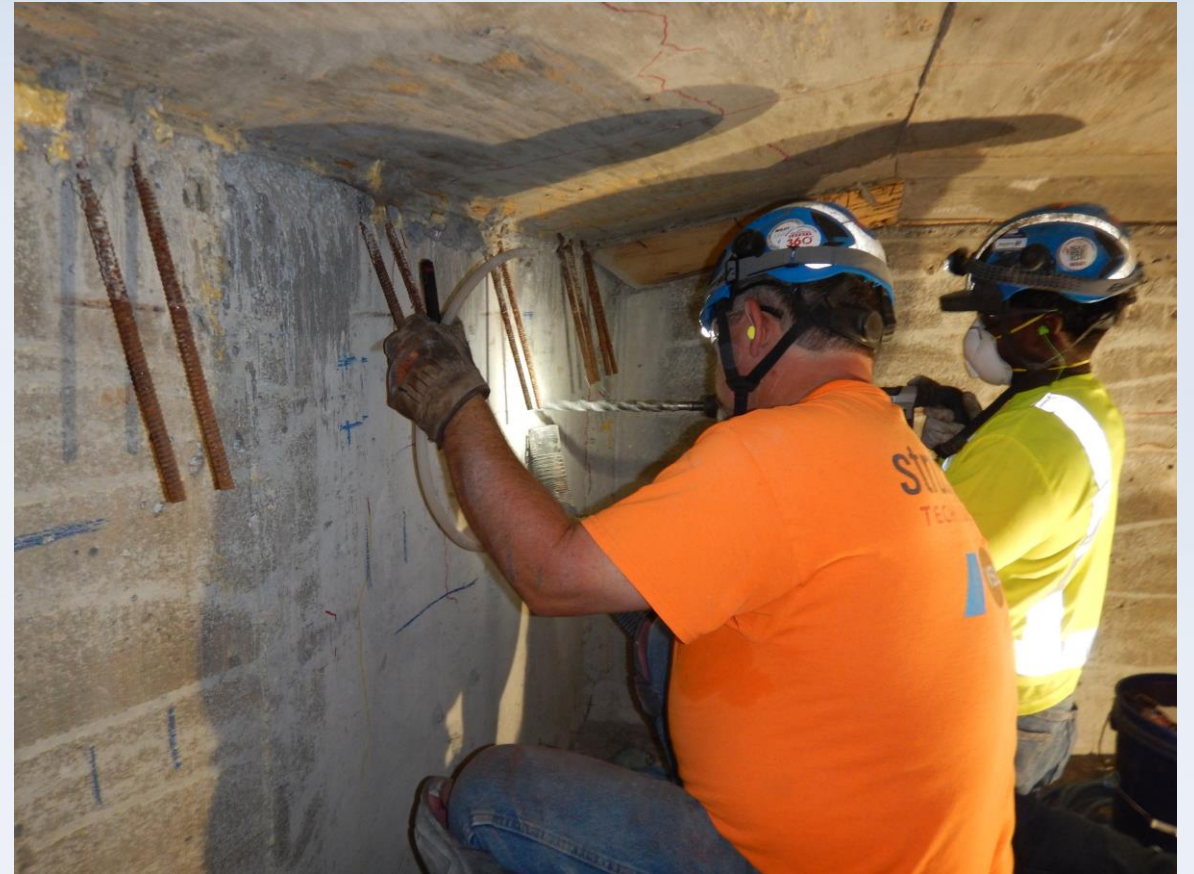
TESTING/INVESTIGATION (P2) GPR SCANNING/LAYOUT & DRILLING

- Phase 2 was broken into two parts (also called phases):
 1. Borescope testing of 40 longitudinal tendon duct locations, two diaphragm tendon ducts, and 3 corrosion rate testing sites.
 2. If a significant number of voids were discovered (**yes this was the case**), the remaining 128 longitudinal tendon duct locations and 6 corrosion rate testing sites were to be investigated.

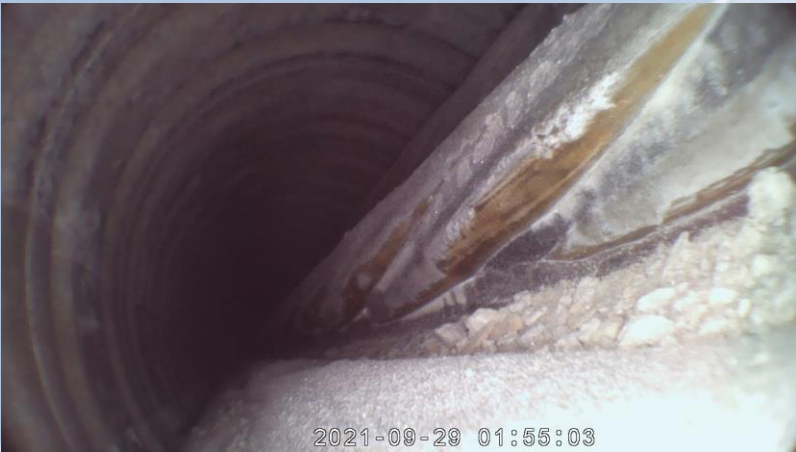
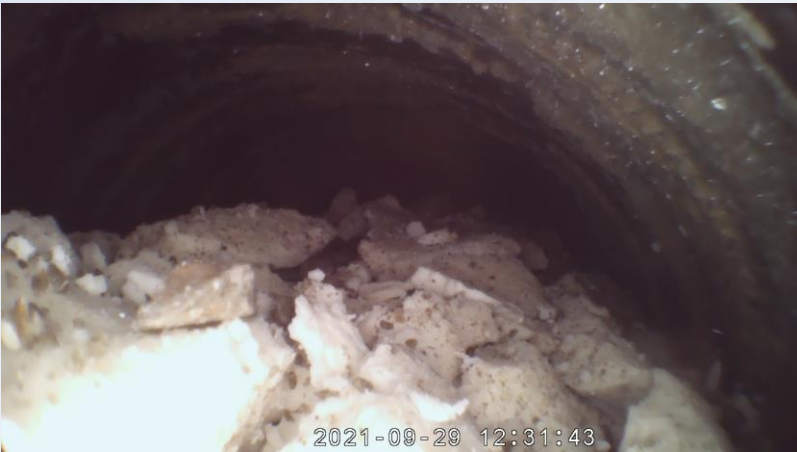
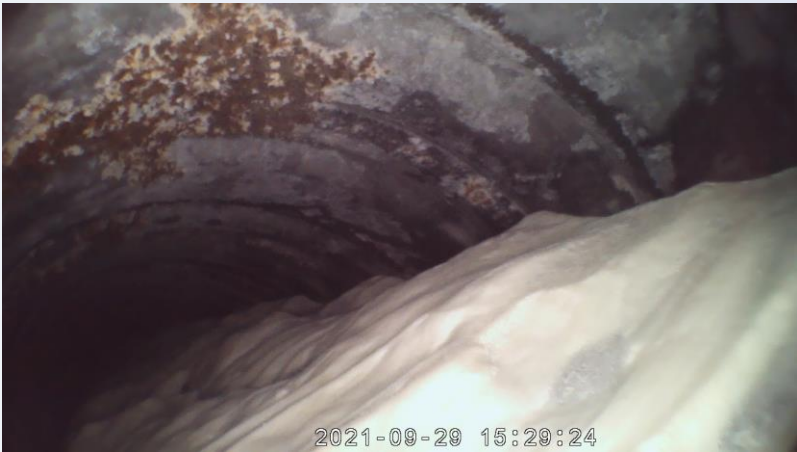
TESTING/INVESTIGATION (P2) INVESTIGATION/BORESCOPE

- Voids were encountered at 100 of 170 borescope locations (59%). Void depths ranged from 0.25 inches to 4 inches (no grout).
- Six locations had visible water. 4 of 6 had standing water which exited during the drilling process.
- Fifty-one locations contained exposed strands.
- Sixty locations contained white/chalky grout pieces (**chunky**).
- Thirty-eight test locations contained white/chalky colored grout (**smooth**).
- Seventy-two locations contained hard, gray colored grout (**hard**).
- Strands were in fair-to-good condition with light corrosion.
- Ducts were in poor-to-fair condition with light to heavy corrosion on the insides.

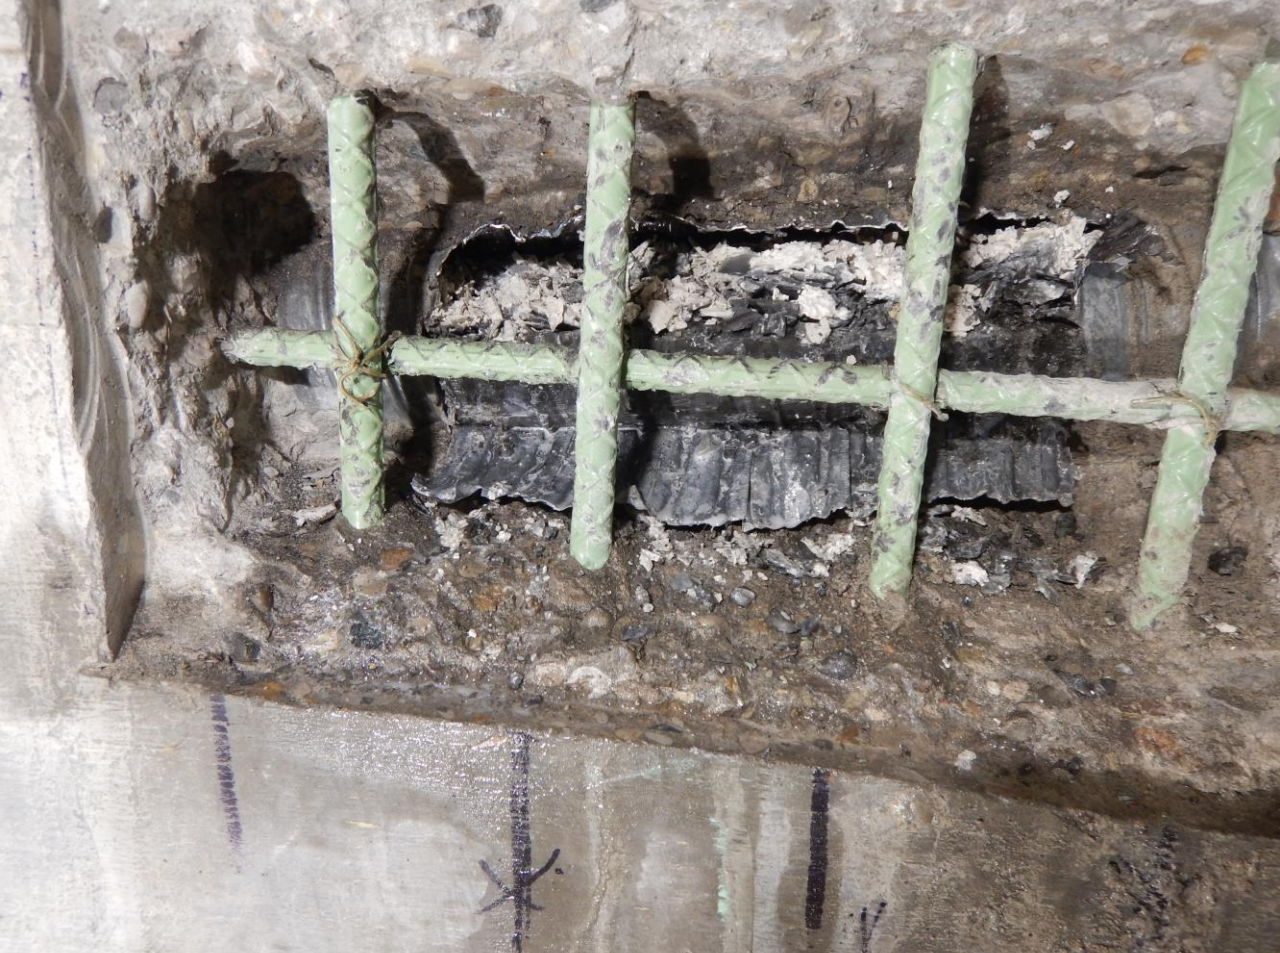
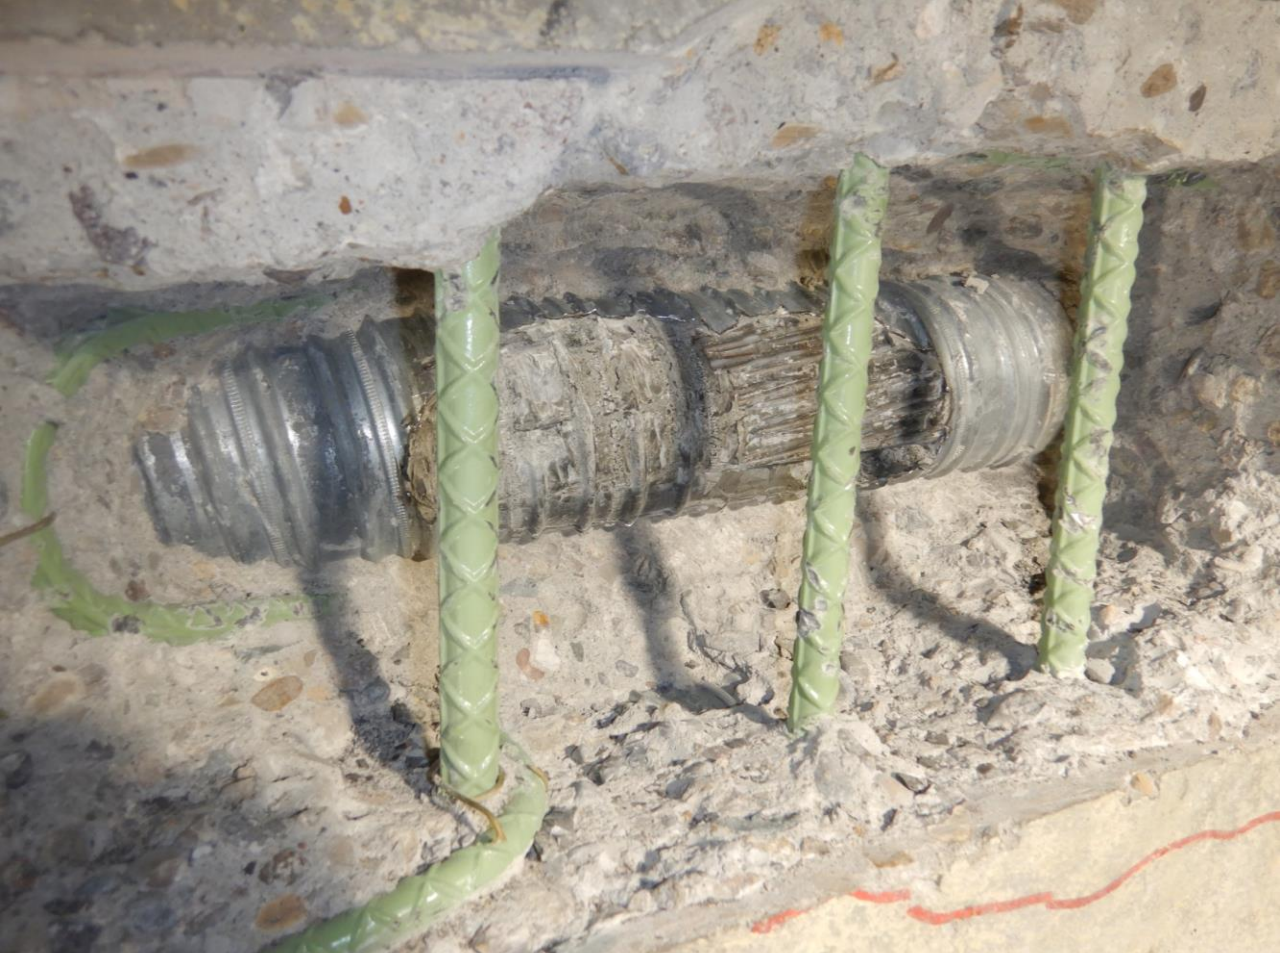
TESTING/INVESTIGATION (P2) CORROSION RATE TESTING/GROUT SAMPLING

- Upper limit of normal moisture content is 25%. Some of the chunky and smooth grout had up to 36.2%!
- Chloride content ranged from 0.011% to 0.042% below the upper threshold of 0.08% for new PT structures.
- Sulfate content ranged from 2.0% to 2.8% within upper threshold limits (3% typically).
- Six of nine locations exhibited a 90% probability of active corrosion (potential), 5 of 6 locations exhibited corrosion on duct interiors and/or strands. Remaining locations had inconclusive results.
- Four of seven locations exhibited moderate corrosion rates.
- Petrographic analysis indicated high pHs of 12 and above while within the duct. When exposed to air, carbonation took effect reducing the pH.
- Of the two borescope tests performed for the diaphragm tendons of pier 3, no deficiencies were found.

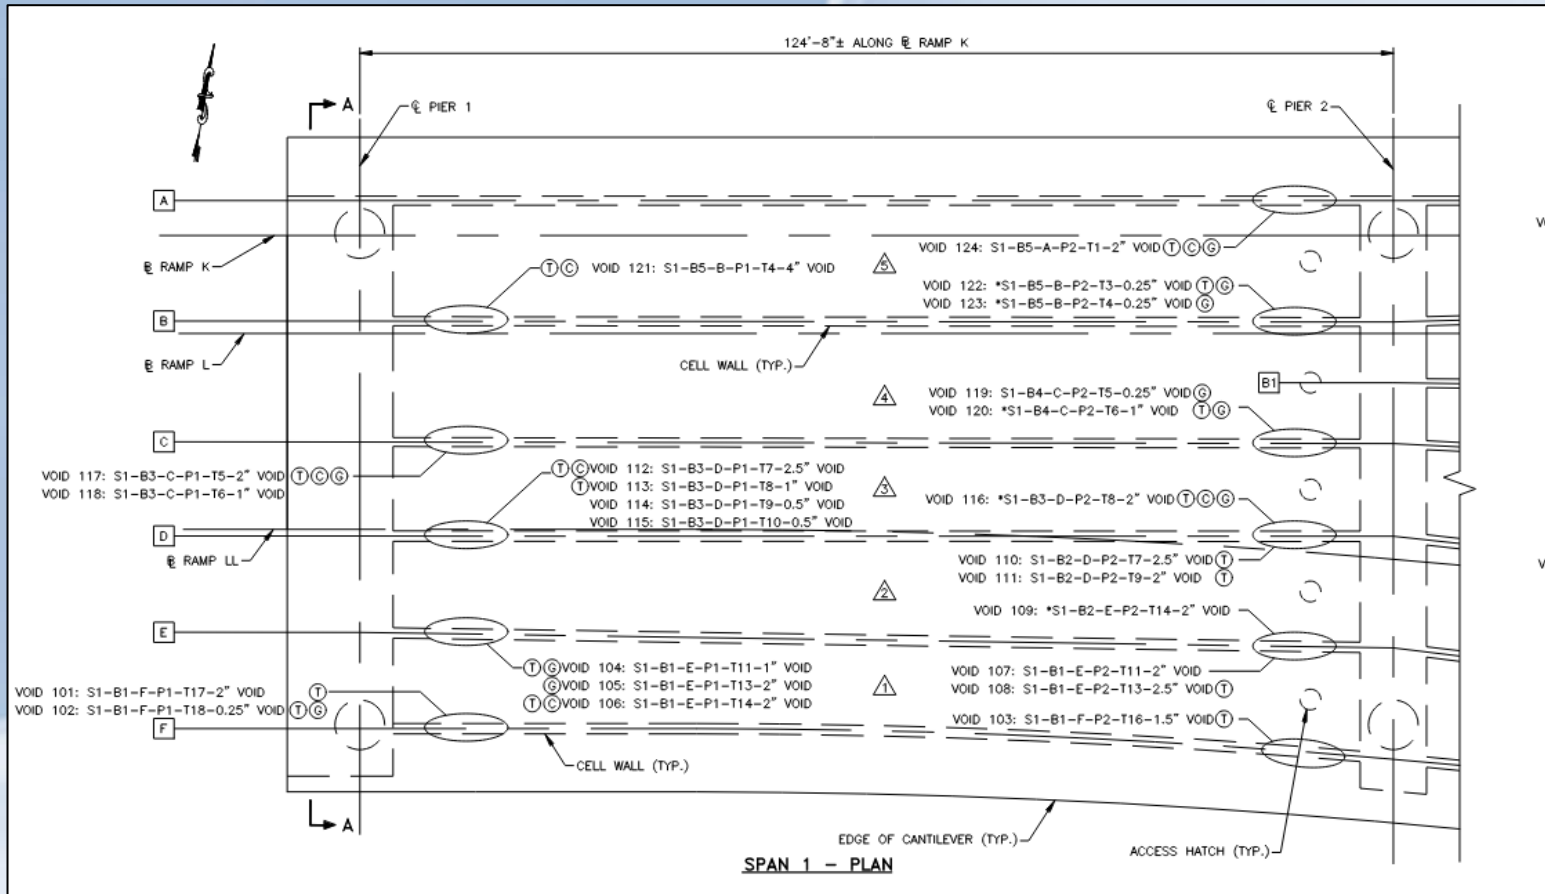
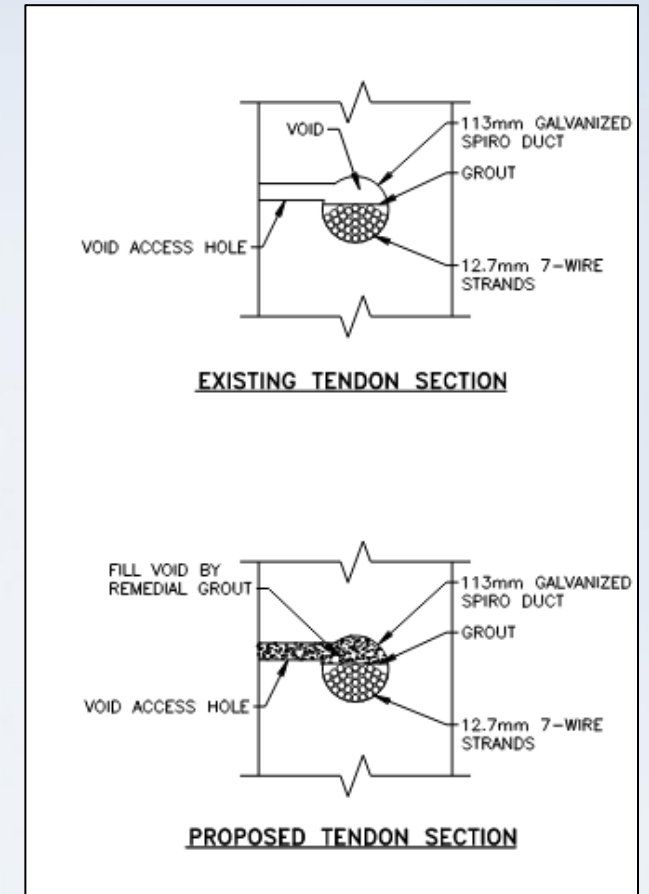
REPAIR PLANS (P3) PLAN SETS

- Void ID
- Dimensions/Location of to perform grouting.
- Void depths
- Continuous voids
- Exposed tendons
- Chunky grout (locations with pieces of grout in duct).
- Water/moisture
- Corrosion present
