TxDOT In-House Bridge Repairs

Seth Cole, P.E.

TxDOT Bridge Division

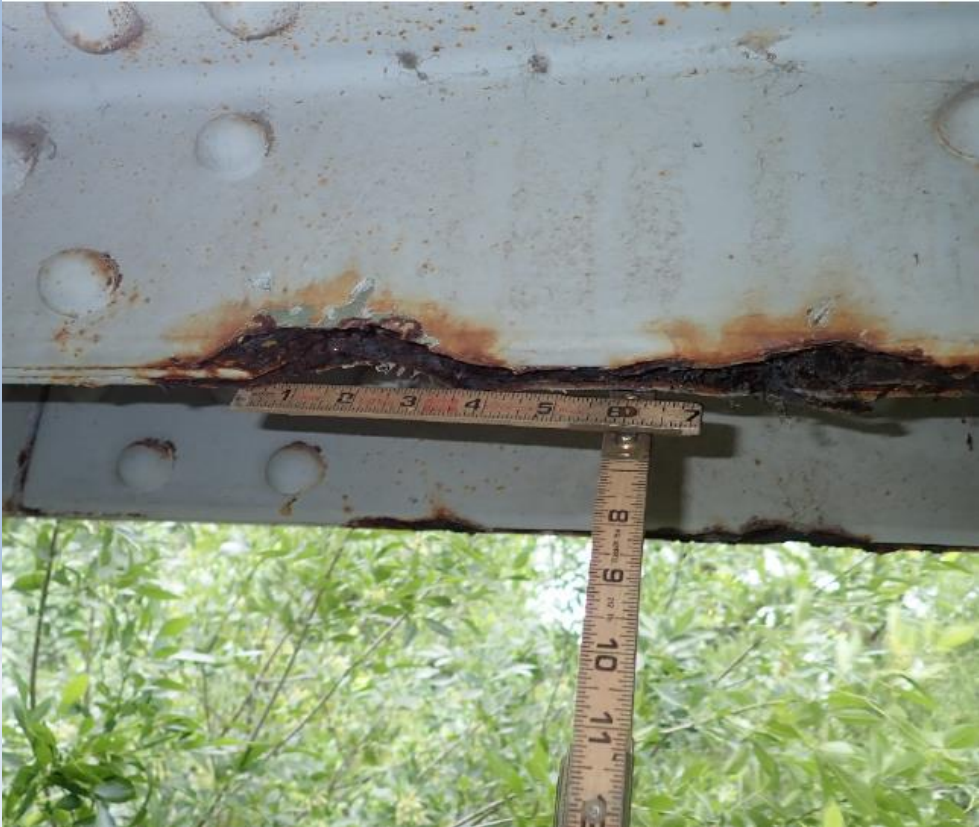
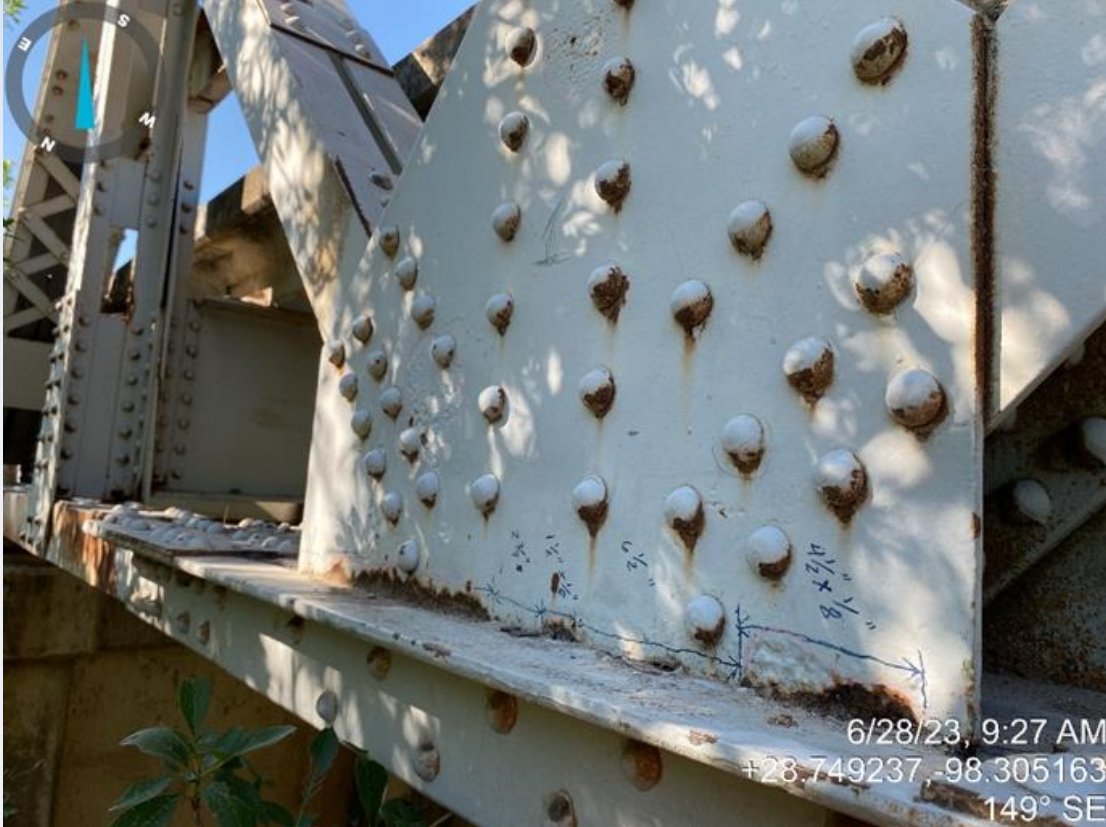
Truss Repairs – San Antonio District

- US 281A @ Atascosa River
- Built 1925
 - Single span, warren pony truss
- Advanced section loss in gusset plates and lower chord, prompting a reduction in load posting
- Replacement in 1-2 years
- Goal – avoid reduction in load posting until replacement

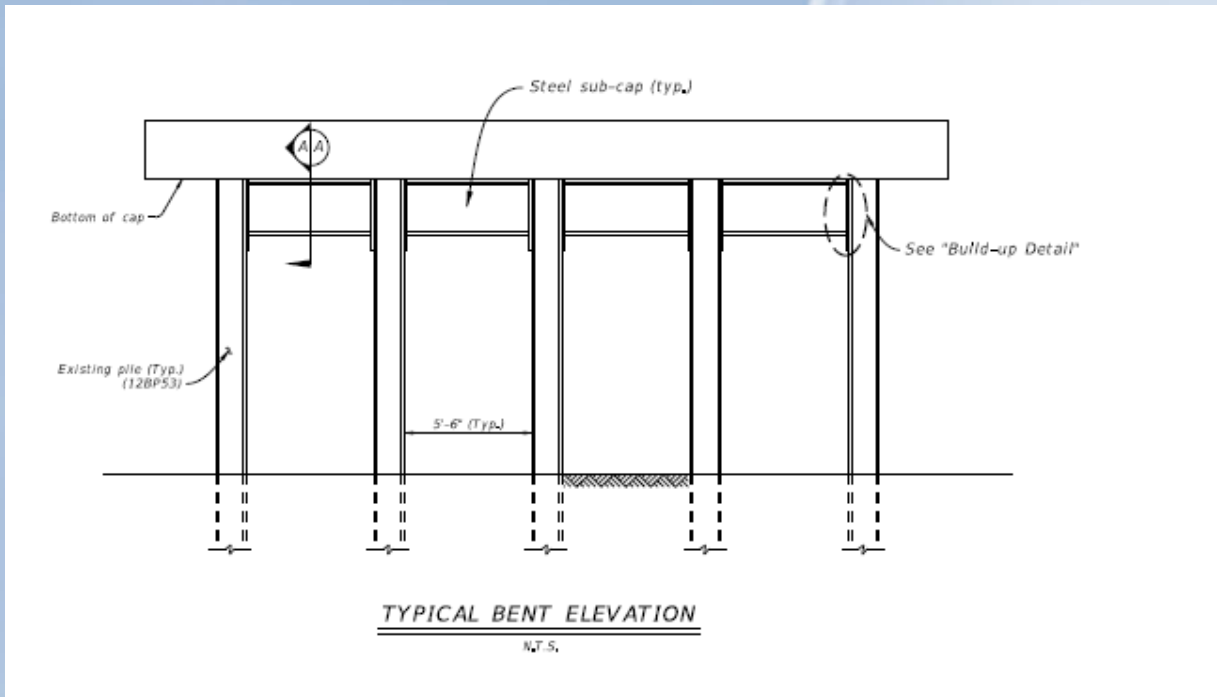
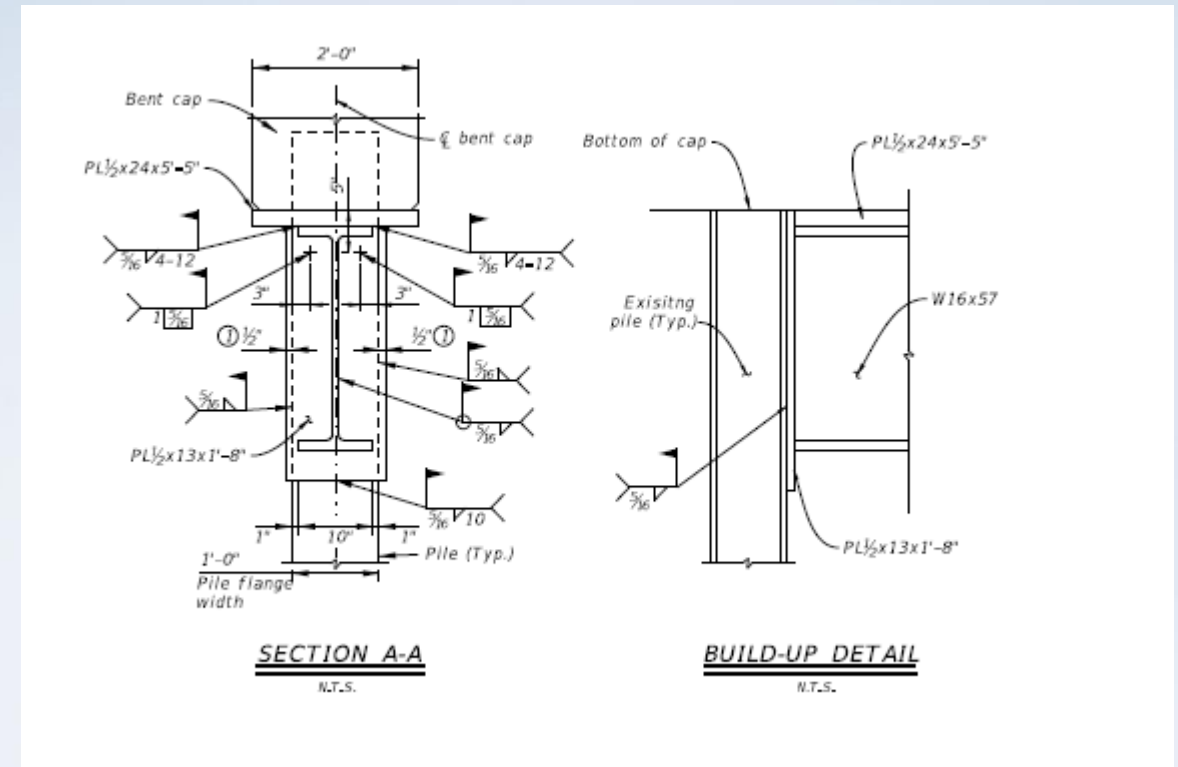
Steel Cap Retrofit – Childress District

- SH 70 @ Quitaque River
- Built 1965
 - CIP “Pan girder” bridge
- Advanced section loss in primary cap reinforcing, prompting a load posting
- Replacement in 3-4 years
- Goal – avoid load posting until replacement

- Considered Vertical/Overhead Concrete Repairs with CFRP
 - Estimated at over 1,000 SF
 - Many previous VOH repairs
 - Cost
 - CFRP strengthening system
 - Large quantity of concrete repairs
 - Time
 - Quicker to do in-house

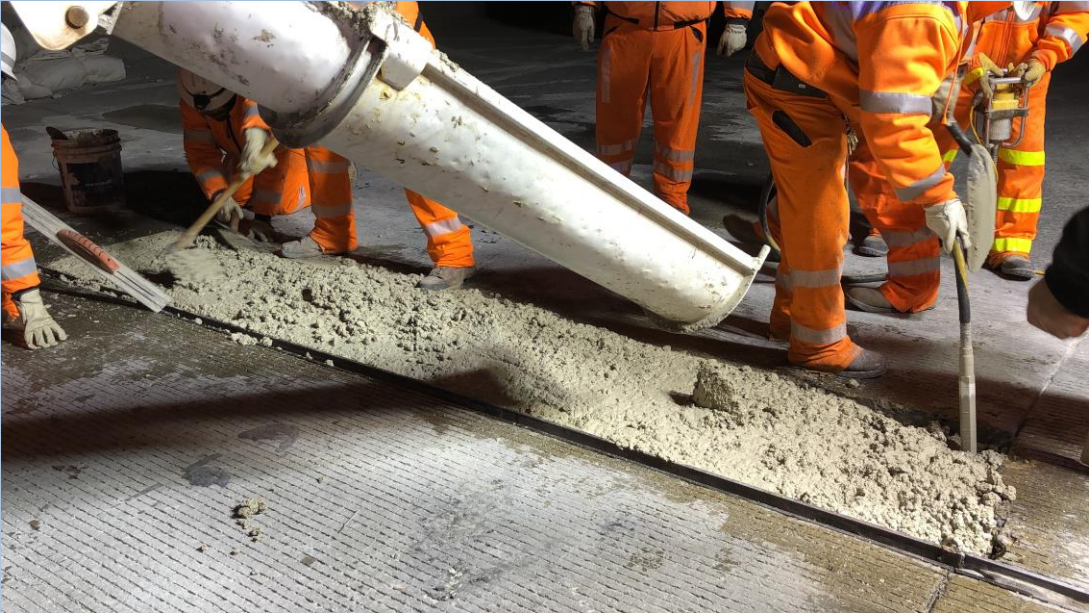
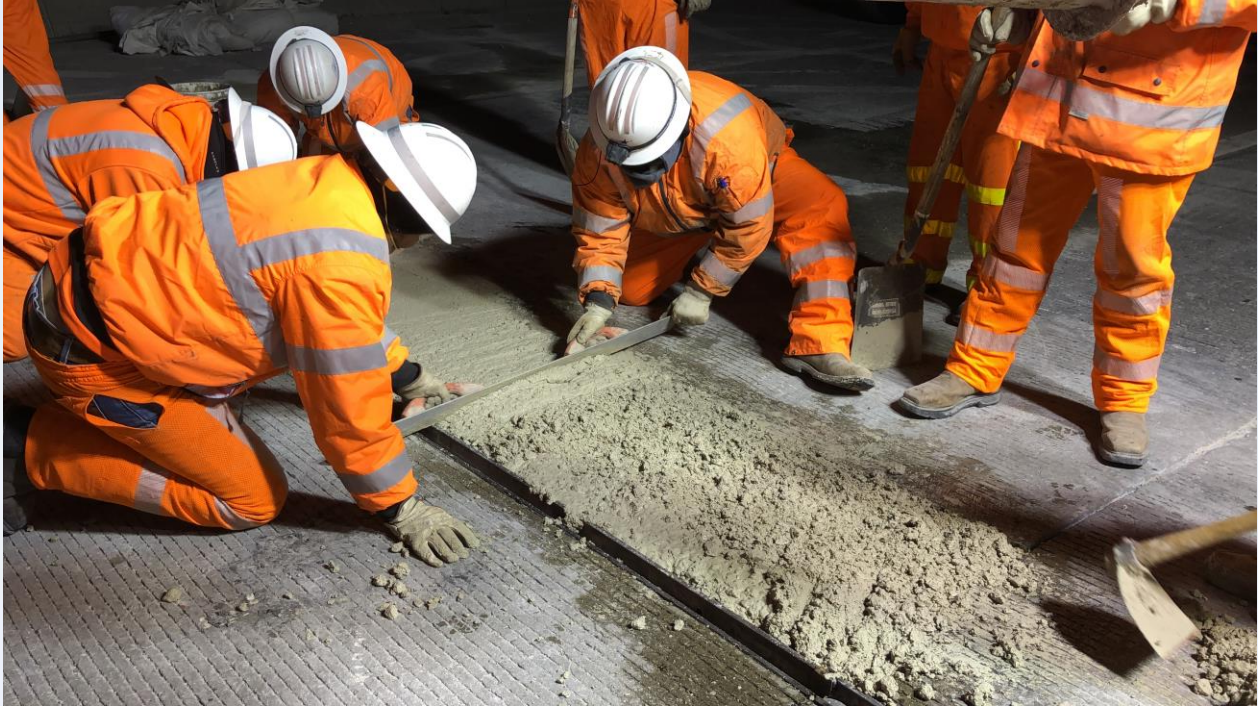
Joint Repair – El Paso District

- IH 10 WB @ Geronimo
- Built 1990
 - Prestressed Conc. Box Beams
- Major spall in deck and loose armor plate
- Emergency Repair – week before Christmas!

- Repairs performed at night using partial freeway closure

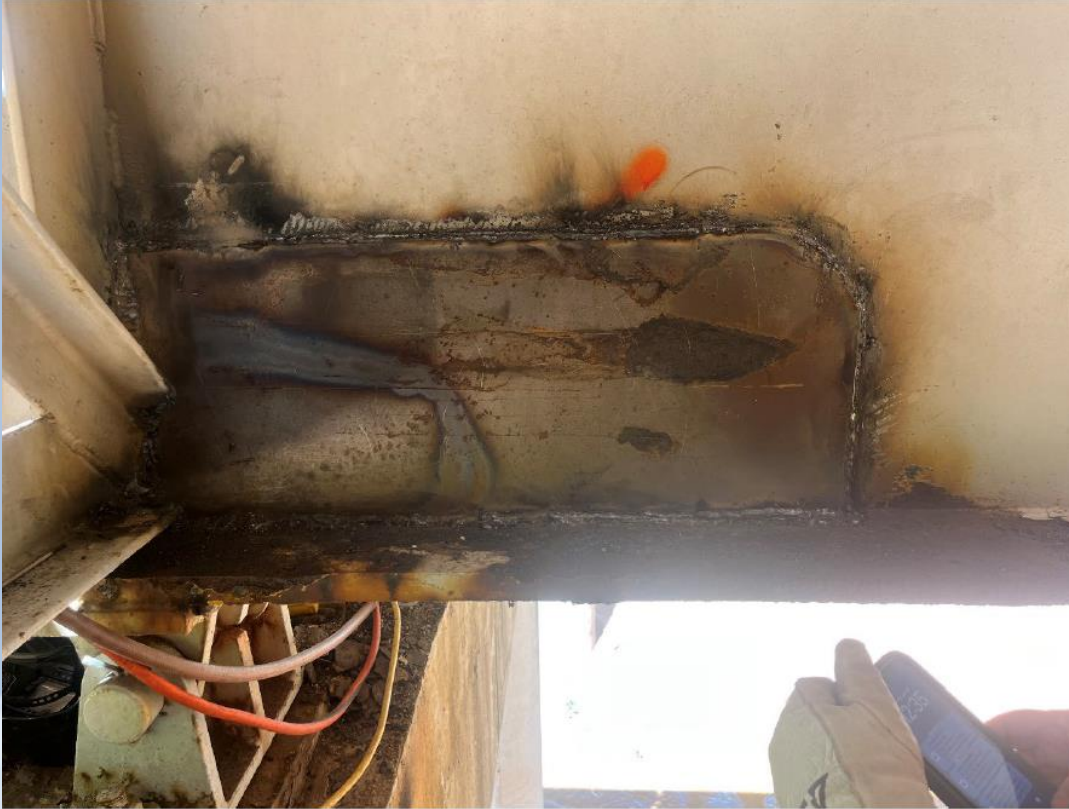
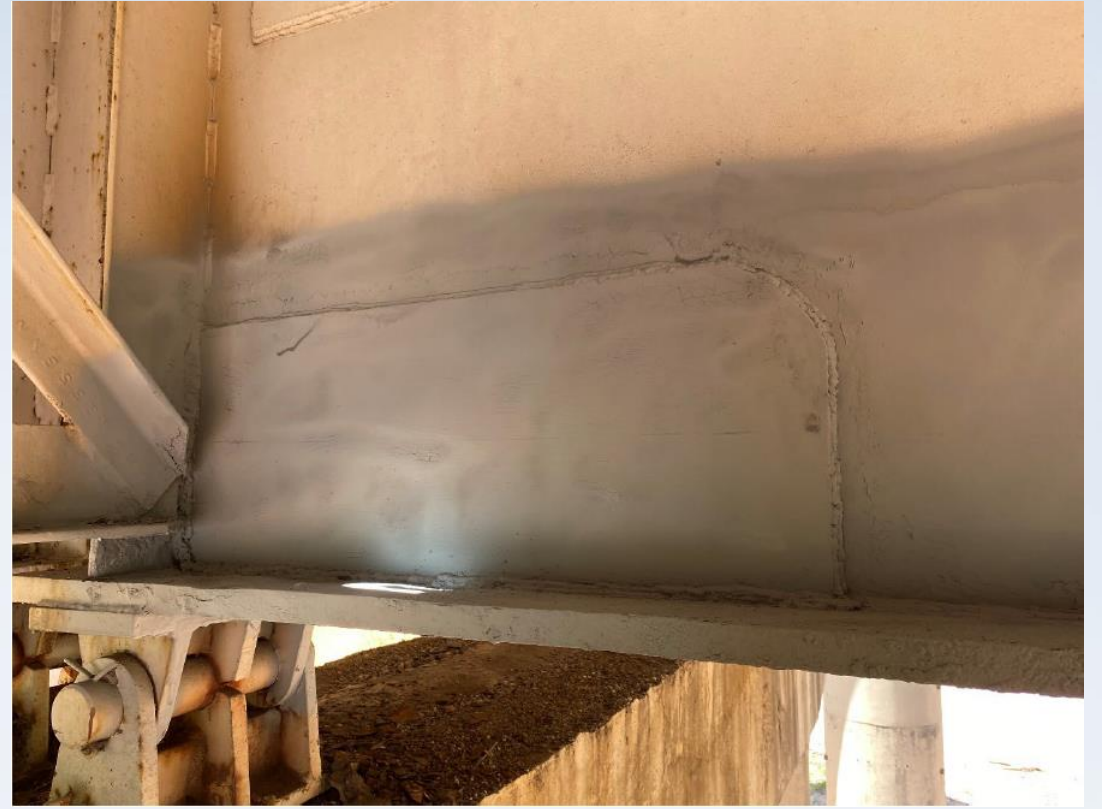
Steel Web Repair – Wichita Falls District

- IH 35 @ Red River
- Built 1957
 - Steelplate girder bridge
 - 48” webs
- Inspection – Oklahoma
- Maintenance - TX
- Advanced section loss at beam end prompting critical finding

- Collaborative effort between Bridge Division and Wichita Falls District
- Bridge Division designed repairs
- Wichita Falls district performed the work (in-house certified welder)
- Bridge Division provided snooper for access
