MALP Stops Corrosion but Can We Live with the Cracks?

Coatings & Corrosion Protection Session I
Tuesday September 10, 2024
Imperial Ballroom C/D

Walt Peters P.E.
wpeters@odot.org

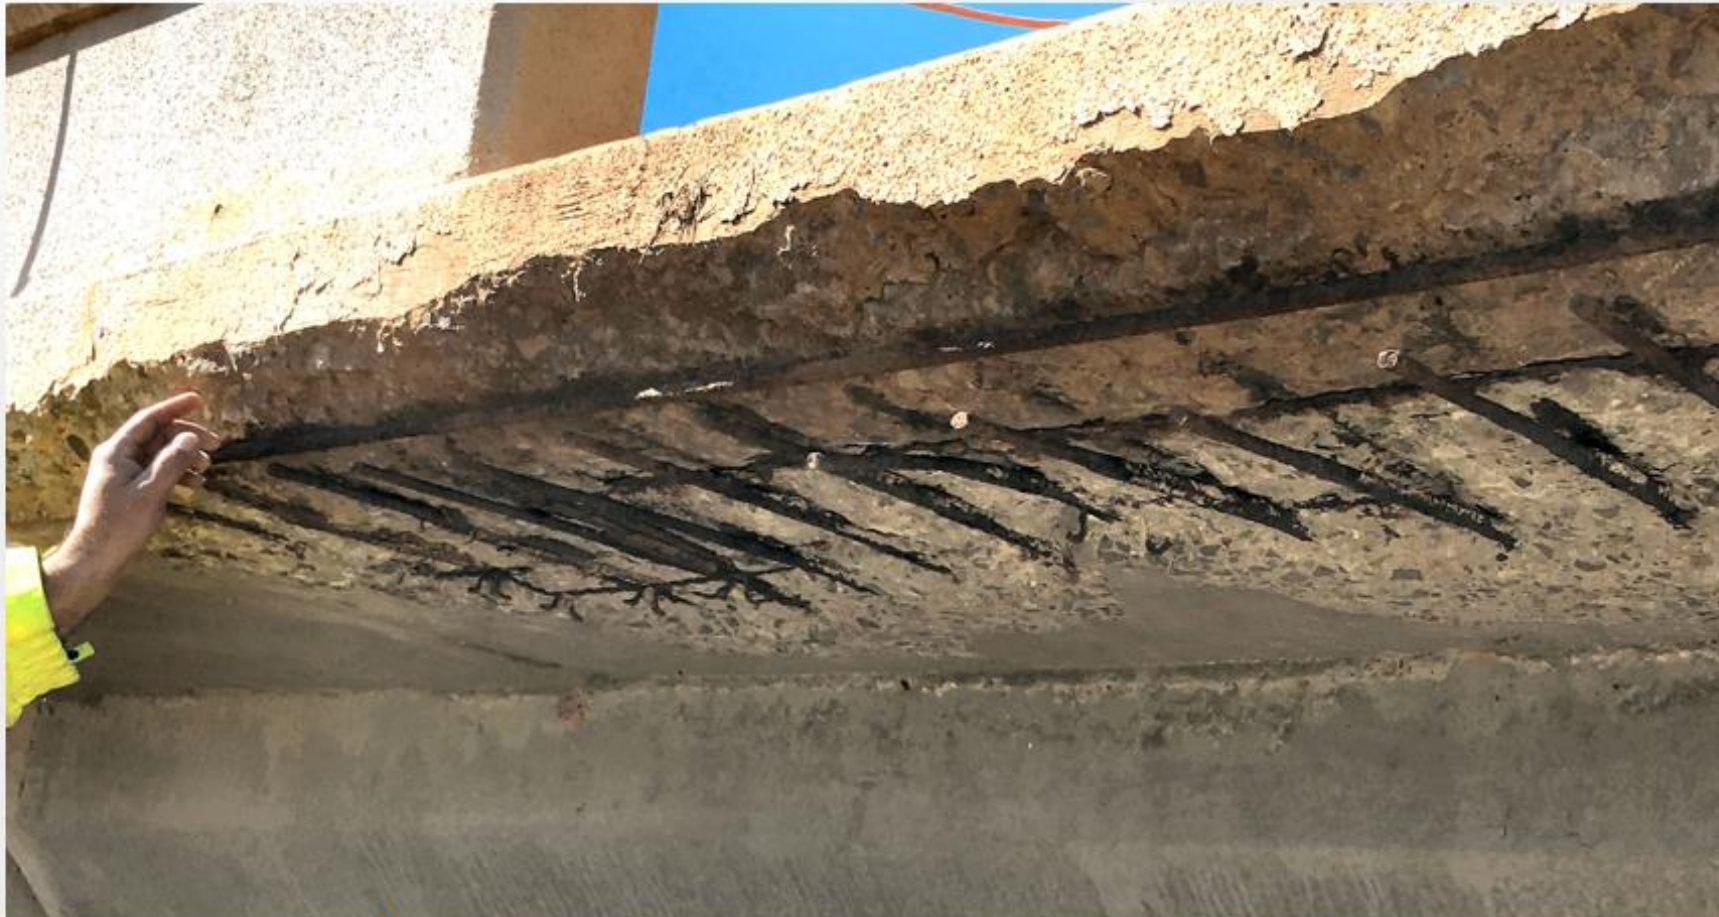
Packsaddle Bridge – Repaired March 1, 2017

Very Little Surface Preparation Required

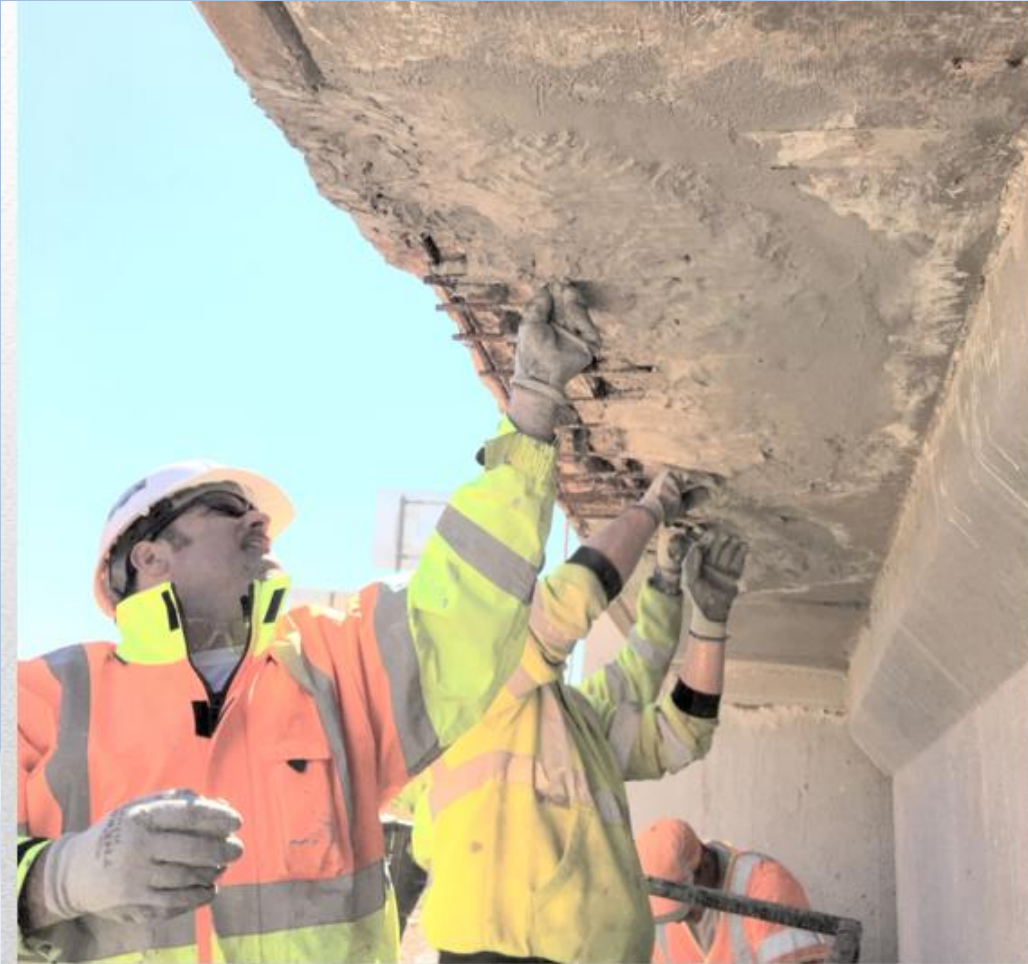
MALP - Packsaddle Bridge Repair

NBI 21132, US-283 over South Canadian River, Roger Mills – Ellis Counties

**Labor intensive
minimal
training
required
Note that
application
does not
require a lot of
skilled labor**

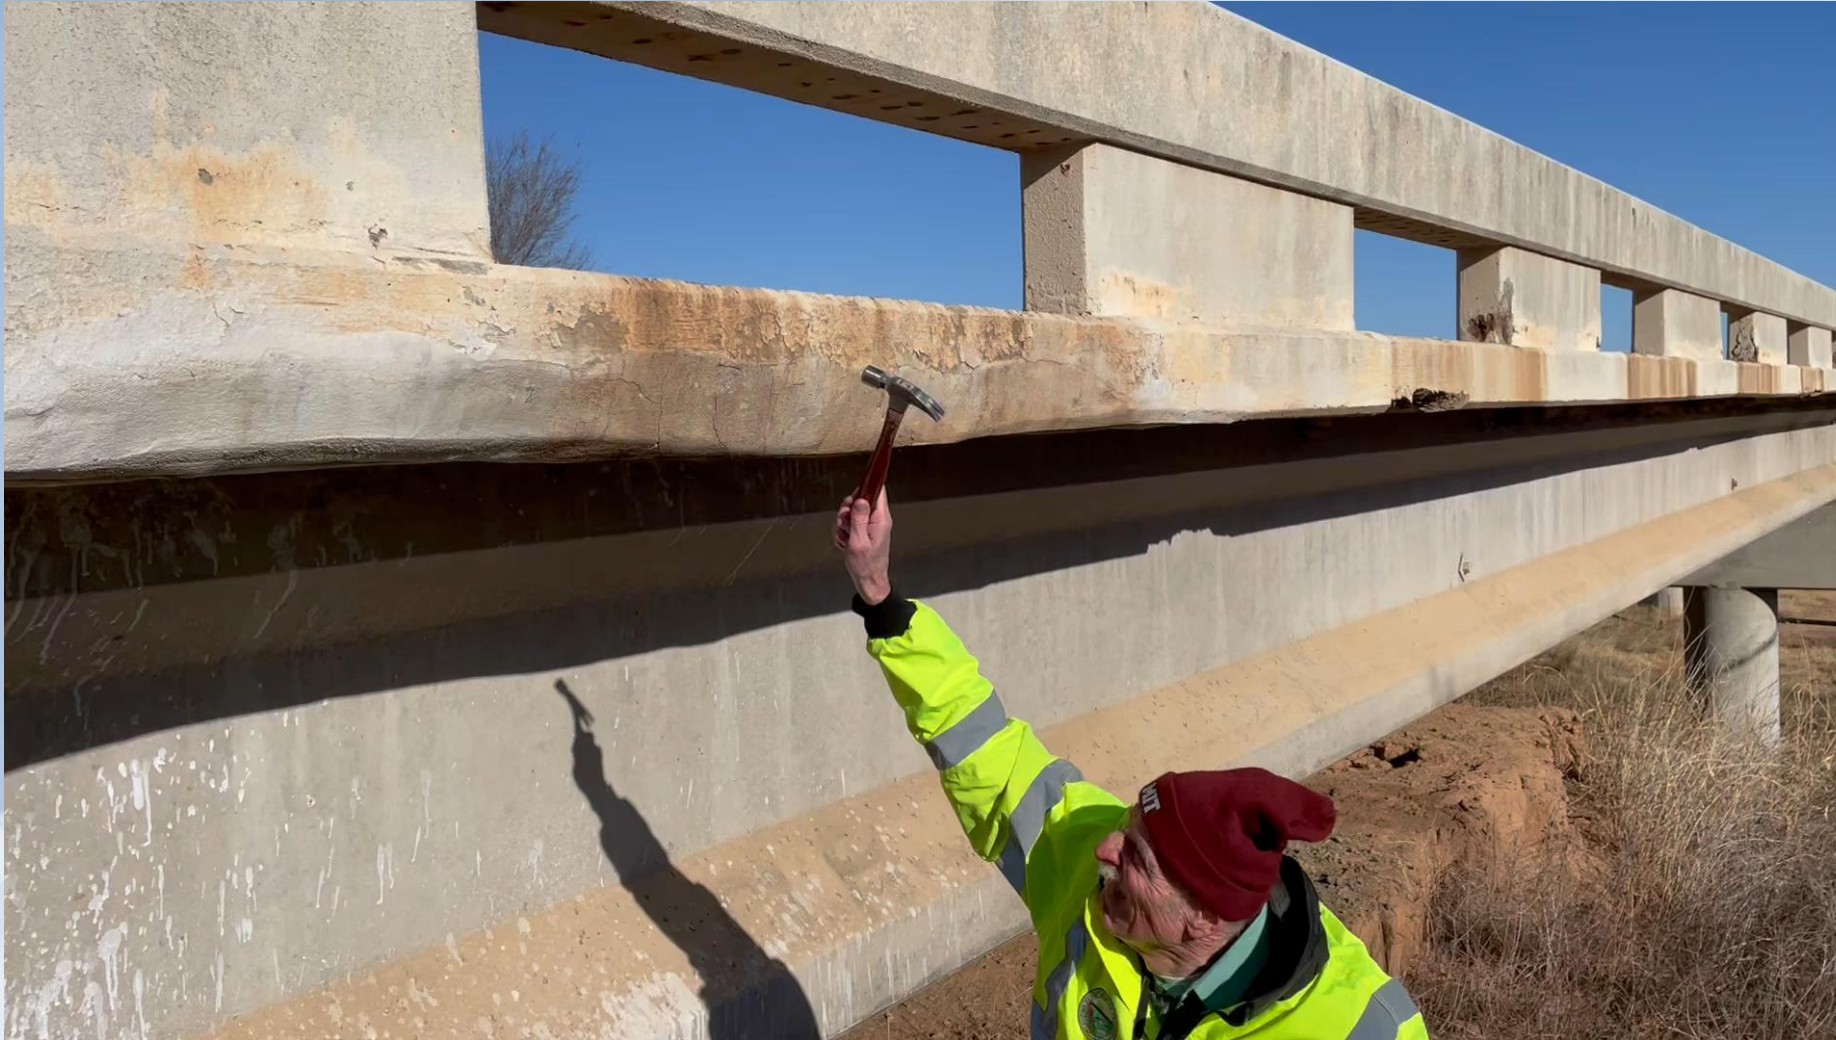
Cracks felt very solid when tapped with a hammer.

**Hammered on
the bridge in
2023 and 2024.
Video was
made in
February 2023.**
