# Investigation and Repair Design of Impacted Damaged Bridge Steel Superstructure in Nevada

# I-1255

Winnemucca Blvd (SR 289)  
Over Interstate 80

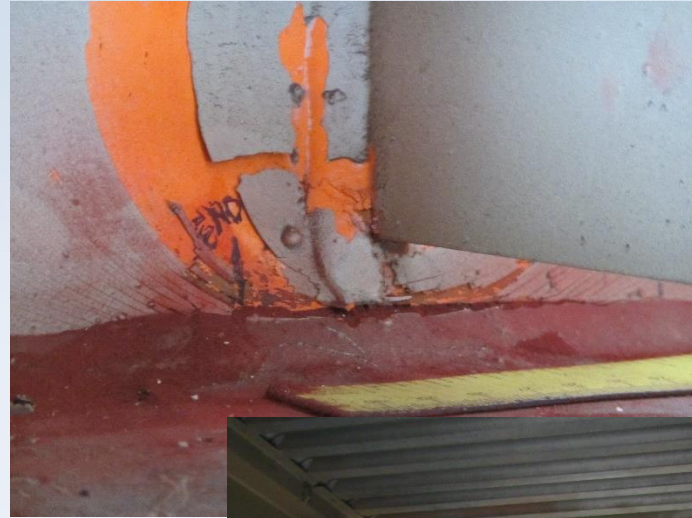
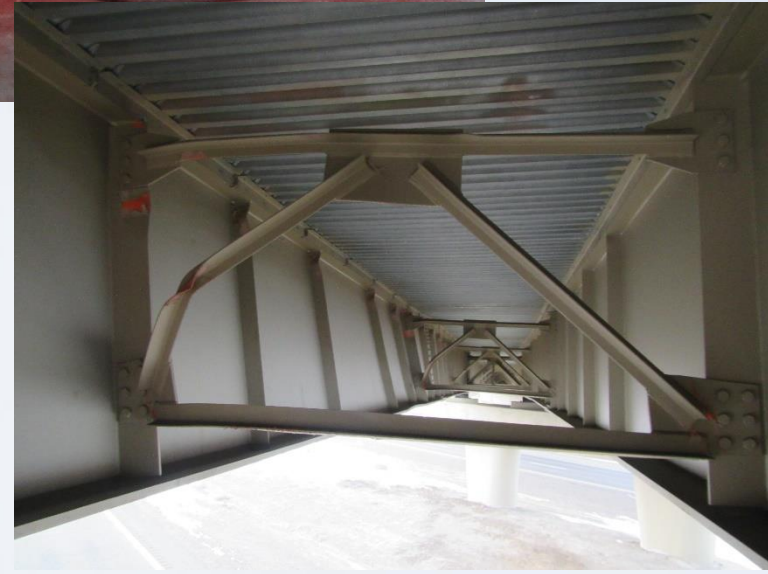
- Girder 3
  - Crack at Diaphragm 4
  - Crack between Web and Floorbeam
- Diaphragms
  - Buckled in Bay 1 and along impact line in Bays 2 and 3

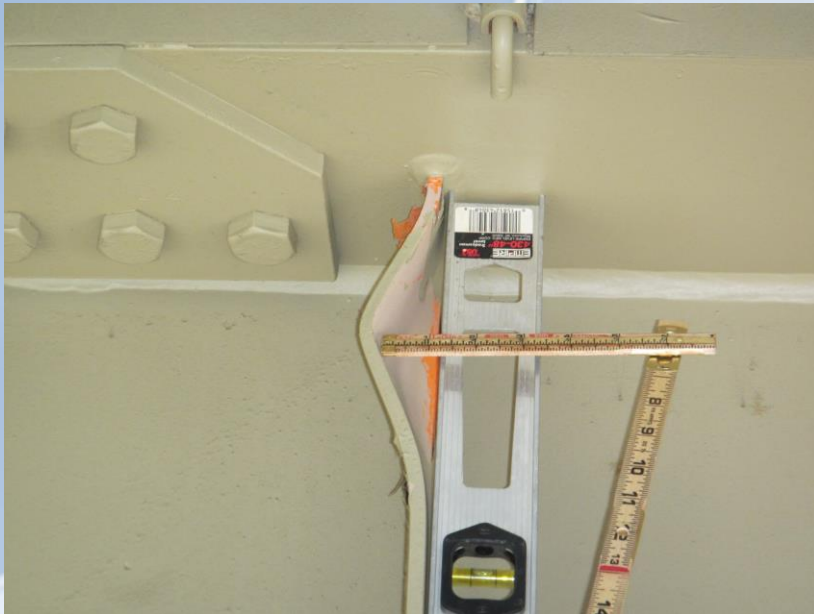
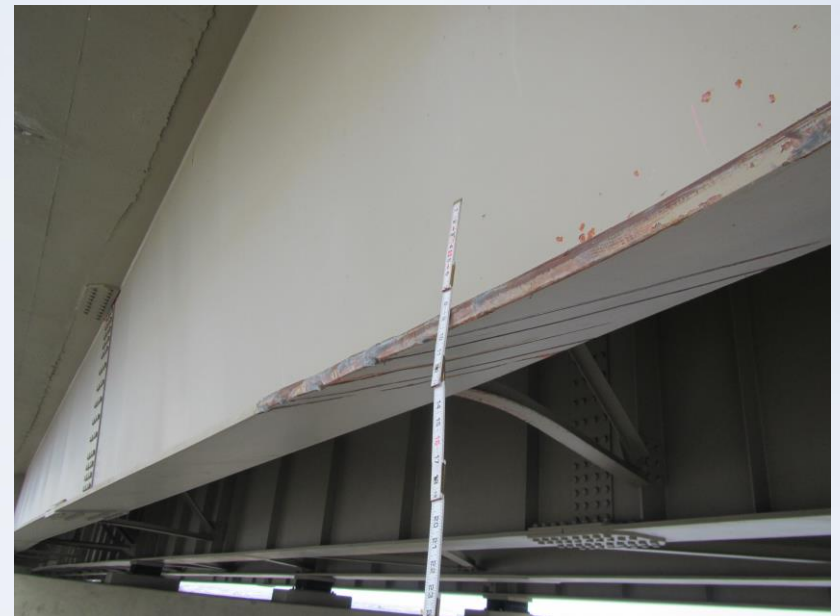
Figure 2: Affected Elements

- 1. Deflection/deformation of Girder 1
  - a. Shaking of Girder 1 under load
- 2. Diaphragm buckling
- 3. Vertical Web Stiffener buckling
- 4. Crack - Girder 1, Diaphragm 5, Bay 1, Web Stiffener, Top
- 5. Crack - Girder 3, Diaphragm 4, Bay 2, Web Stiffener, Bottom
- 6. Crack - Girder 3, Diaphragm 4, Bay 3, Web-Bottom Flange weld
