Bridge Deck NDE Program

Philip Meinel, PE

Structures Asset Management Engineer

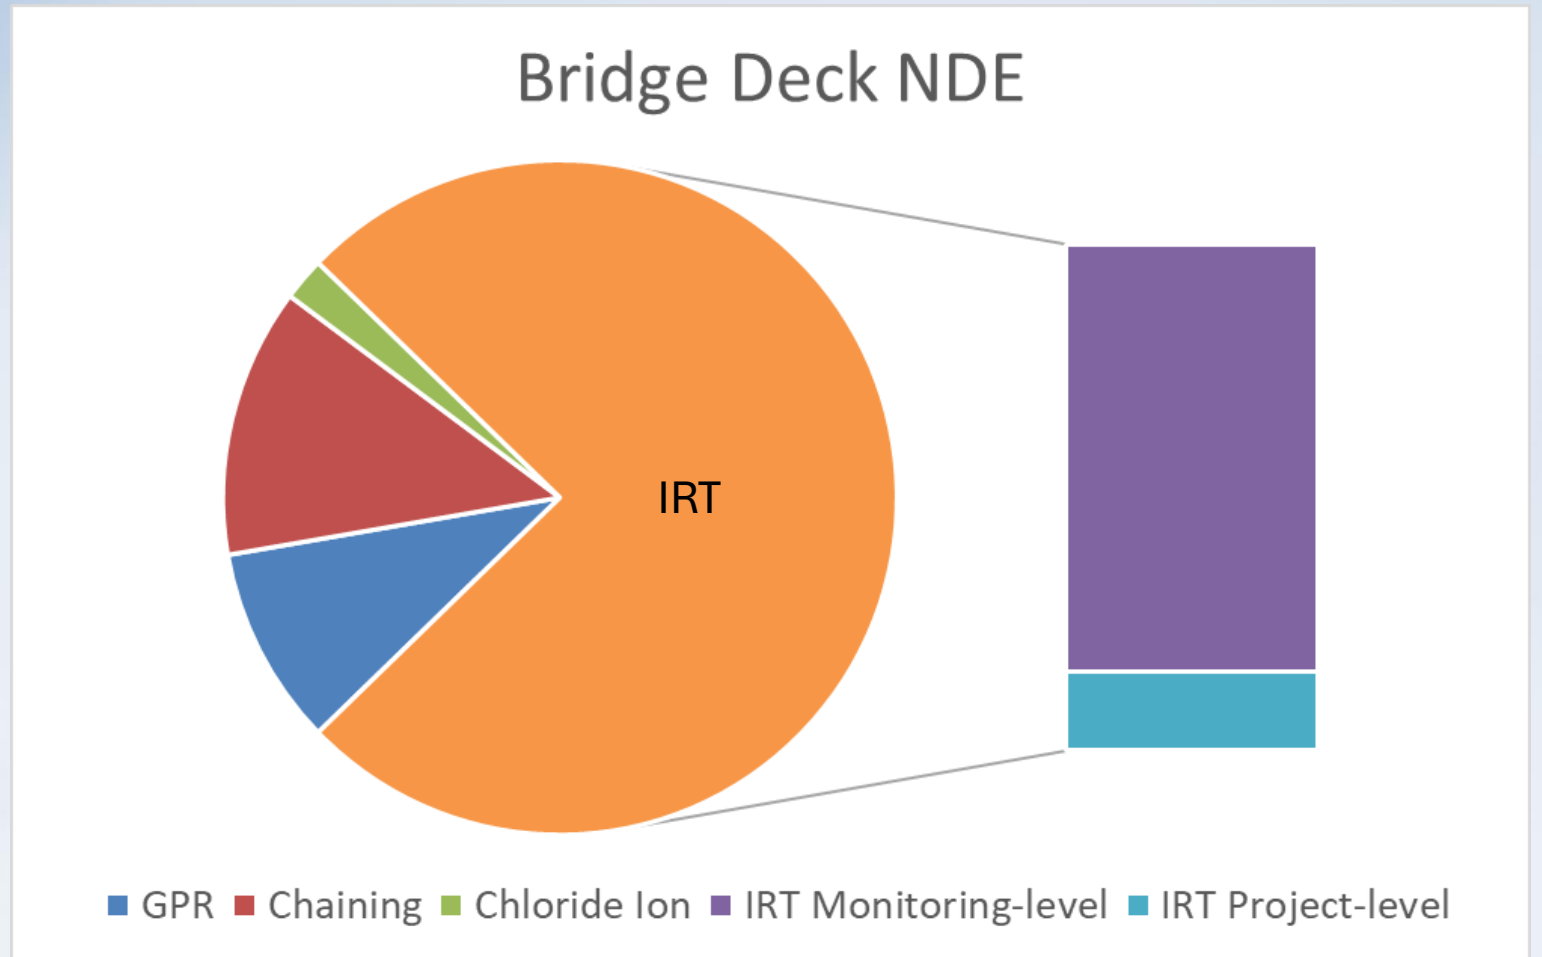
- Bridge Deck NDE
 - IRT
 - GPR
 - Manual Chaining
 - Chloride Ion Testing
 - Automated Sounding

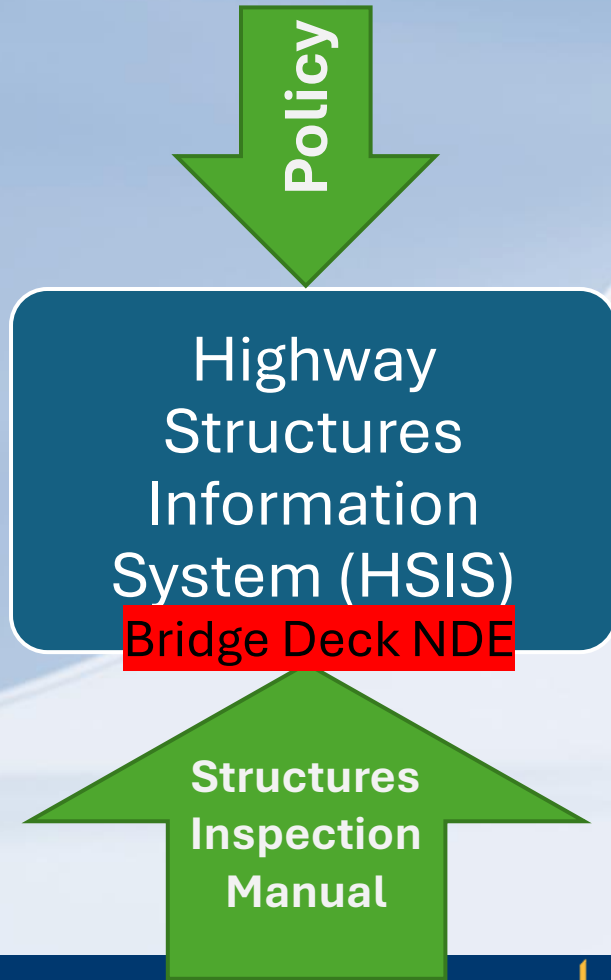
Chapter 6.D – Wearing Surfaces

- 2014 – Implemented AASHTO Elements statewide
 - WI uses ADEs to track deterioration of individual wearing surfaces

D. Wearing Surfaces

Wearing Surface Elements

Wearing Surfaces (Other) (Element 510) - This element is for all decks/slabs that have overlays other than those listed below, such as timber running planks.

Wearing Surface (Bare) (Element 8000) - This element defines decks/slabs that do not have a wearing surface and will be coded to capture the top of a deck/slab without a wearing surface.

AC Overlay (Element 8511) – Defines flexible asphaltic overlay.

AC Overlay & Membrane (Element 8512) - Defines flexible asphalt overlays with membranes or PMA systems.

Thin Polymer Overlay (Element 8513) - Defines thin polymer overlays.

Concrete Overlay (Element 8514) - Defines rigid concrete overlays.

Polyester Concrete Overlay (Element 8515) - Defines polyester concrete overlay systems.

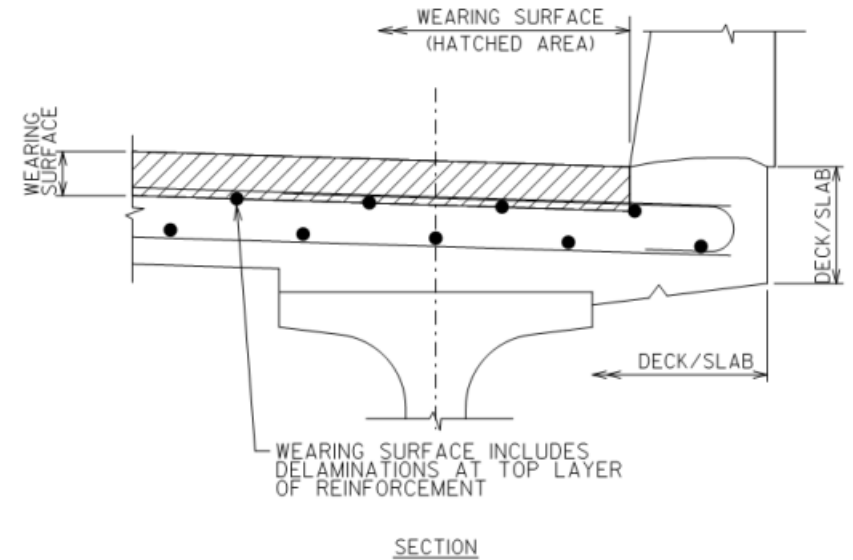
Chapter 3.J – Wearing Surfaces

- 2016 – Clarified Wearing Surface extent
 - Ensure results are recorded under each wearing surface element defect

Wearing Surfaces	
510 – Wearing Surfaces (Other)	SF
8000 – Wearing Surface (Bare)	SF
8511 – AC Overlay	SF
8512 – AC Overlay & Membrane	SF
8513 – Thin Polymer Overlay	SF
8514 – Concrete Overlay	SF
8515 – Polyester Concrete Overlay	SF

Defect 3210 IR/Thermography or GPR Results for delaminations down to the top layer of reinforcement should be quantified under Defect 3210 under the applicable wearing surface element.

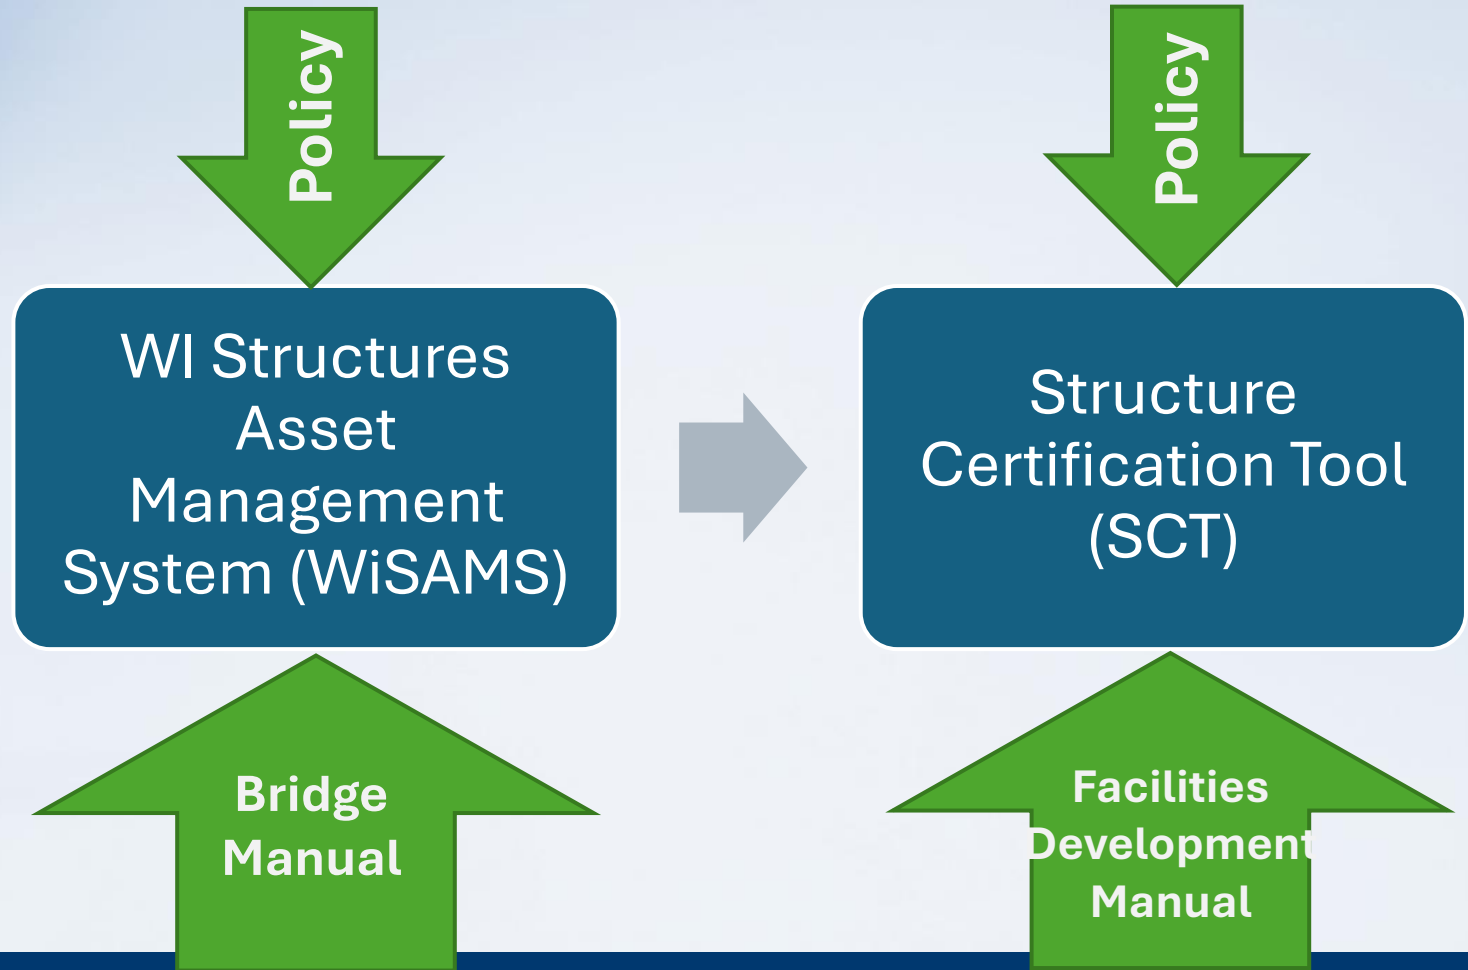
- 2017 – WiSAMS first official report
 - BMS Optimizer
 - Projected work recommendations
- 2019 – Structures Certification process
 - Central office approval of all structure work

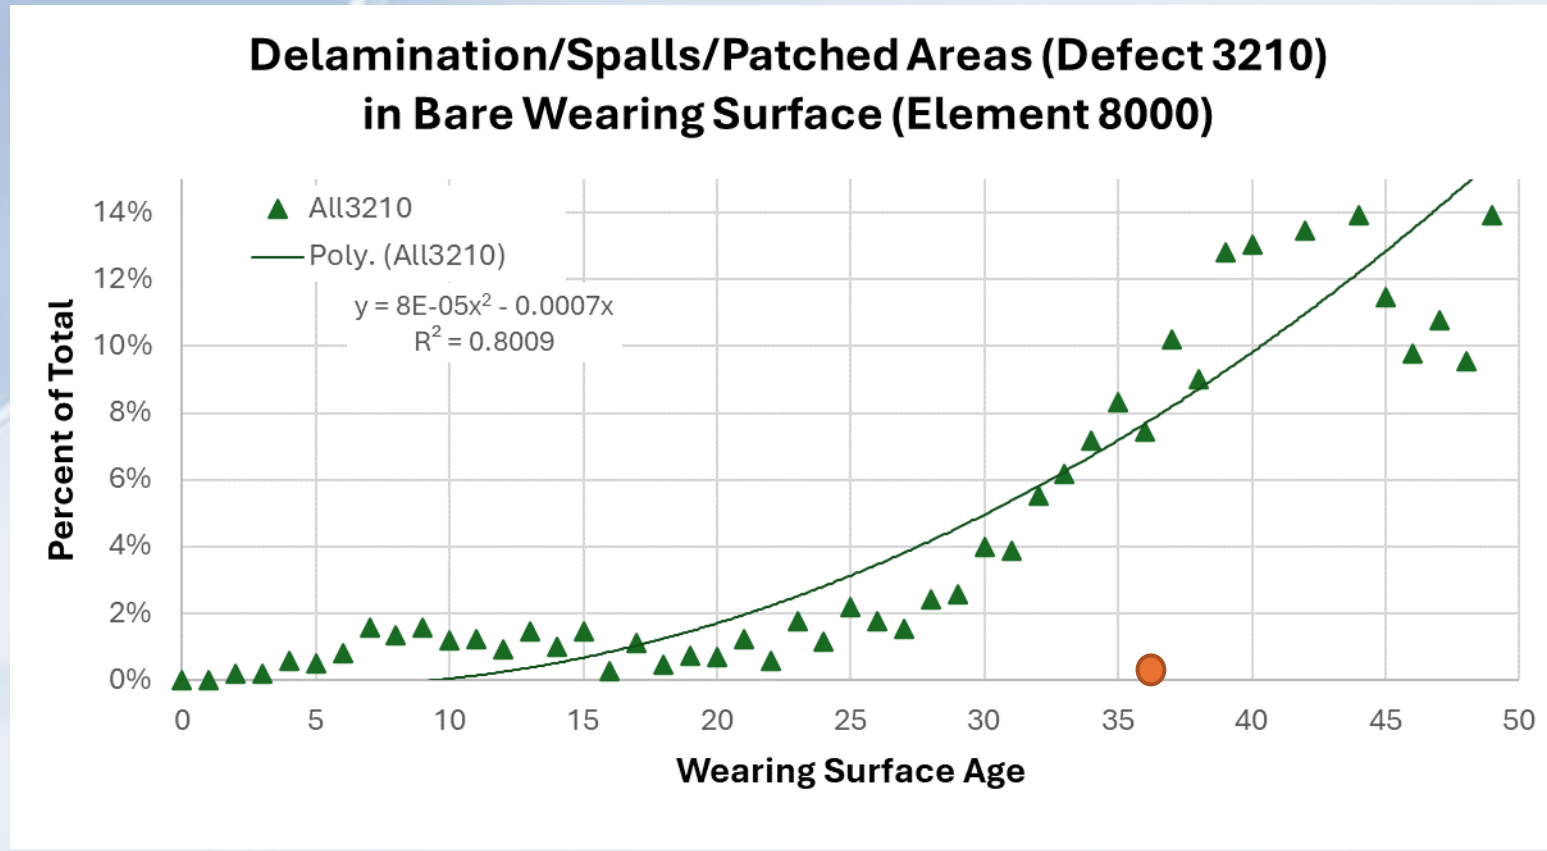
- Typical deterioration of Wearing Surface (Bare) ADE 8000

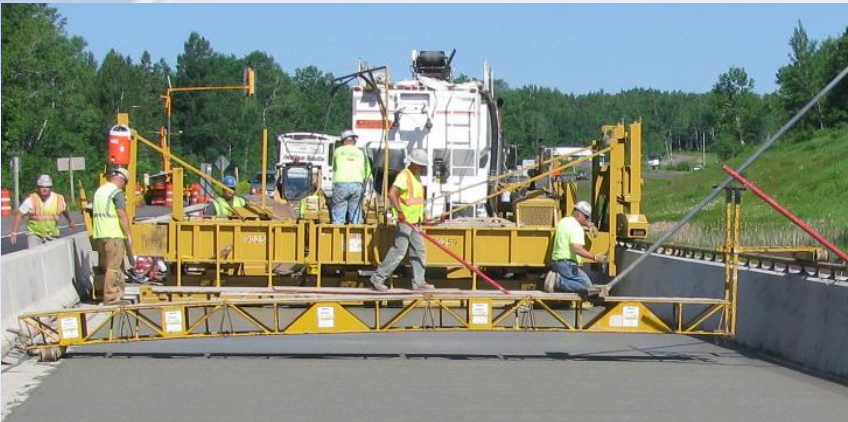
- Globally...not much, but for this individual structure...
 - Visual only inspection
 - No work action
 - Visual with IRT results
 - 2035 concrete overlay

Work Concept	Fiscal Year	Add to Project	Delete Proposed	Review
OVERLAY DECK - CONCRETE	2035	Add	N/A	Review/Edit Propose New
