Scour Mitigation Program in Oklahoma DOT Local Government Division

Melissa Davis, PMP – Oklahoma DOT Local Government Division

Michael Dukes, PE – Consor

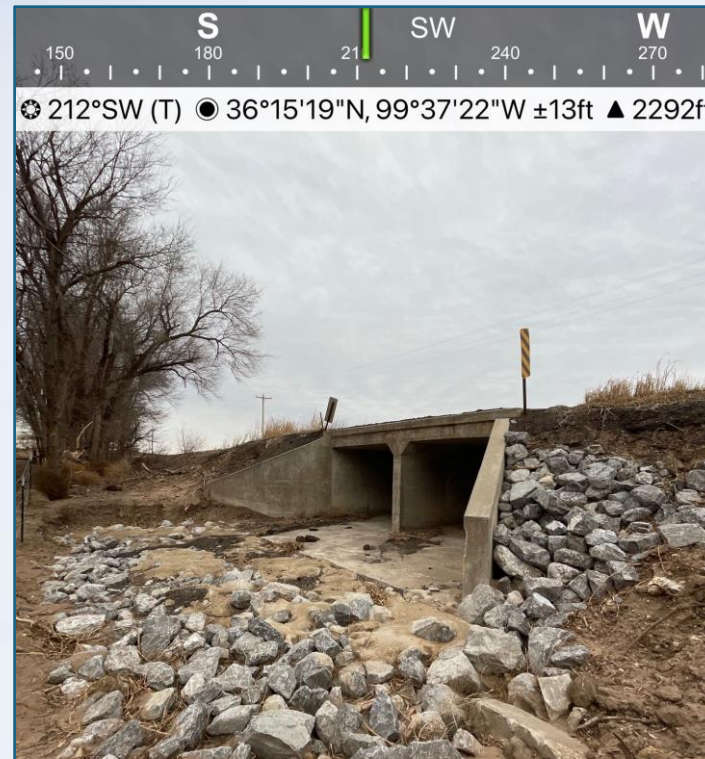
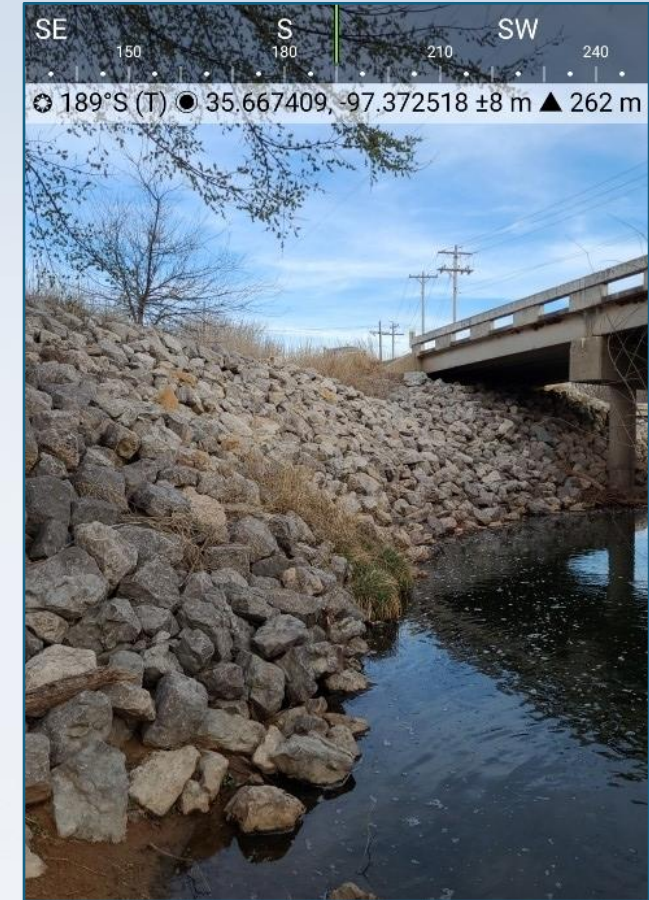
- Discuss common findings
 - **Repairs already completed**
 - Update rating
 - Debris
 - Foundation Exposure
 - Poor Channel Alignment

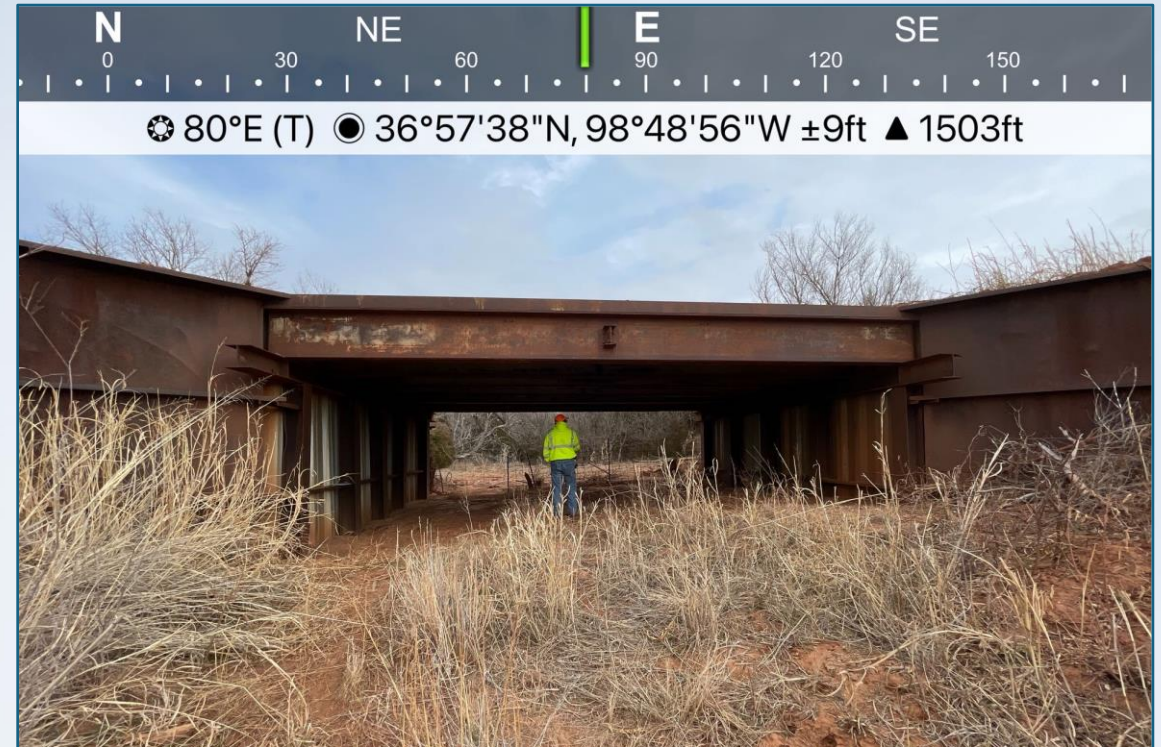
- Discuss common findings
 - Repairs already completed
 - **Update rating**
 - Debris
 - Foundation Exposure
 - Poor Channel Alignment

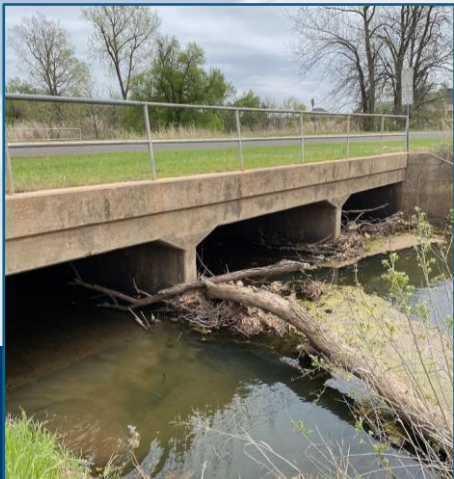
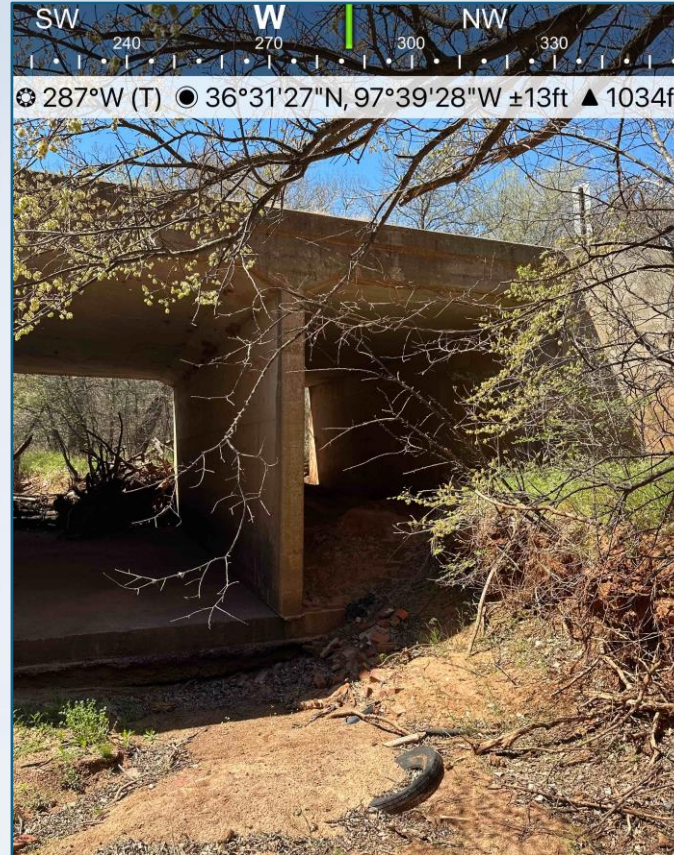
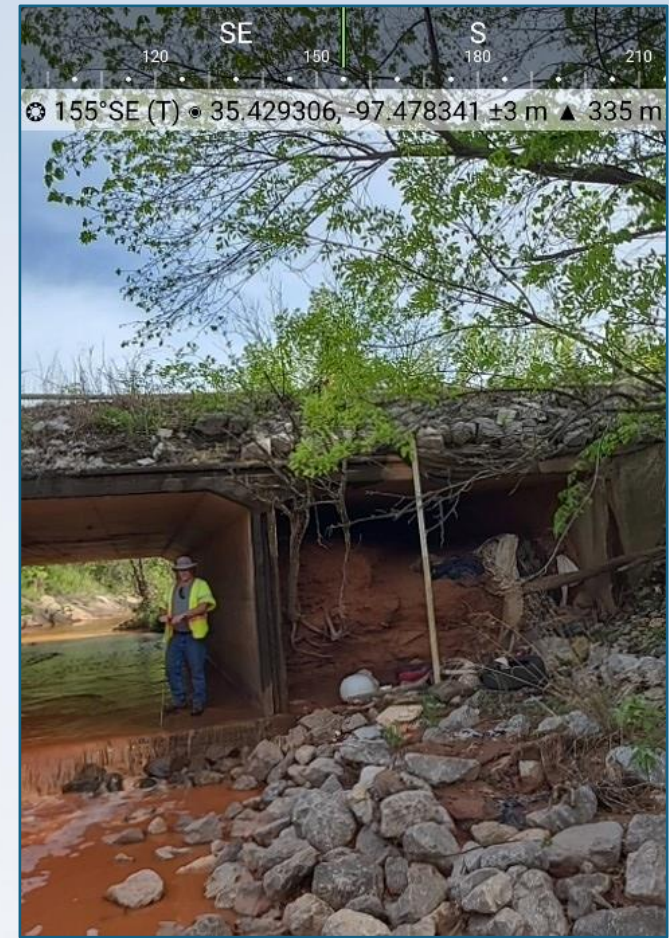
- Discuss common findings
 - Repairs already completed
 - Update rating
 - **Debris**
 - Foundation Exposure
 - Poor Channel Alignment

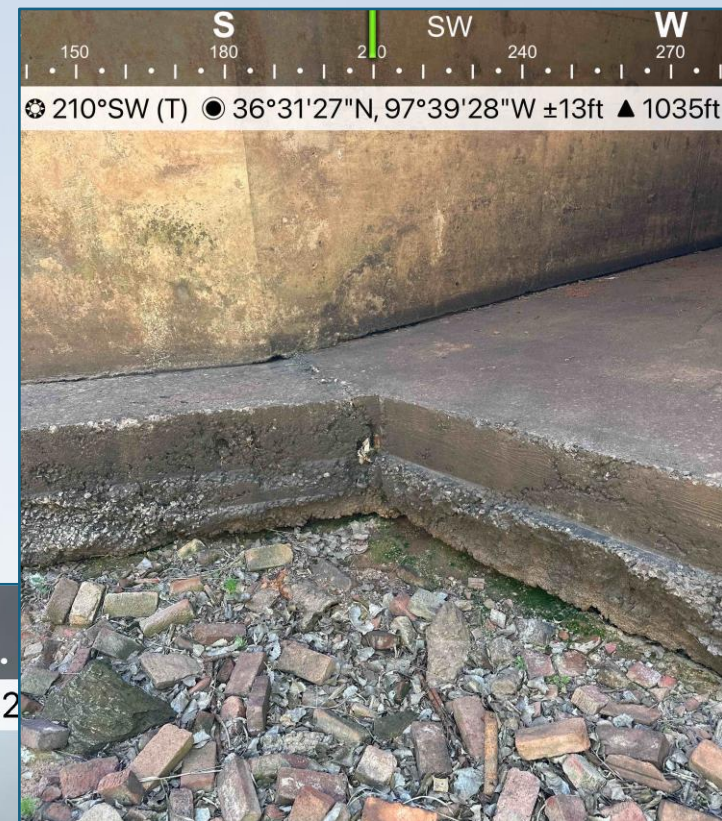
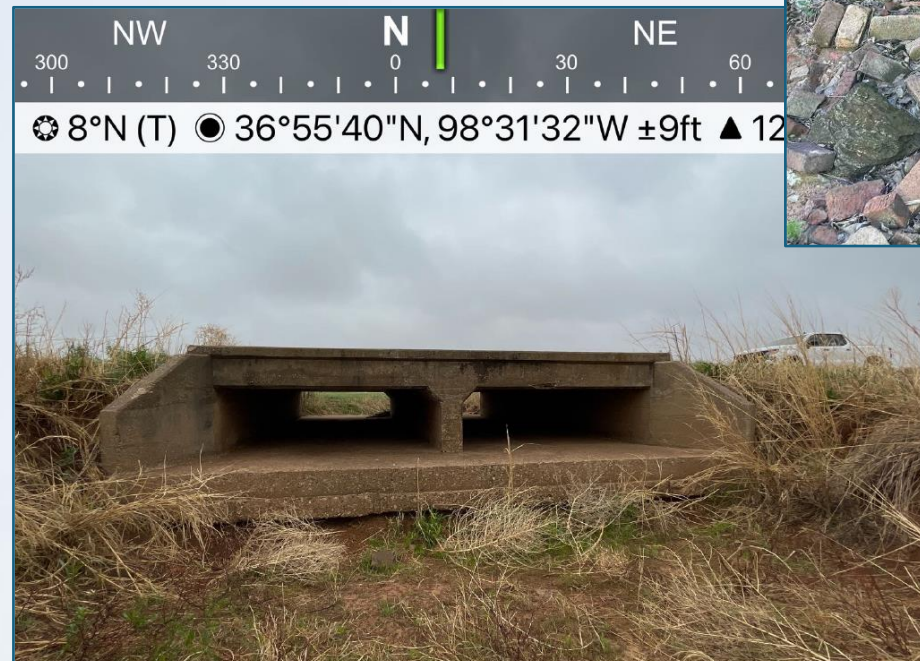
- Discuss common findings
 - Repairs already completed
 - Update rating
 - Debris
 - **Foundation Exposure**
 - Poor Channel Alignment

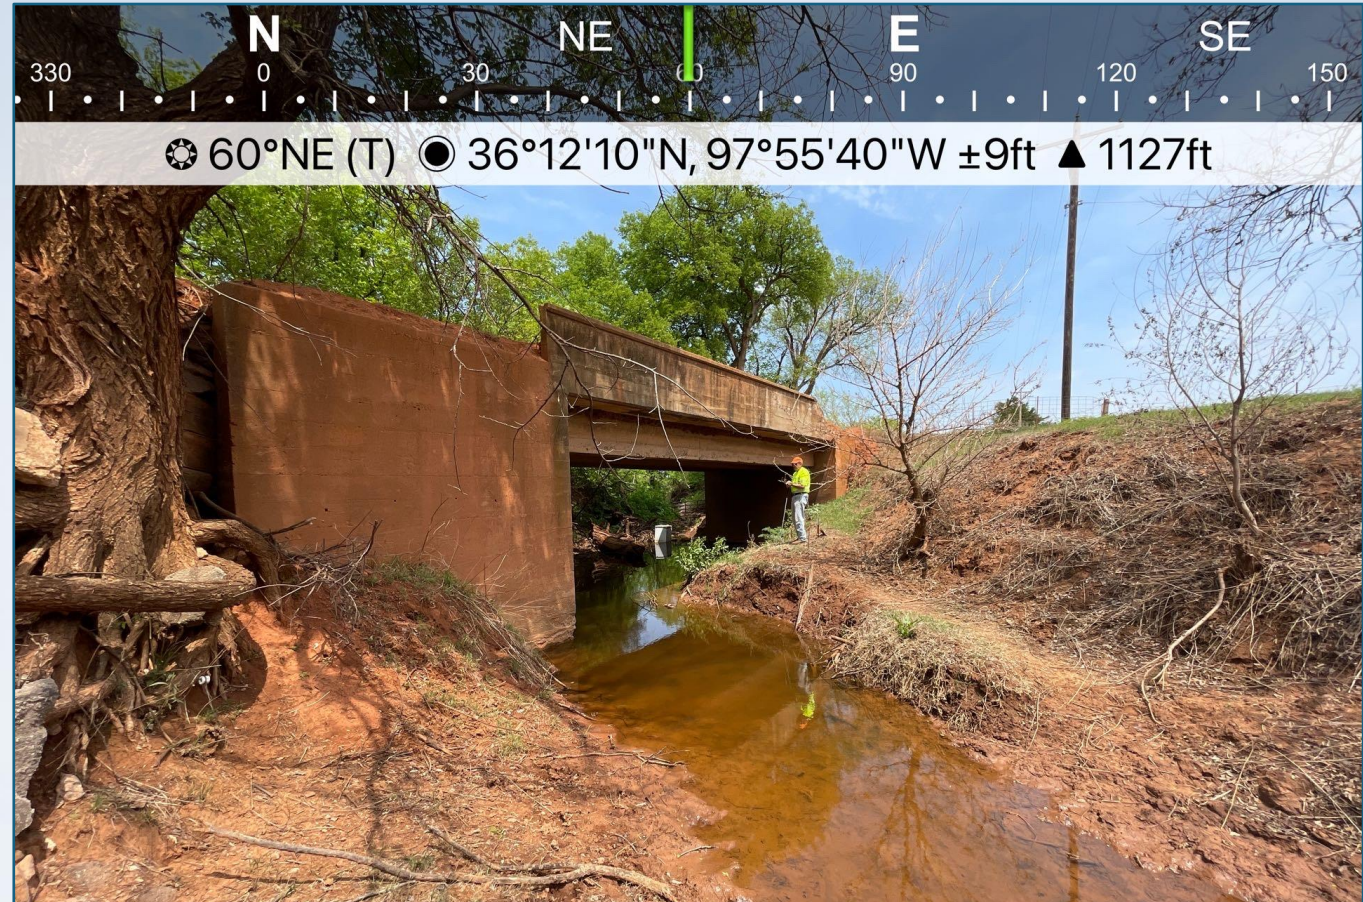
- Discuss common findings
 - Repairs already completed
 - Update rating
 - Debris
 - Foundation Exposure
 - **Poor Channel Alignment**
