# I-26 Green River Bridges

National Bridge Preservation Partnership  
September, 2024

Tim Sherrill, PE – NCDOT  
John Sloan, PE – AECOM

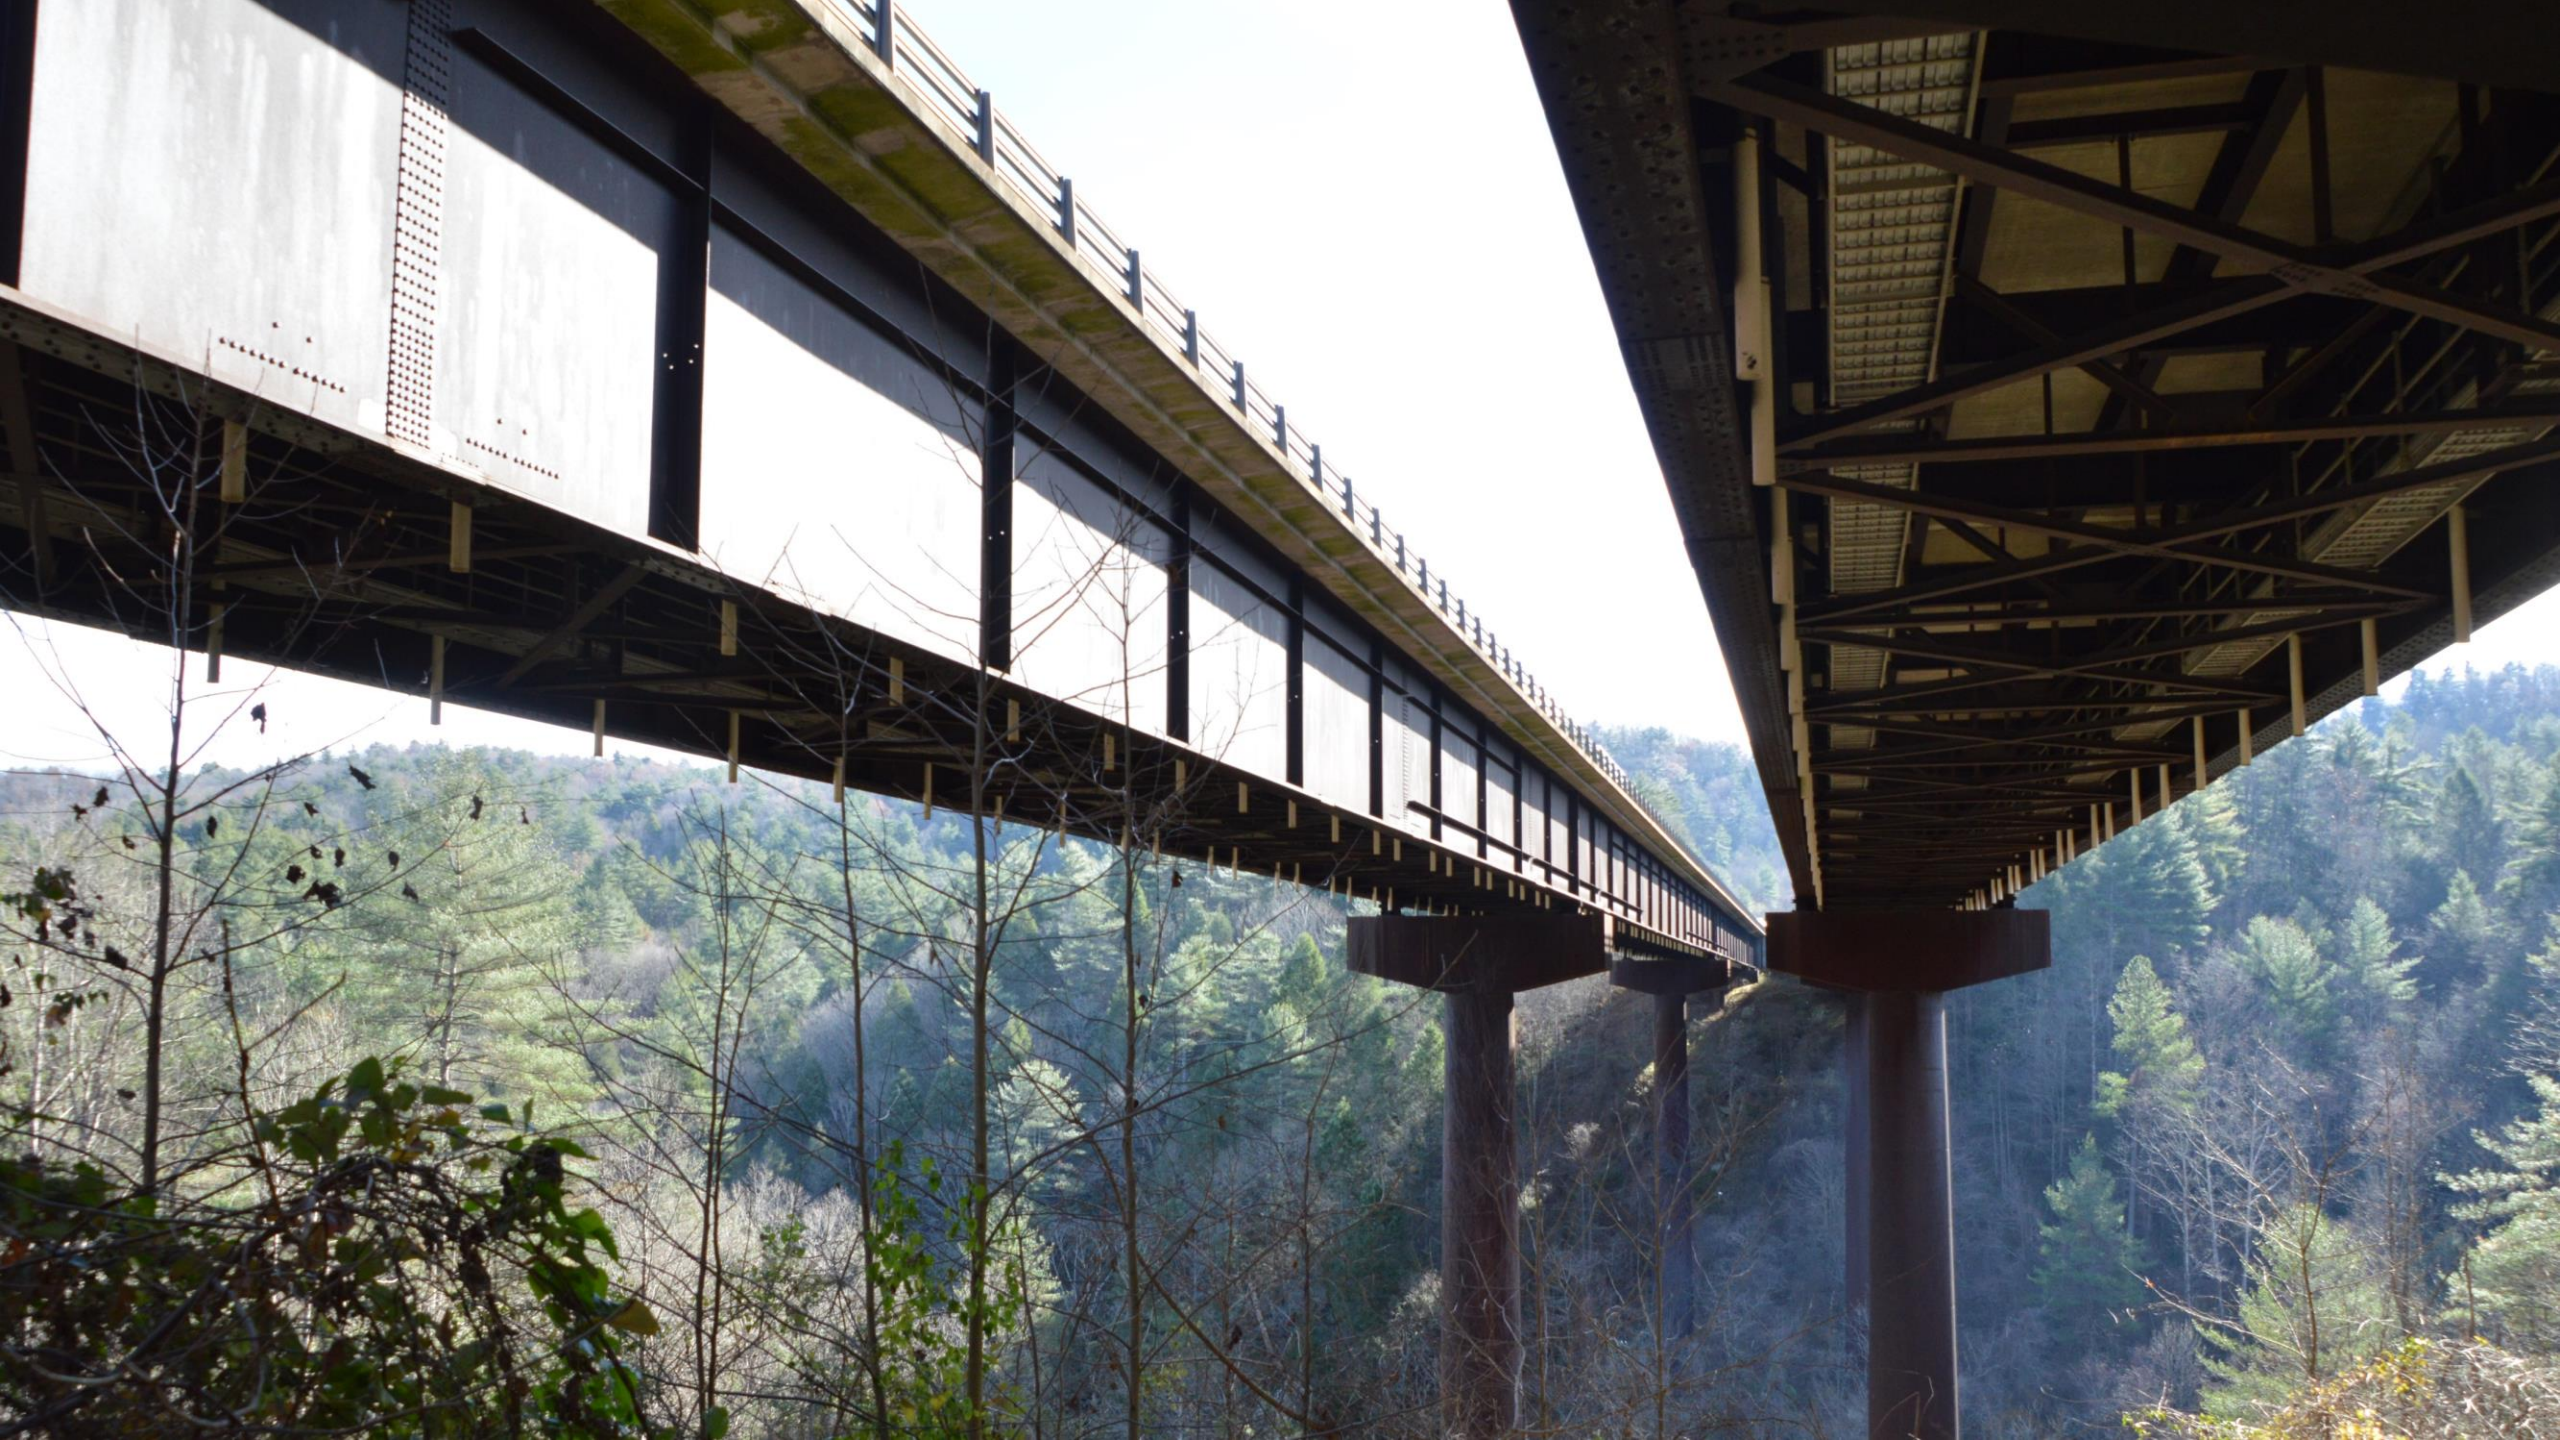
EXISTING STRUCTURE

100'

260'-0"

330'-2"

230'-0" +/-

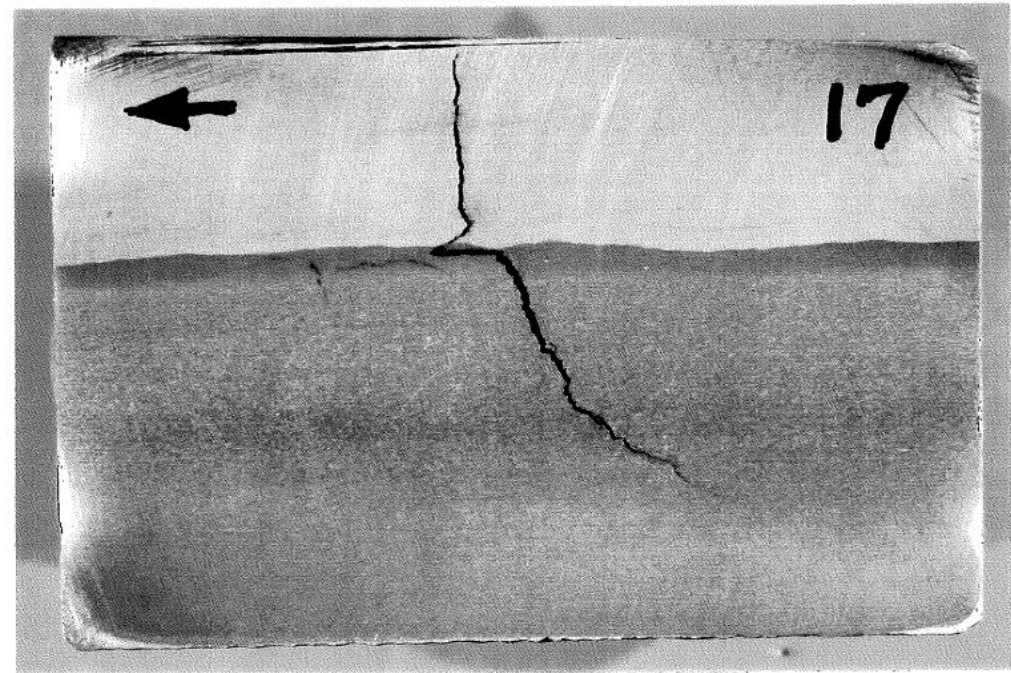
Figure 6: Longitudinal Cross-Section through Core #17 Showing a Transverse Weld Metal Crack and Propagation of the Crack into the Flange. Arrows Show HAZ Cracks and their Propagation into the Base Metal Adjacent to Primary Crack.

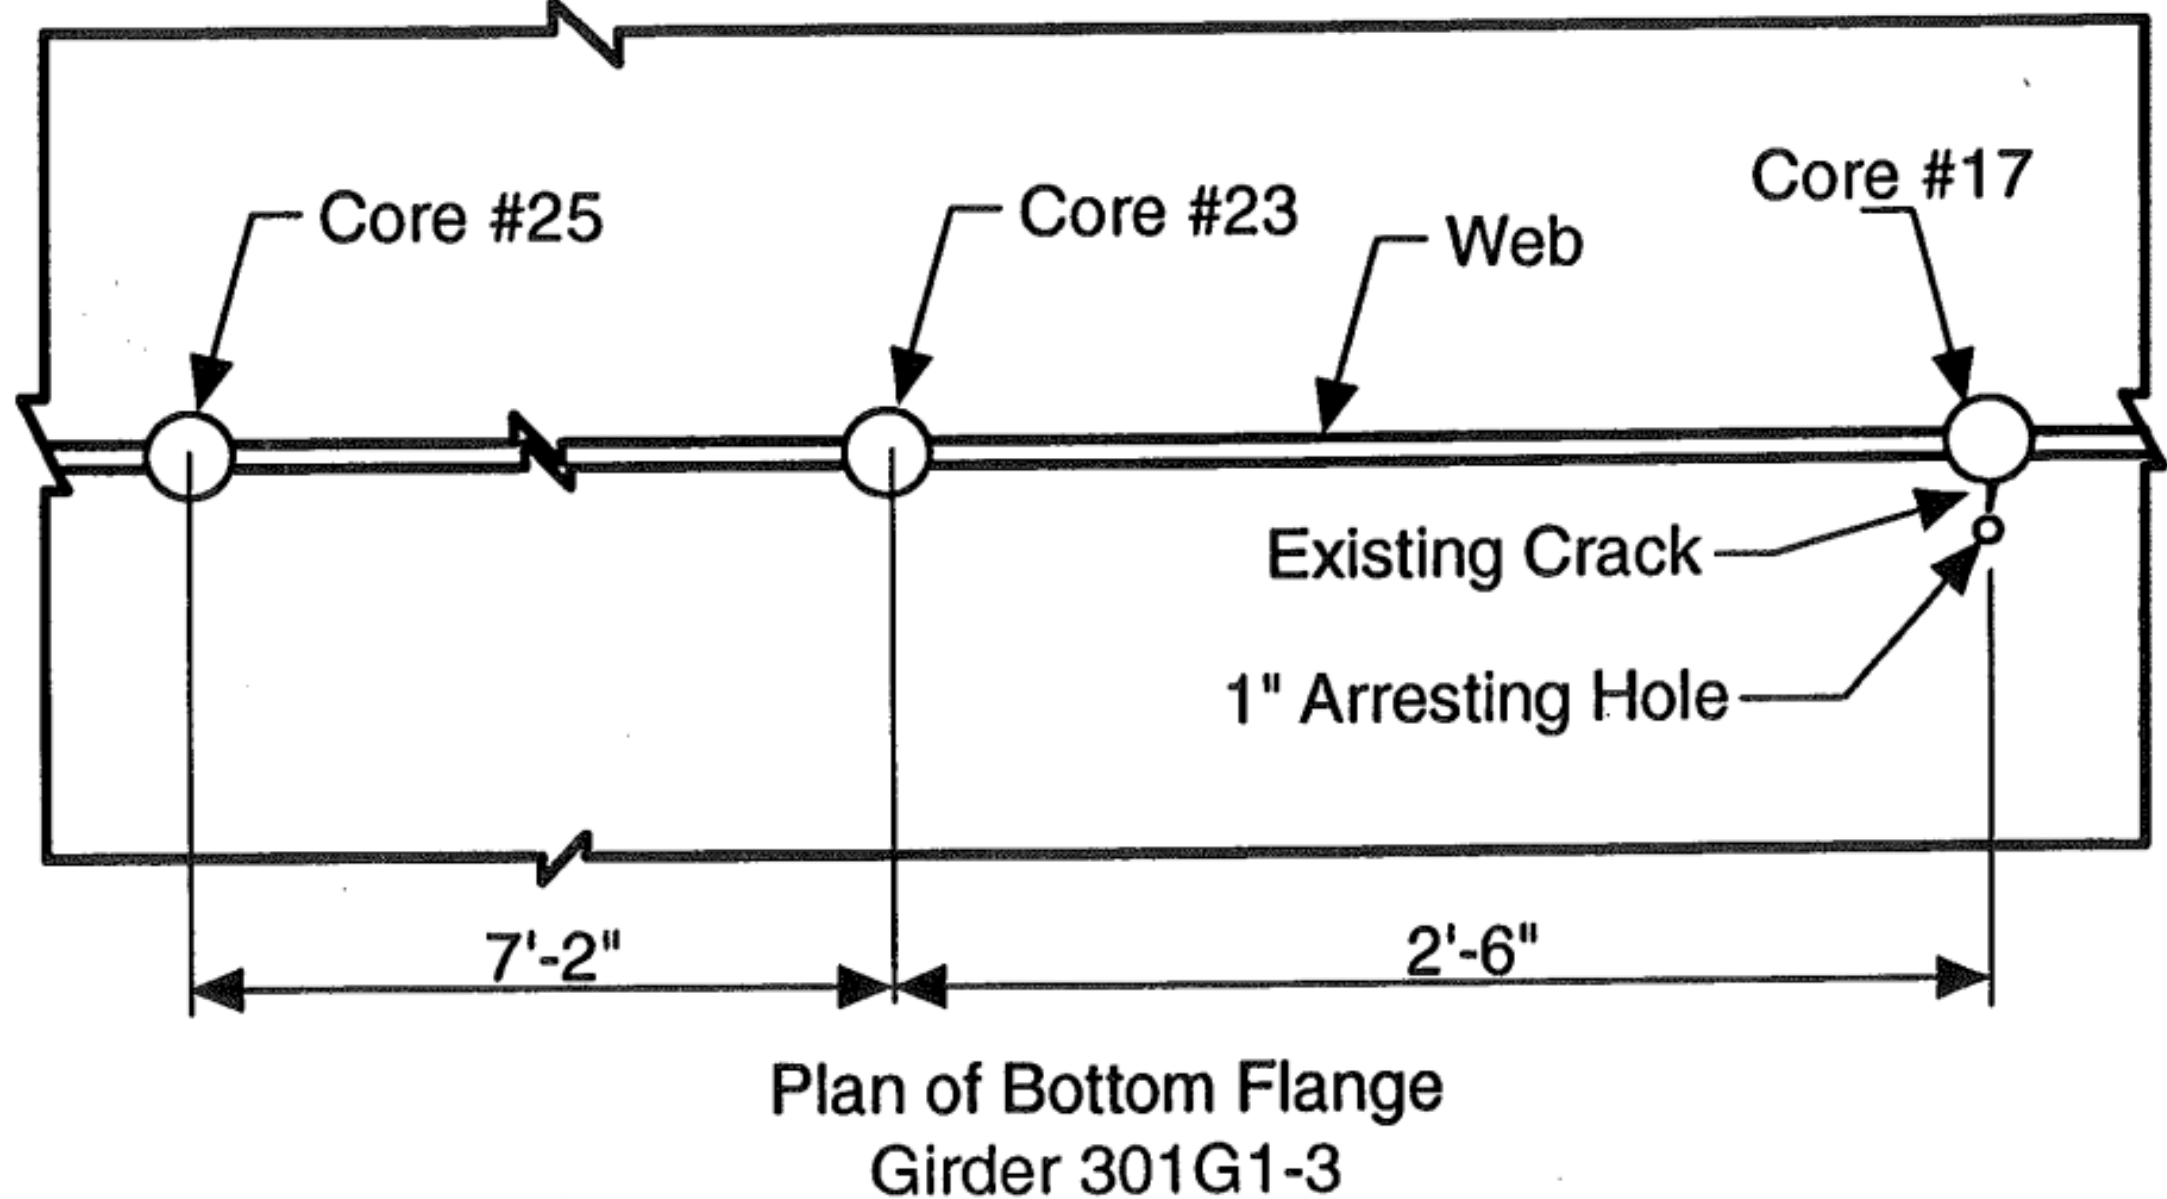
Figure 14a: Schematic of Girder 301G1-3 at Location Where Cores 17, 17-1, 23 and 25 Were Removed.

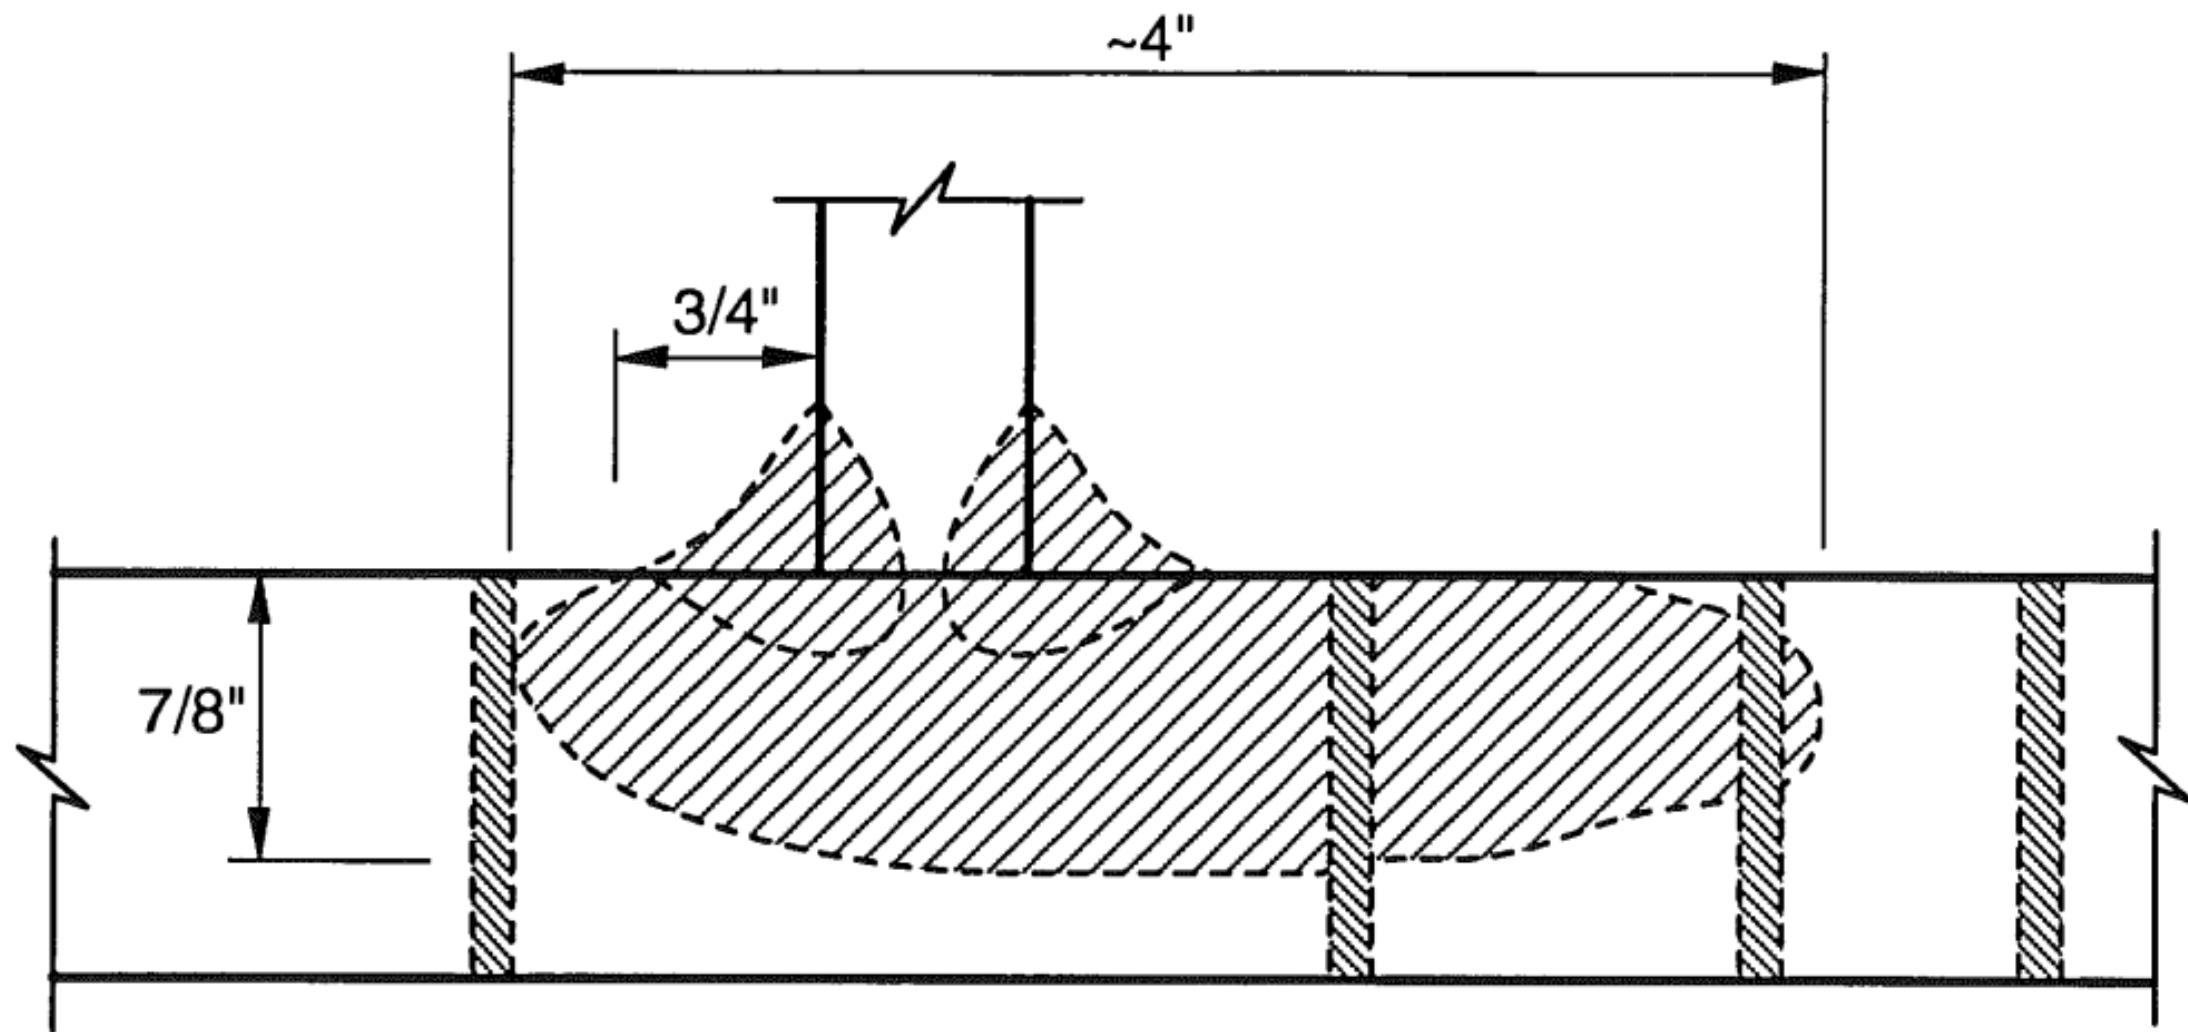
(a) Schematic of Crack in Flange at Core #17

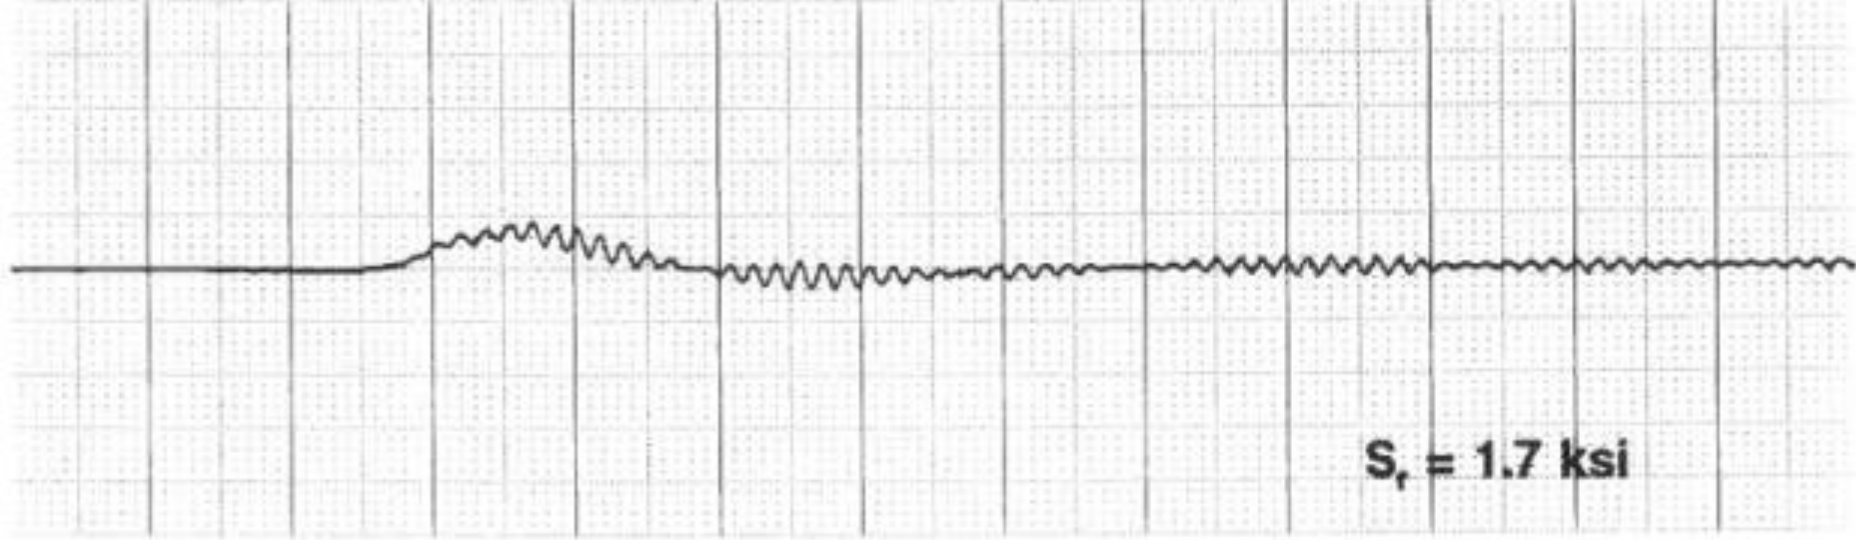
**Gage 15**  
**Lateral Brace**

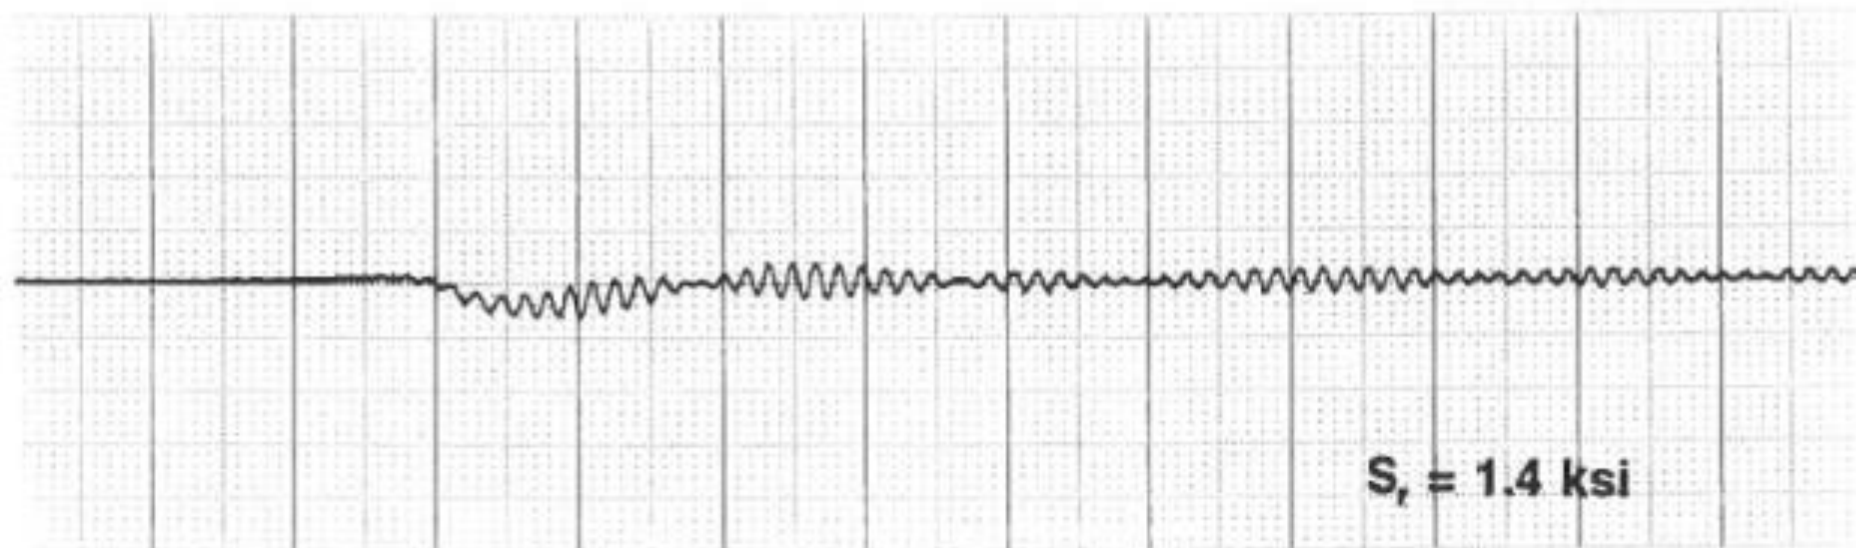
**Gage 16**  
**Lateral Brace**

**Truck 1 Right Lane at 40 mph**

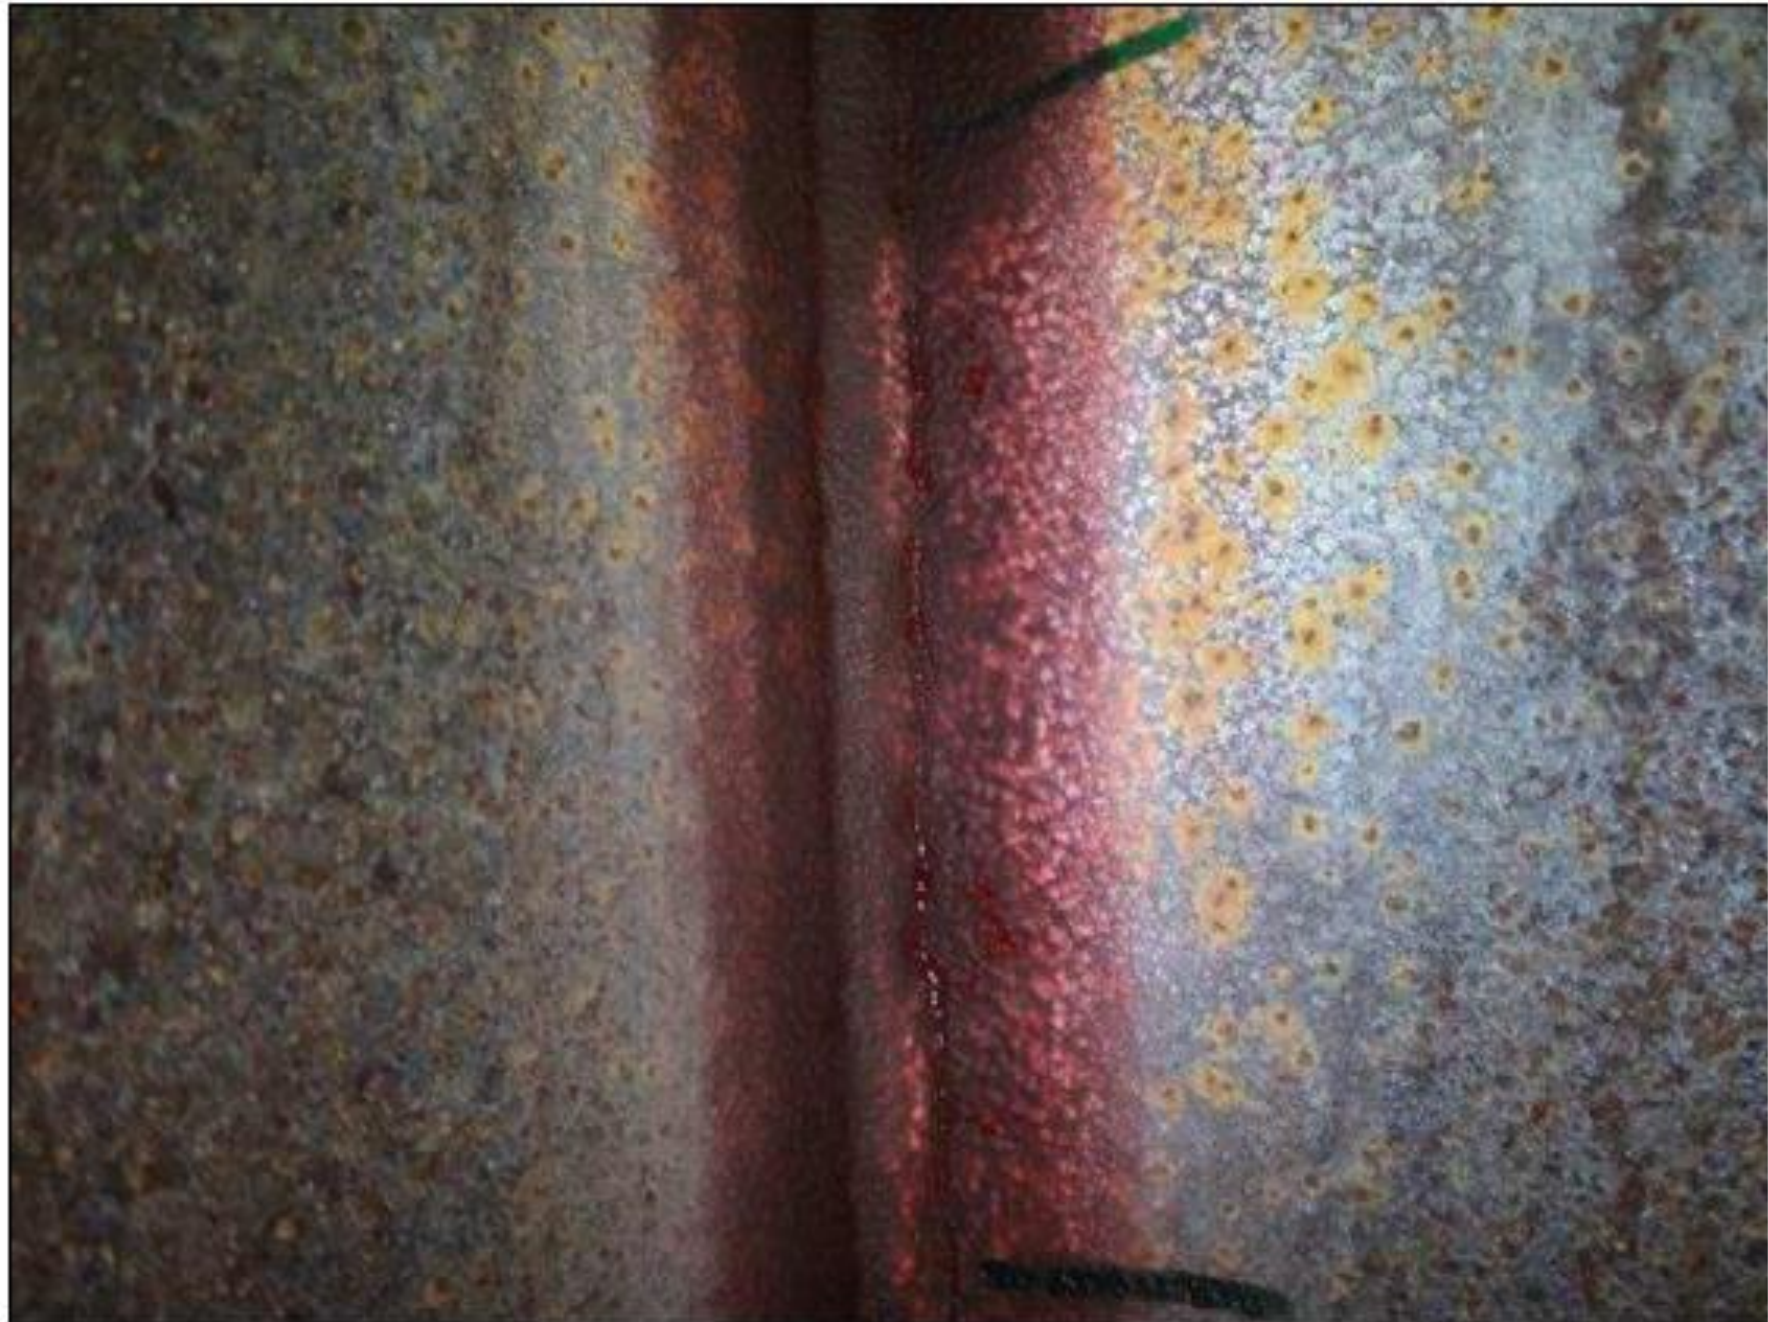
Span 2 Beam 2: upper web to 4th web stiffener from bent 2 exterior face, crack in weld (5in) found after dye-penetrant test performed (photo 1 of 2)

Span 5, beam 1 web underside longitudinal  
Stiffener between 2nd and 3rd vertical  
stiffener exterior.

Web

Start and stop of weld

Fillet weld

Stiffener
