I-80 Corridor Feasibility Study

Introduction of NDE in Utah

I-80 Airport Bridges

PIN 18527 | May 2022

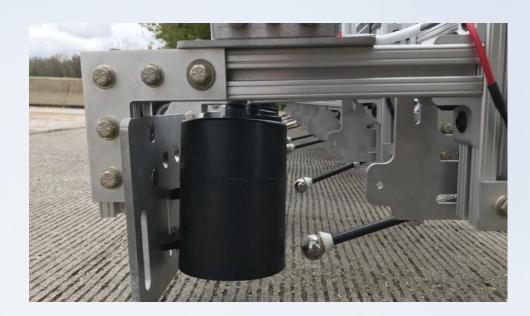
NDE – Automated Acoustic Sounding

Name:	Automated Ac	oustic Sounding (SounDAR)
# of Bridges Tested:		18
Descriptio n:	back of a vehicle	of sounding, mounted to the e. Identifies delaminations in e or overlay materials
	Pros:	Cons:
speeds	used at high ent automation	 Does not perform well on bridges with HMA overlays

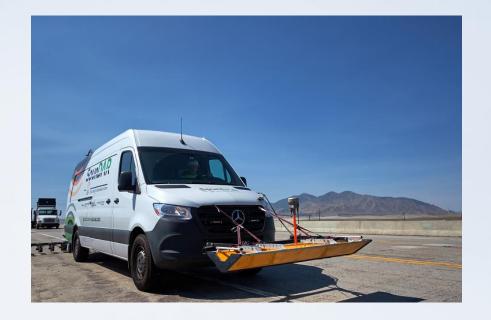
NDE – Ground Penetrating Radar (GPR)

Name:	Ground P	enetrating Radar (GPR)
# of Bridges Tested:		36
Descriptio n:	depth of rebar, a concrete deficient	determine overlay thickness, and evaluate the likelihood of cies in the bridge deck (existing and predicted)
	Pros:	Cons:
speeds	used at high ent automation	 Requires longer periods of time to process results Data is not intuitive and difficult to interpret

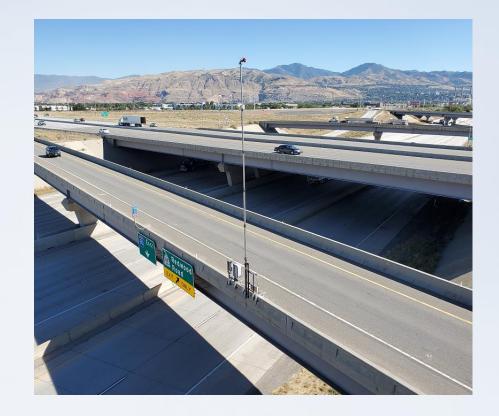
NDE – Ultra-Time Domain IR (IR-UTD)

Name:	Ultra Time Domain	Infrared Thermography (IR-UTD)
# of Bridges Tested:		side and 10 underside)
Descriptio n:	longer period of	mounted in one location for a time, capturing temperature curately than static images.
	Pros:	Cons:
 Low user Simple s equipme 	et up and	 Prone to environmental events Accuracy

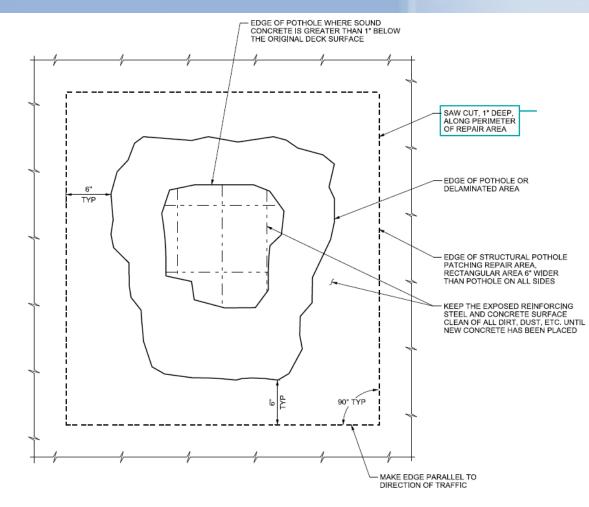
TYPICAL SECTION

OPEN POTHOLE DECK REPAIR
